Article title: Rocker Pipe Solution to Alleviate Settlement Induced Distress in Flexible Pipes

ROCKER PIPE SOLUTION TO ALLEVIATE SETTLEMENT INDUCED DISTRESS IN FLEXIBLE PIPES

D. C. Wijeyesekera and J.T.Reginold

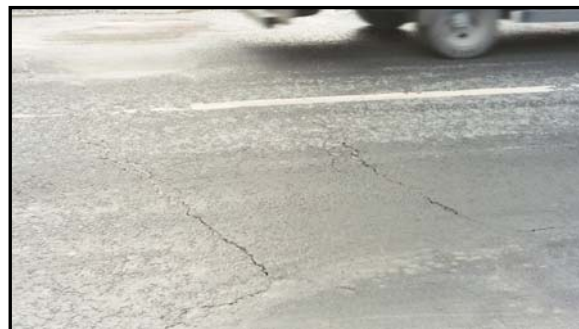
300mm AC water main, which was laid across a busy highway (see figure 1). The AC water main pipe failed within 3days after the installation of the same at the site. The constructional specification required pea gravel bedding. The extent of excavation of the trench access the highway is seen in figure 1 and also evident is the conspicuous transverse subsidence cracking (figure 1) of the highway pavement that indicated traffic induced settlement of the backfilled trench walls.

Figure 1. Subsidence cracks, parallel to trench walls on the surface

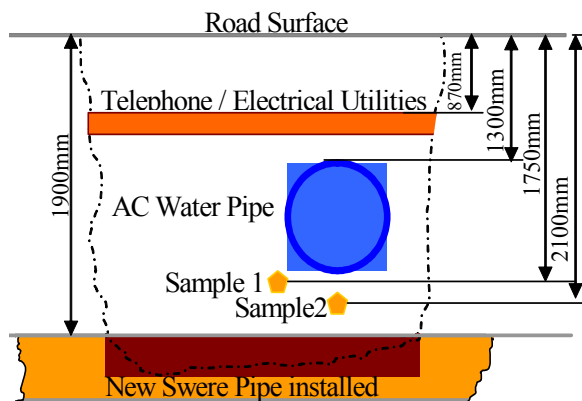
Figure 2 below shows the approximate dimensional details of pipe location and note

that the AC water main was above and perpendicular to the sewer line being installed. It was also noted that the heavy traffic passing over the irregular road surface caused noticeable vibration of the road surface above the pipe.

Figure 2. Sectional detail of the pipe trench

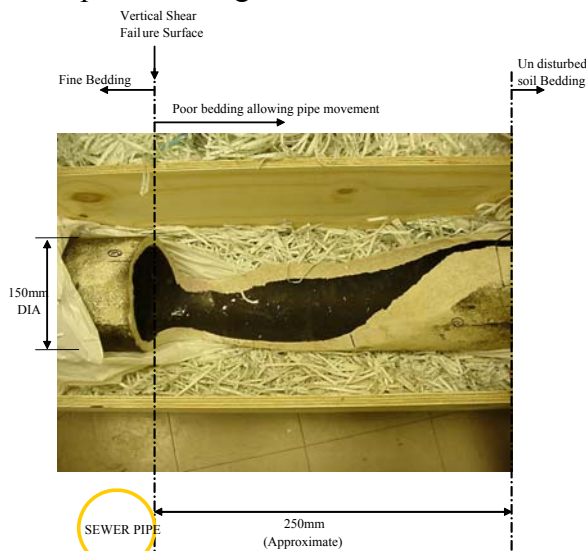
Figure 3 shows the failure surface observed on AC pipe. The geometry of the failure surface shows a vertical feature at the end of the zone with fine secure unexcavated pipe bedding. The fracture surface shows the propagation of the failure resulting from the repeated vertical movements of the pipe with poor bedding.

Figure 3. View of the fractured section of the 150mm AC pipe

Figure 3 also indicates the additional support given by the sewer, which resulted in the peculiar vertical failure surface. The site investigation indicated ground water level was near the spring line and above the pipe invert of the 300 mm water main. This indicated high water table conditions and the soil to be of high permeability that could cause rapid flooding into the trench.

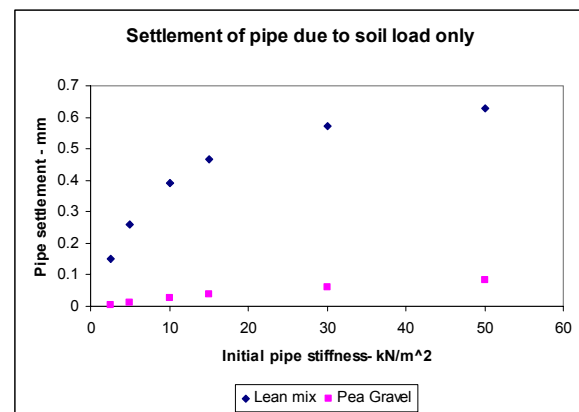
Figure 4 shows the amount of settlement that can occur for a pipe when embedded in lean mix or pea gravel. This depends on the stiffness of the pipe. Nevertheless the

settlements are very small and that with pea gravel embedment is about 10th of the settlement anticipated with lean mix surround. Figure 5 below illustrates the corresponding effects when traffic loading is also considered. Settlements of the order of 3.25 mm can be anticipated for pipes with a stiffness of 50 kN/m².

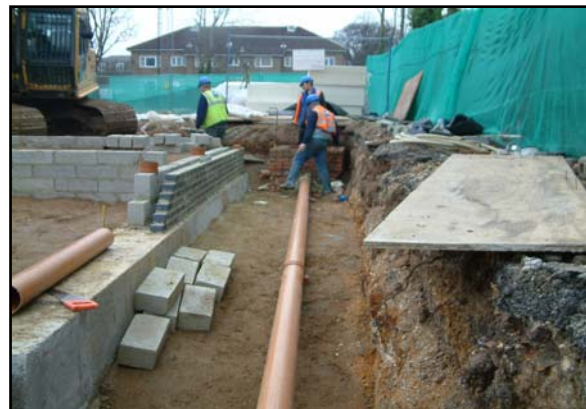
Figure 6. Two length of pipe connecting manhole without construction Joint at the interface

The figure 6 shows a typical layout of manhole with two length of plastic pipe. No bedding is used. Pipes are laid 2-3m away from the structure and hence influence of surcharge and loading is minimum.

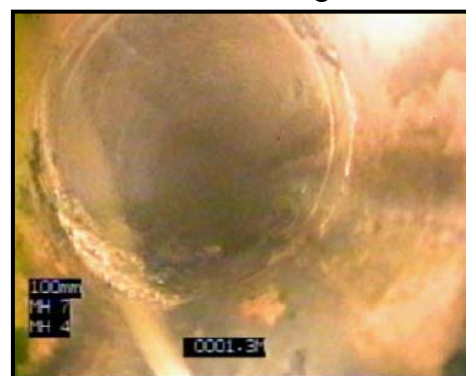
Figure 7. CCTV Monitoring circumferential crack [Failure location from manhole: 15xDia] Failures of such (figure 7) sewer pipelines cause an environmental problems and the effect of the fracture and pipes remains un

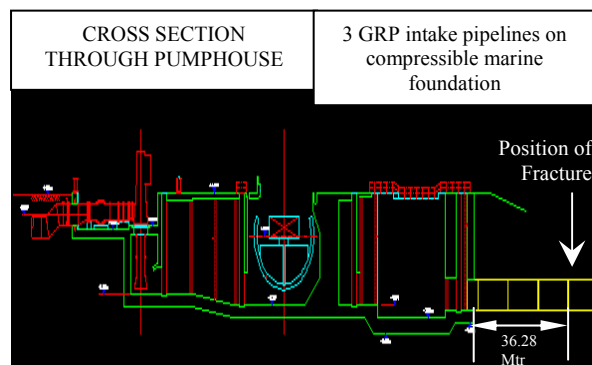
Figure 8. Cross section through Cooling water Pumphouse [Failure location 13xDia]

interface of the pipe with the structure in the transition zone. The three 2.7m diameter GRP pipes failed at the forebay inlet area as a consequence of the flooding of the cooling water pumphouse. The failure took place at a distance of 36.28m from the inlet wall of the pumphouse, and was consistently at the crown of the joints fracturing both the pipe and the coupling, see figures 8, 9 and 10.

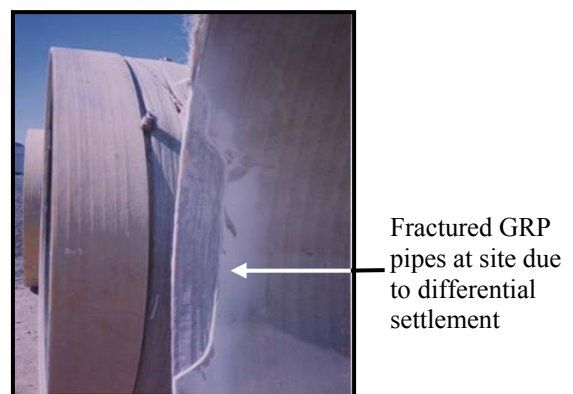
Figure 9. Photographic evidence of the fractured pipes and couplings

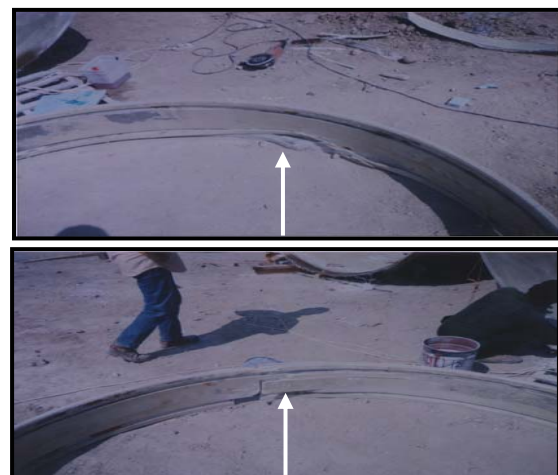
Fractured surface at coupling joint observed at site

Figure 10. Photographic evidence of the fractured pipes and couplings
The design did not accommodate flexible joints or rocker pipe connections at the
