**Climate Proofing Housing Landscapes:  
Monitoring Report 3**

**October 2016 to September 2017**

**Authors: Connop, S., Clough, J., Alam, R. and Nash, C.**

H&F Council and Groundwork London worked with local residents to design and implement climate change adaptation measures on three housing estates in the borough, making them more resilient and adapted for the future.

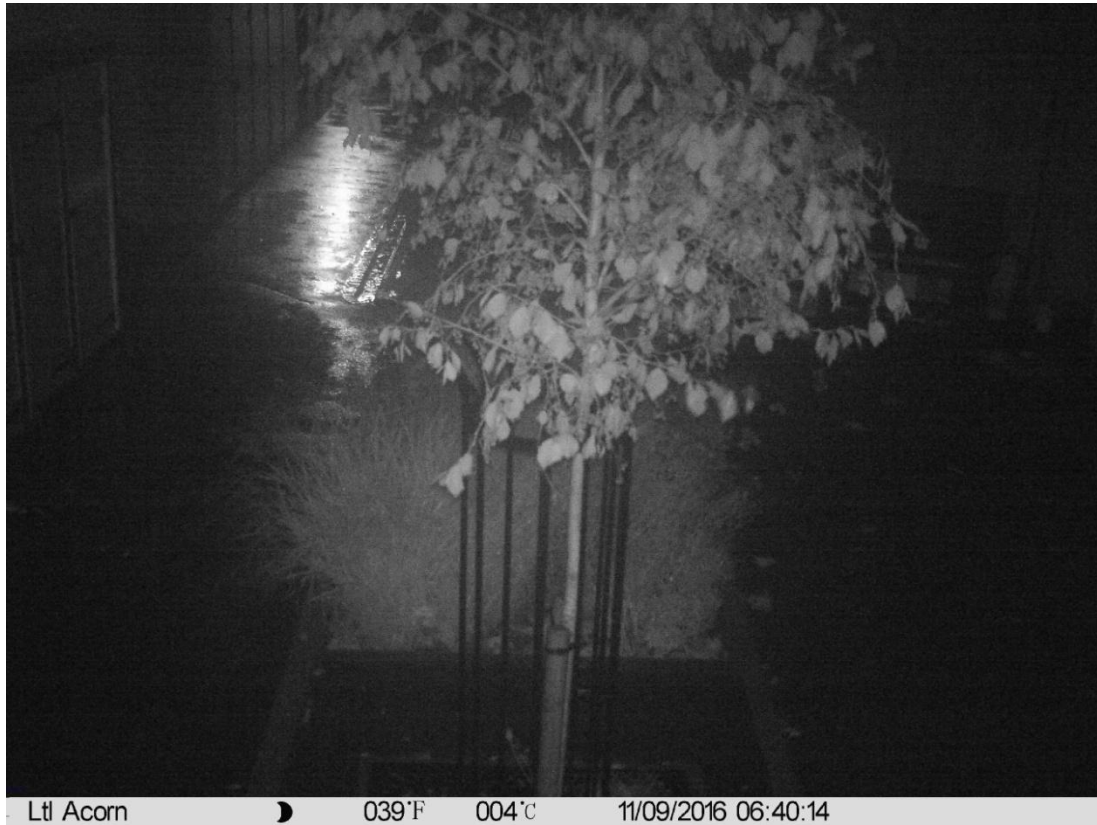
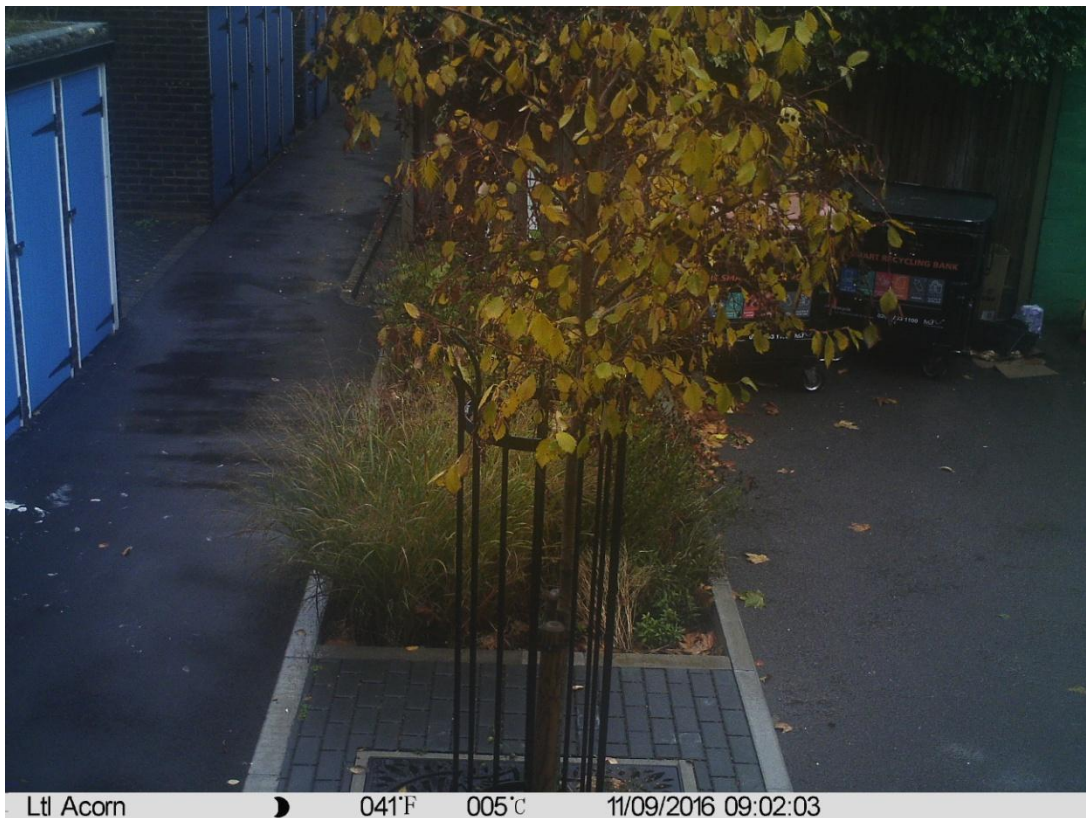
**Figure 6. Time-lapse camera images from Richard Knight House swale (FPC5), 09/11/2016.** Images show i) no evidence of overflowing during period of highest rain intensity at 06:40 and ii) evidence of 100% infiltration/conveyance by the end of the intense rain event at 09:02 on the same day.

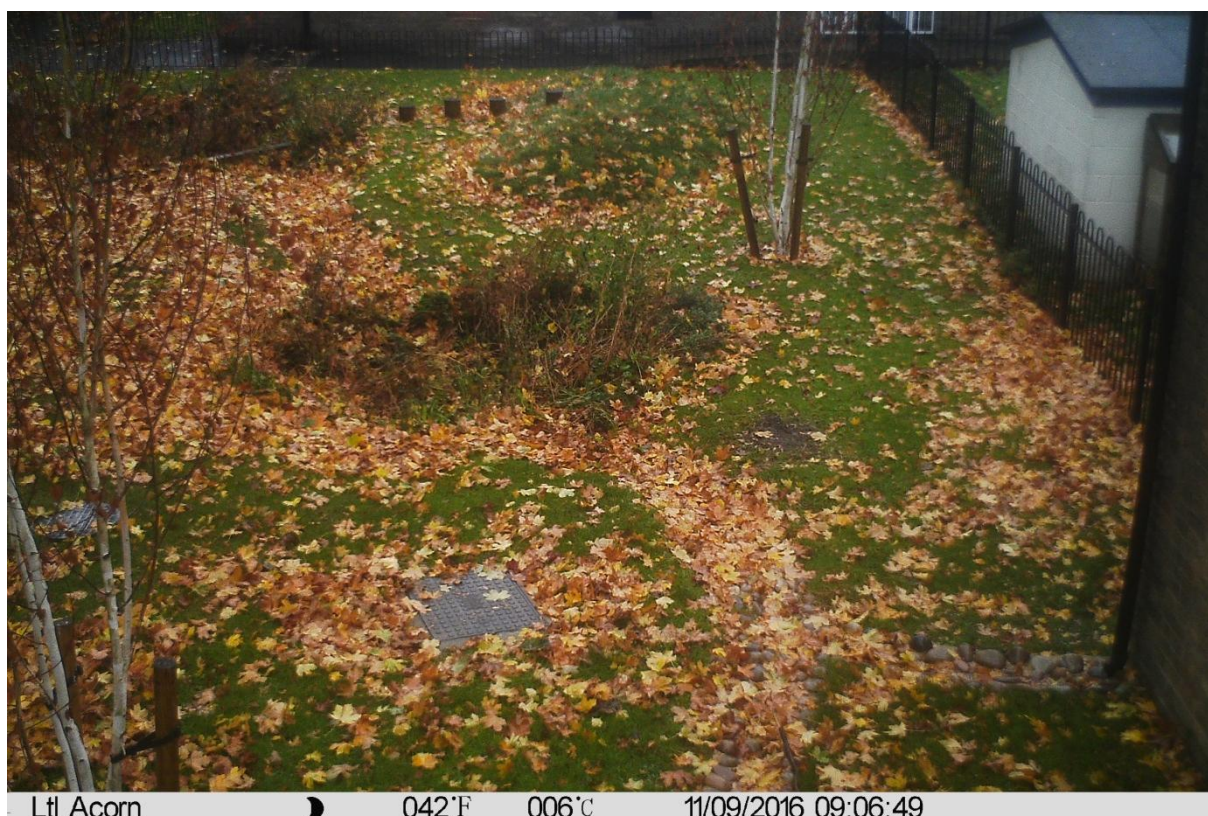
**Figure 8. Time-lapse camera images from Community Hall and Sofia House basins (FPC2), 09/11/2016.** Images show i) no evidence of overflowing during period of highest rain intensity at 06:50 and ii) evidence of 100% infiltration/conveyance by the end of the intense rain event at 09:06 on the same day.

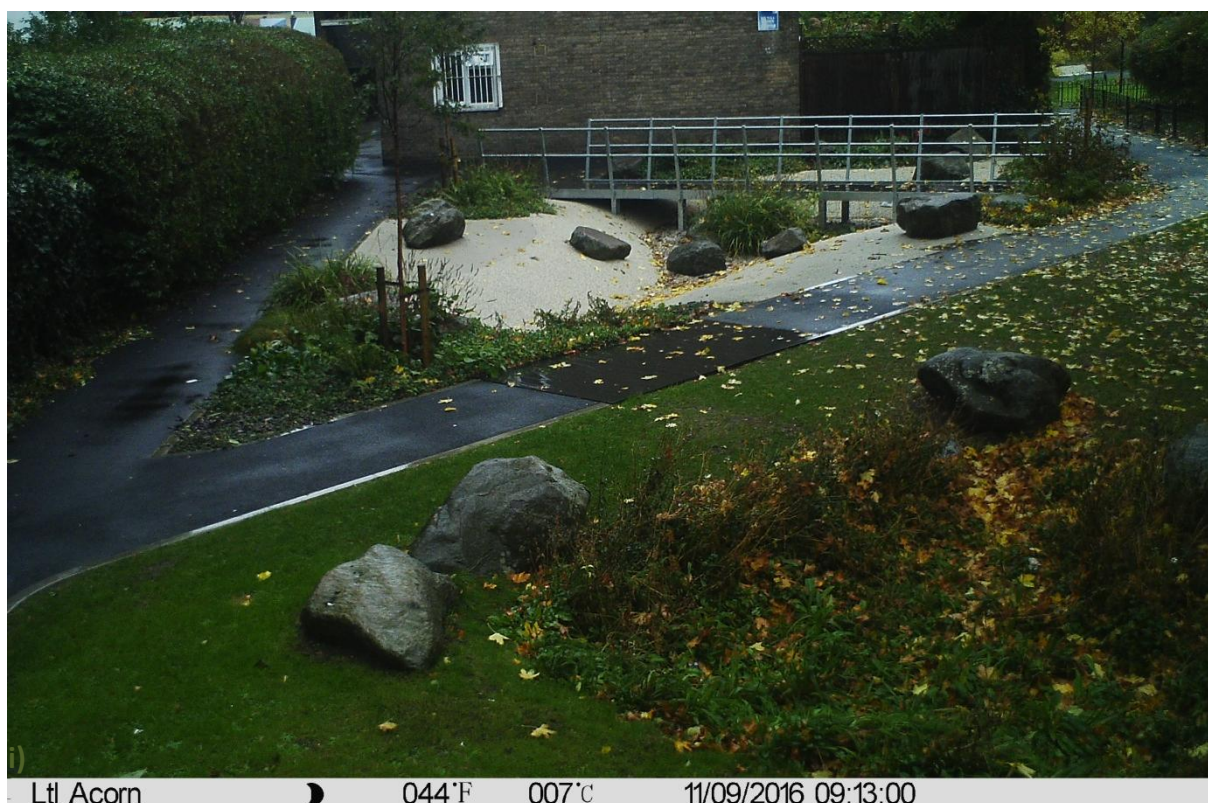
An incomplete collection of the images was collected from the Adella House grass and stoney basins during the rain event from 00:30 to 10:30 on the 9th November 2016 due to a camera malfunction. The images that were collected were analysed. They demonstrated that the rain garden was able to retain and attenuate all of the rainfall that fell directly onto the area and that which was diverted from the neighbouring roofs. By the time of the first daylight images at 09:13, towards the end of the prolonged rain event, there was no obvious pooled water (Figure 9) indicating that the basins were infiltrating all of the stormwater.

**Figure 9. Time-lapse camera images from Adella House grass and stoney basins (FPC3), 09/11/2016.** Image shows no evidence of pooling and evidence of 100% infiltration/conveyance towards the end of the prolonged rain event at 09:13.

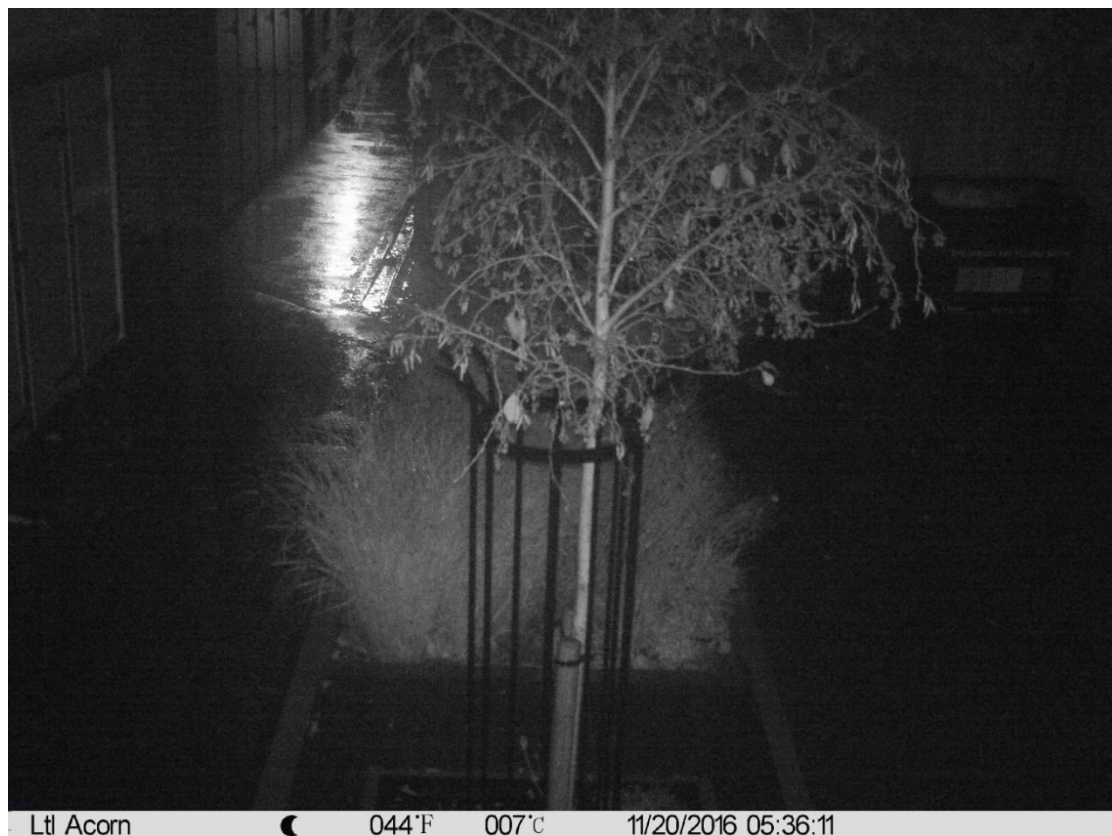
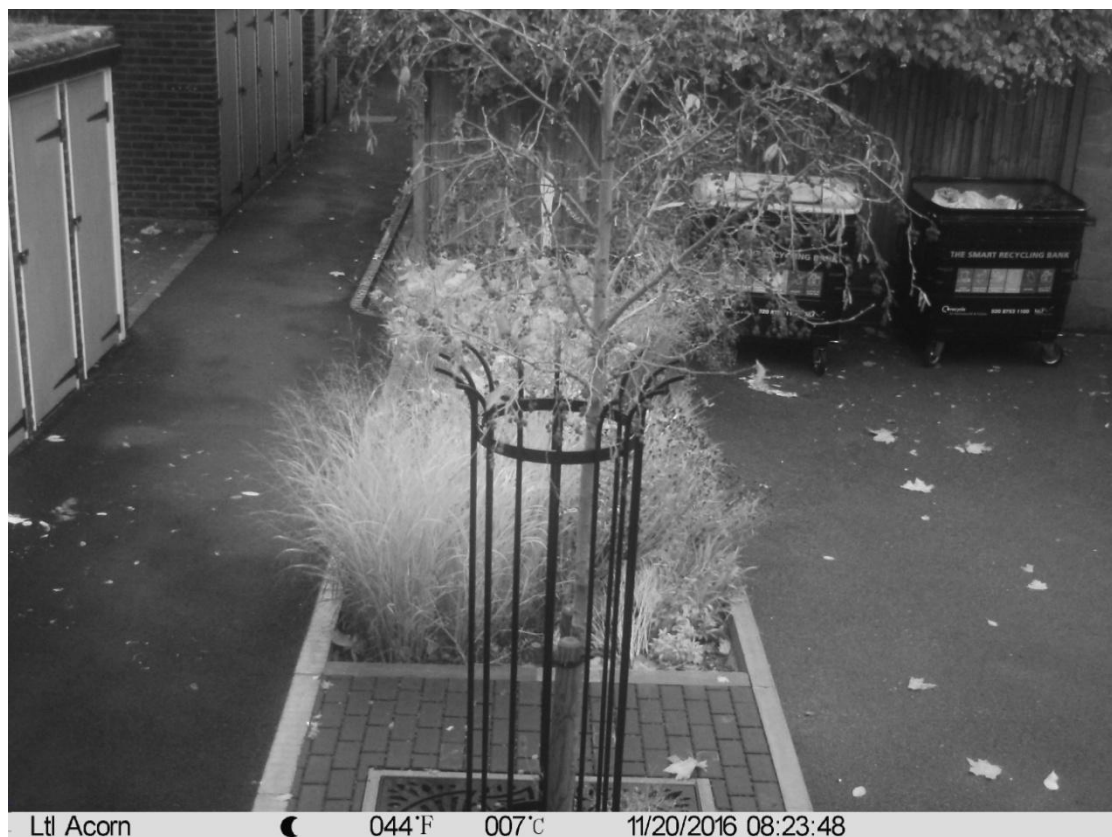
**Figure 11. Time-lapse camera images from Richard Knight House rain garden (FPC5), 20/11/2016.** Images show i) no evidence of overflowing during period of highest rain intensity at 05:36 and ii) evidence of 100% infiltration/conveyance by the end of the intense rain event at 08:23 on the same day.

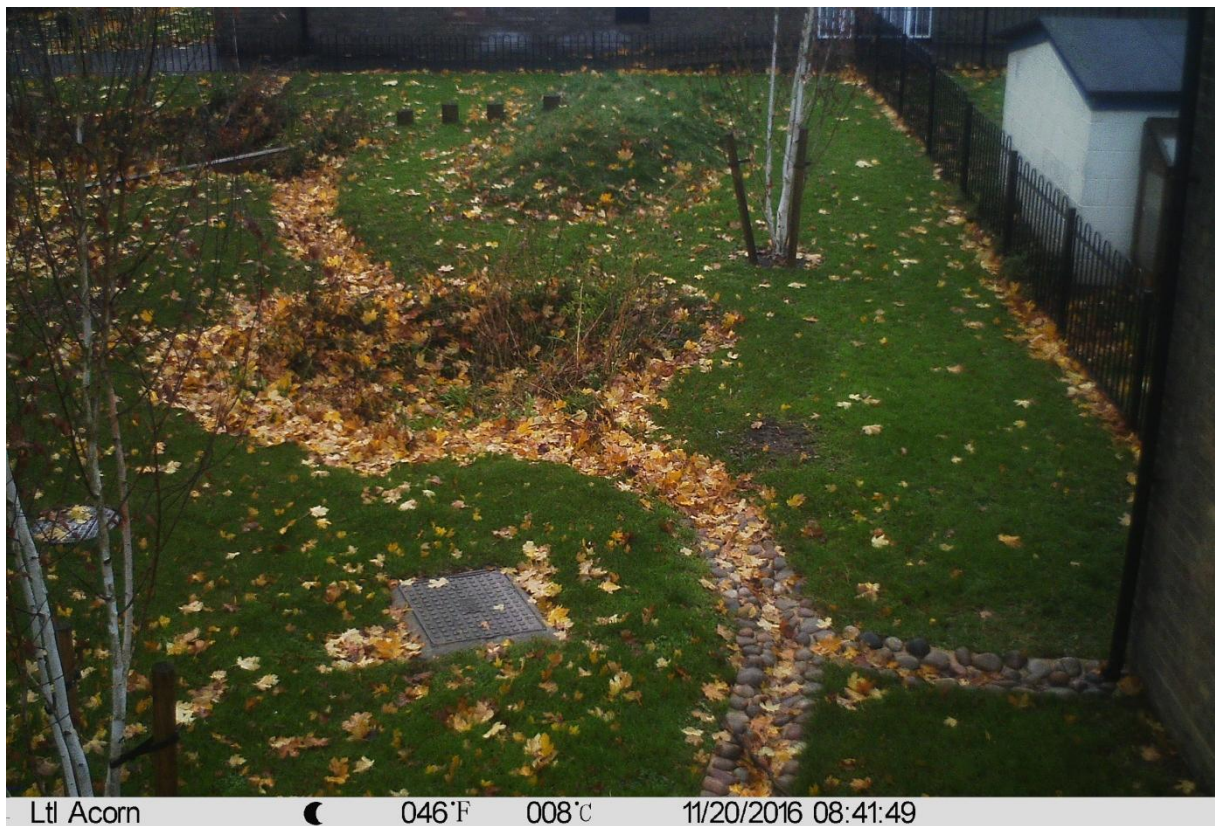
**Figure 13. Time-lapse camera images from Community Hall and Sofia House basins (FPC2), 20/11/2016.** Images show i) no evidence of overflowing during a period of high rain intensity at 04:21 and ii) evidence of 100% infiltration/conveyance by the end of the intense rain event at 08:41 on the same day.

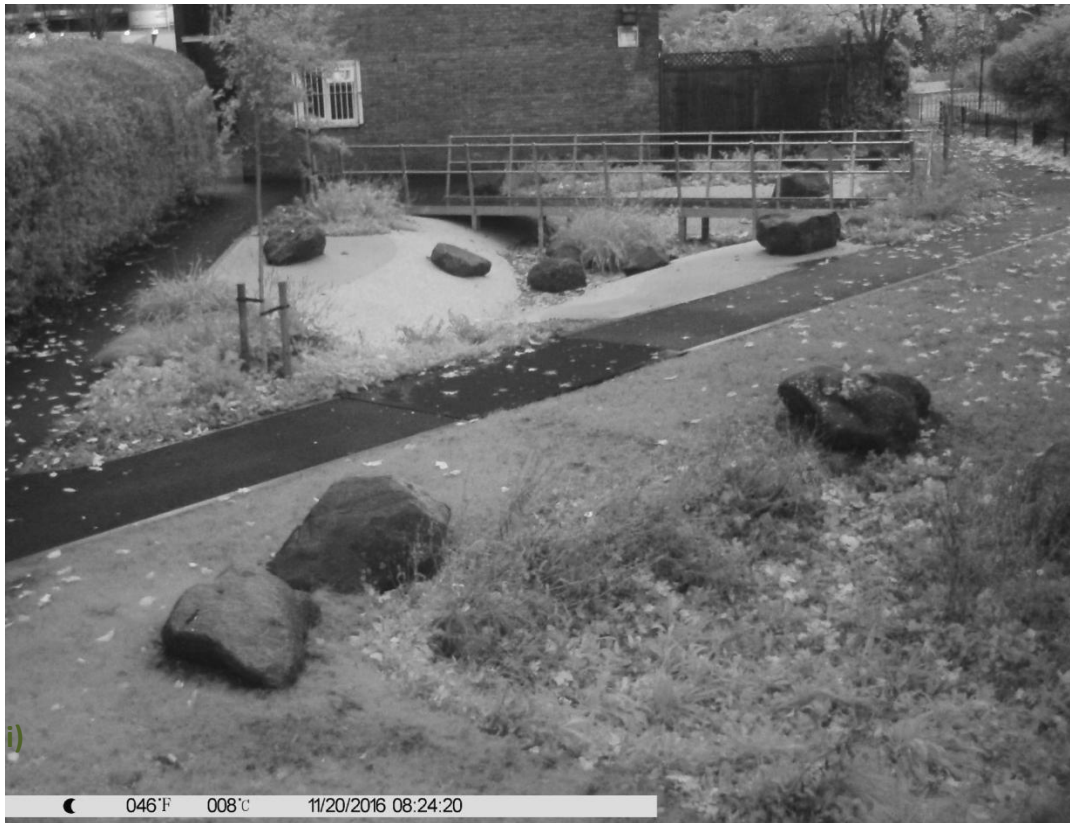
An incomplete collection of the images was collected from the Adella House grass and stoney basins during the rain event from 00:30 to 23:30 on the 20th November 2016 due to a camera malfunction. The images that were collected were analysed. They demonstrated that the rain garden was able to retain and attenuate all of the rainfall that fell directly onto the area and that which was diverted from the neighbouring roofs. By the time of the first daylight images at 08:24, towards the end of the first more substantial part of the prolonged rain event, there was no obvious pooled water (Figure 14) indicating that the basins were infiltrating all of the stormwater.

**Figure 14. Time-lapse camera images from Adella House grass and stoney basins (FPC3), 20/11/2016.** Image shows no evidence of pooling and evidence of 100% infiltration/conveyance towards the end of the prolonged rain event at 08:24.

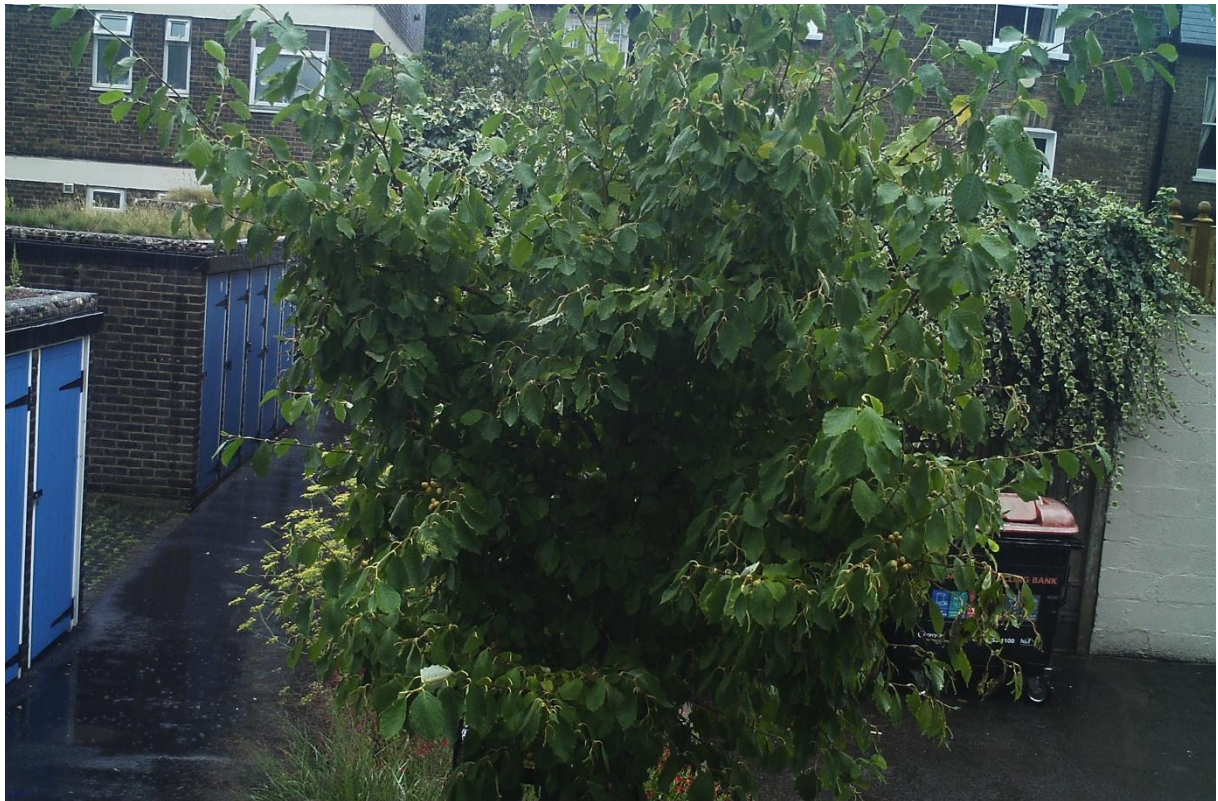
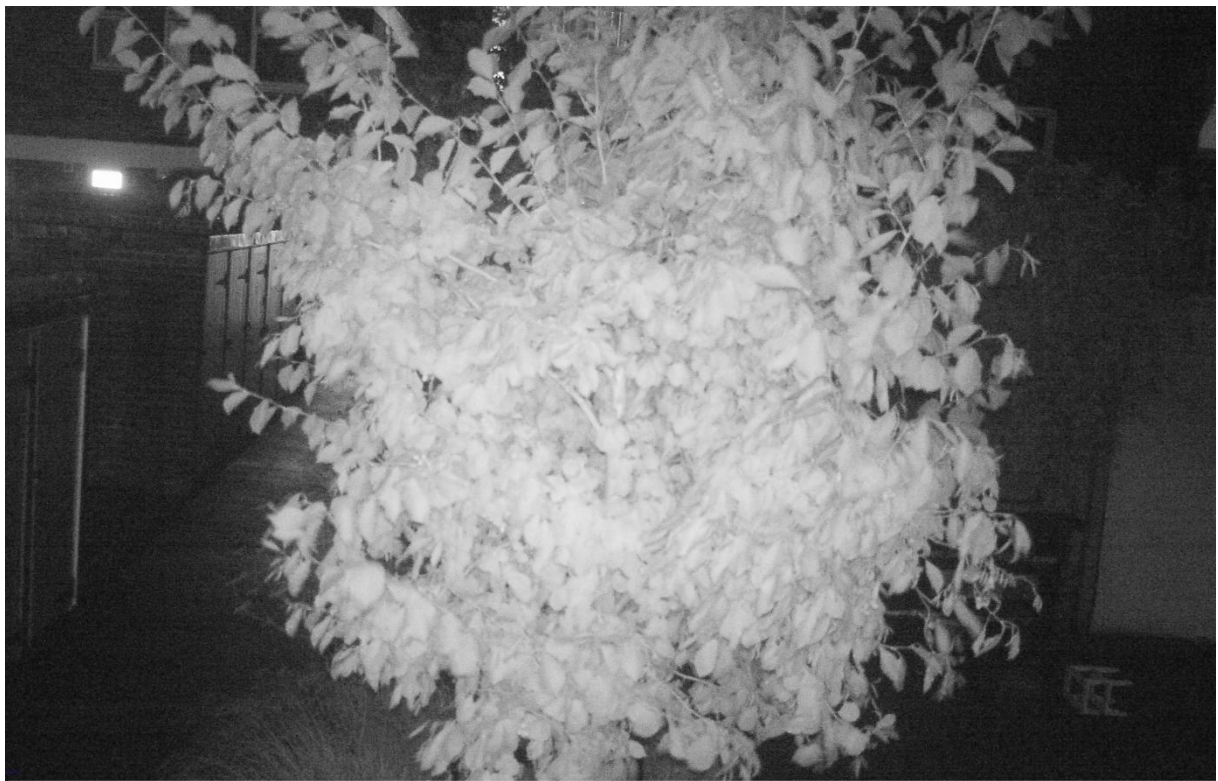
**Figure 16. Time-lapse camera images from Richard Knight House rain garden (FPC5), 09/08/2017.** Images show i) no evidence of overflowing during period of highest rain intensity at 10:37 and ii) evidence of 100% infiltration/conveyance by the end of the rain event at 23:59 on the same day.

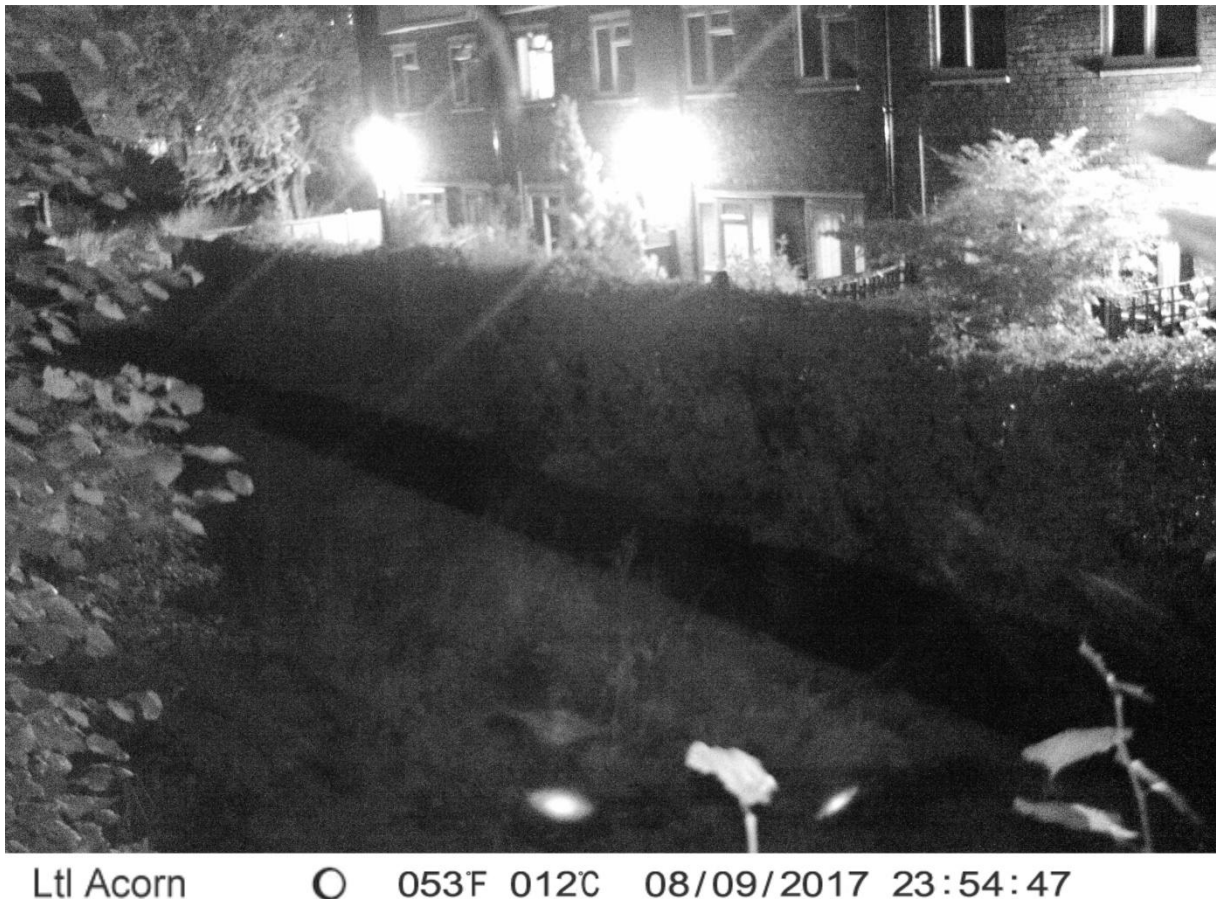
**Figure 18. Time-lapse camera images from Alexandra House swale (FPC1), 09/05/2017.** Images show i) no evidence of overflowing during a period of high rain intensity at 10:40 and ii) evidence of 100% infiltration/conveyance by the end of the intense rain event at 23:55 on the same day.

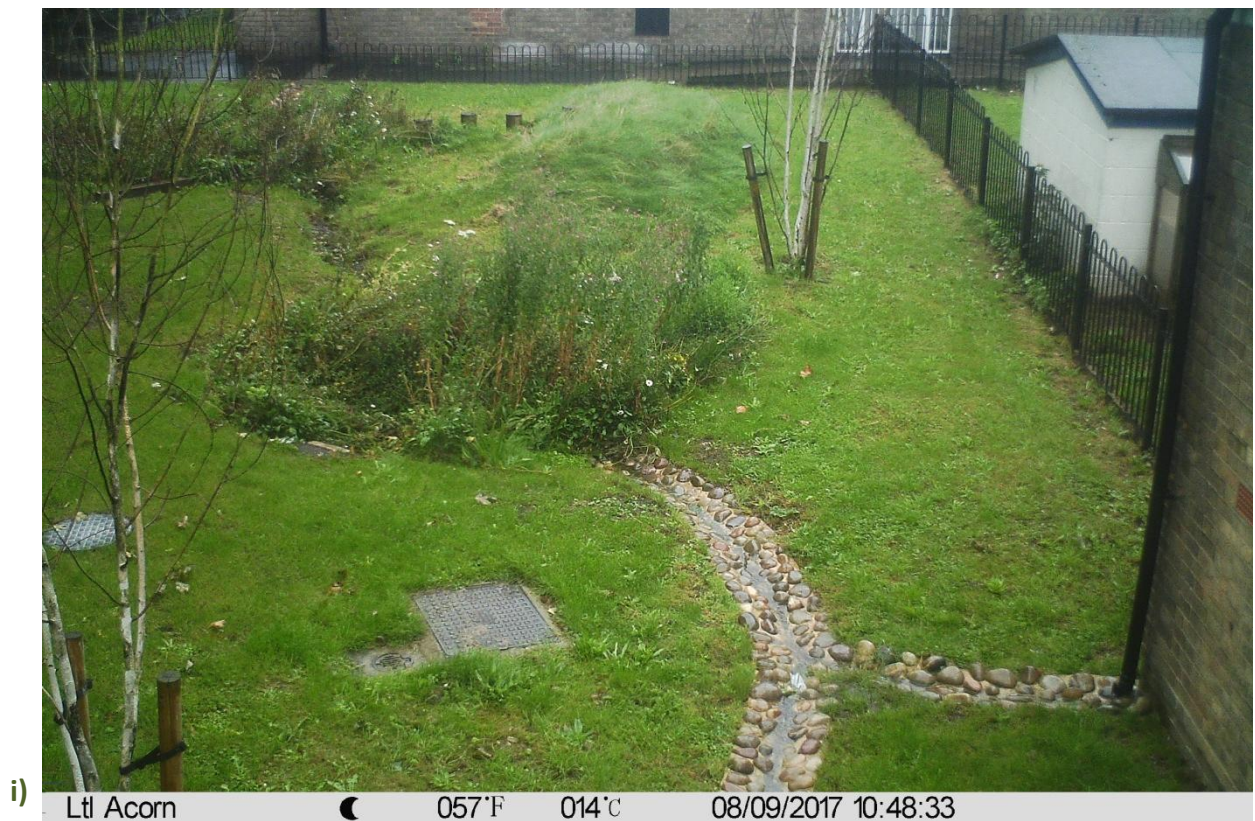
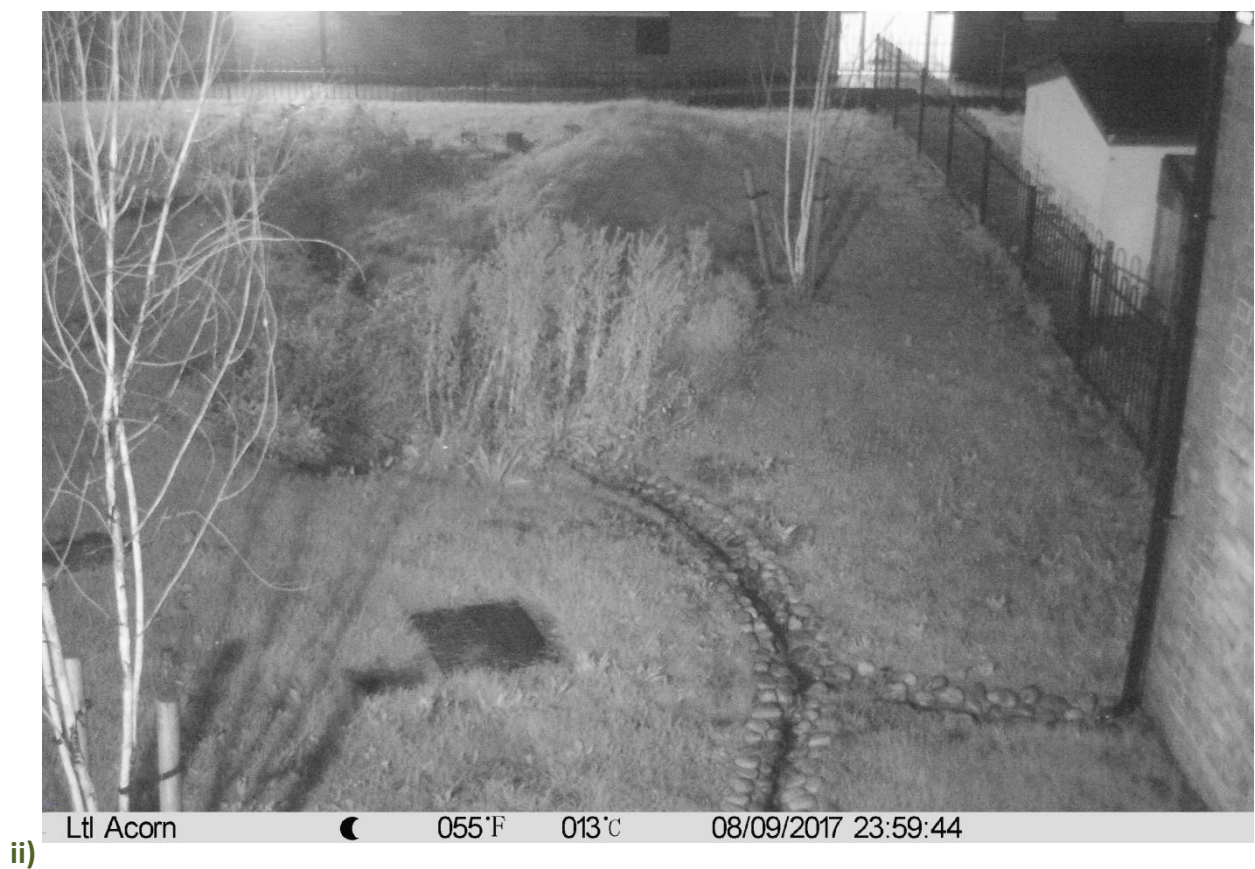
A complete collection of the images from the community hall and Sofia House basins during the rain event from 07:00 to 23:59 on the 9th August 2017 were captured and analysed. They demonstrated that the basins were able to retain and attenuate all of the rainfall that fell directly onto the area and that which was diverted from the neighbouring roofs. The images also demonstrated that at around 10:48 during the peak of the rainfall, despite substantial input from the community hall roof, there was no obvious standing water within or around the basins (Figure 19.i). Following the cessation of the event at 23:59, there was also no obvious pooled water (Figure 19.ii) indicating that the basins were infiltrating all of the stormwater.

**Figure 19. Time-lapse camera images from Community Hall and Sofia House basins (FPC2), 09/08/2017.** Images show i) no evidence of overflowing during a period of high rain intensity at 10:48 and ii) evidence of 100% infiltration/conveyance by the end of the intense rain event at 23:59 on the same day.

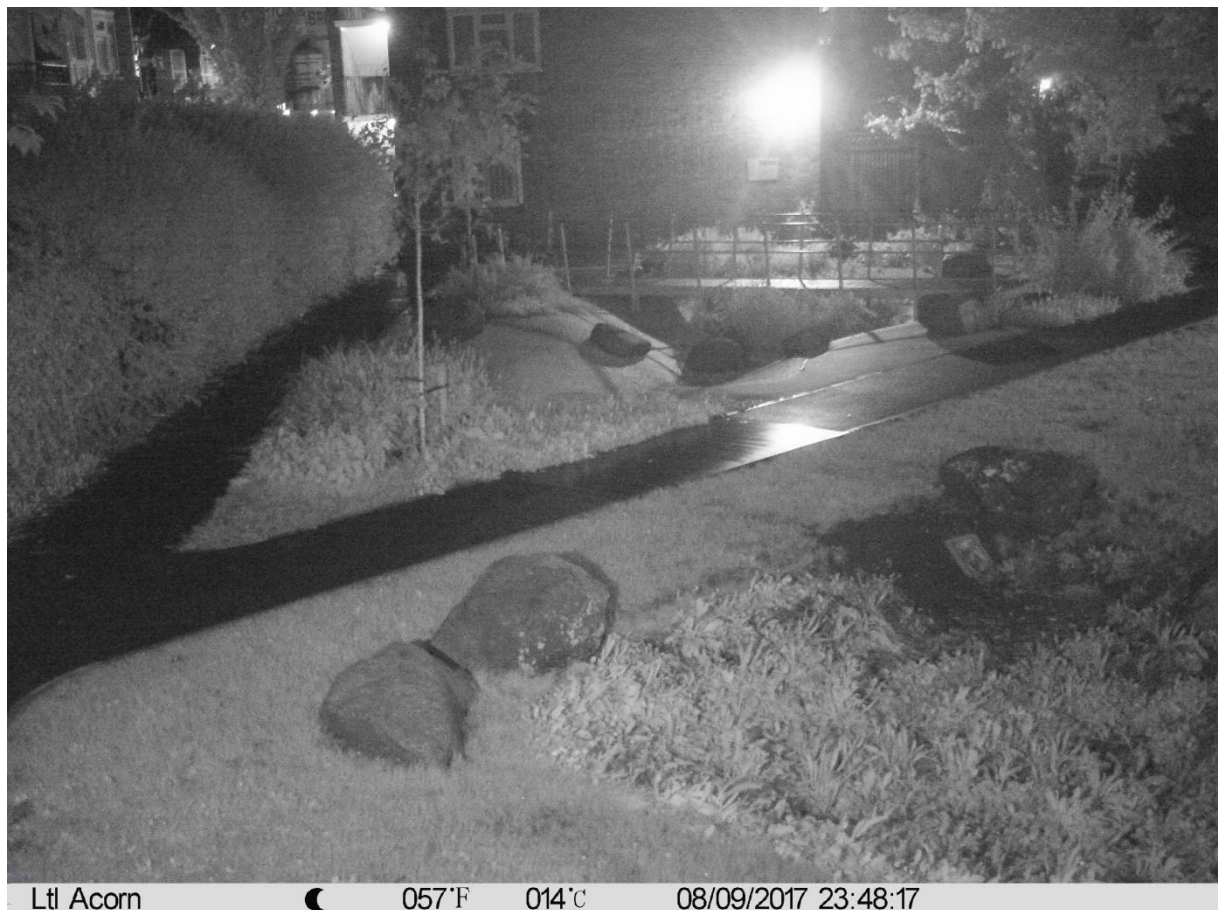
**Figure 20. Time-lapse camera images from Adella House grass and stoney basins (FPC3), 09/08/2017.** Images show i) no evidence of overflowing during a period of high rain intensity at 10:30 and ii) evidence of 100% infiltration/conveyance by the end of the intense rain event at 23:48 on the same day.

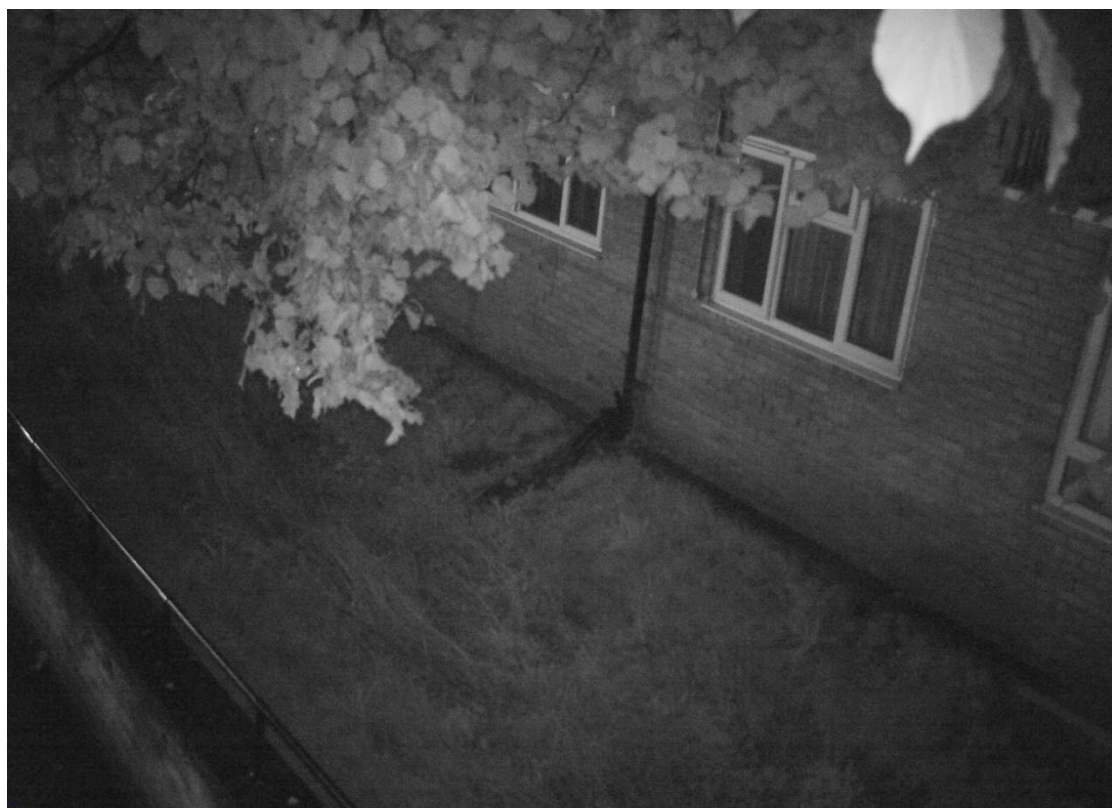
**Figure 21. Time-lapse camera images from Beatrice House swale (FPC4), 09/08/2017.** Images show i) no evidence of overflowing during a period of high rain intensity at 10:36 and ii) evidence of 100% infiltration/conveyance by the end of the intense rain event at 23:54 on the same day.

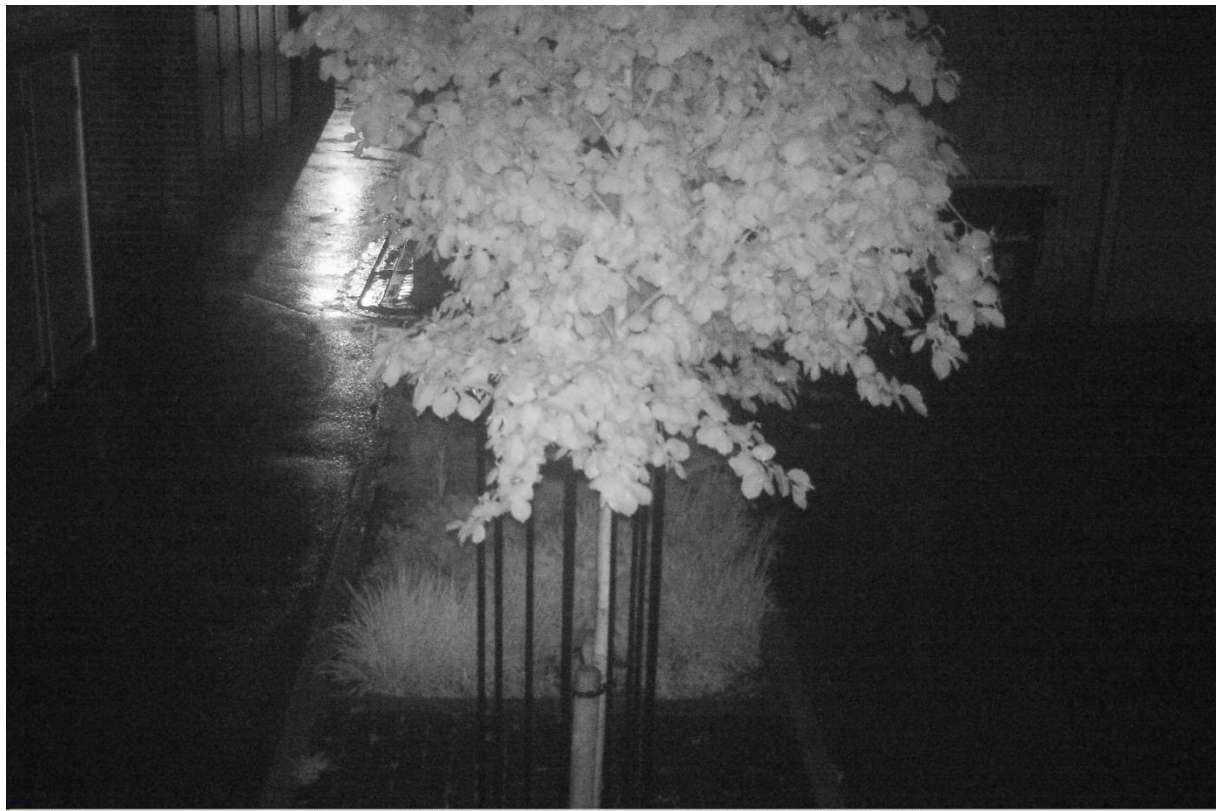
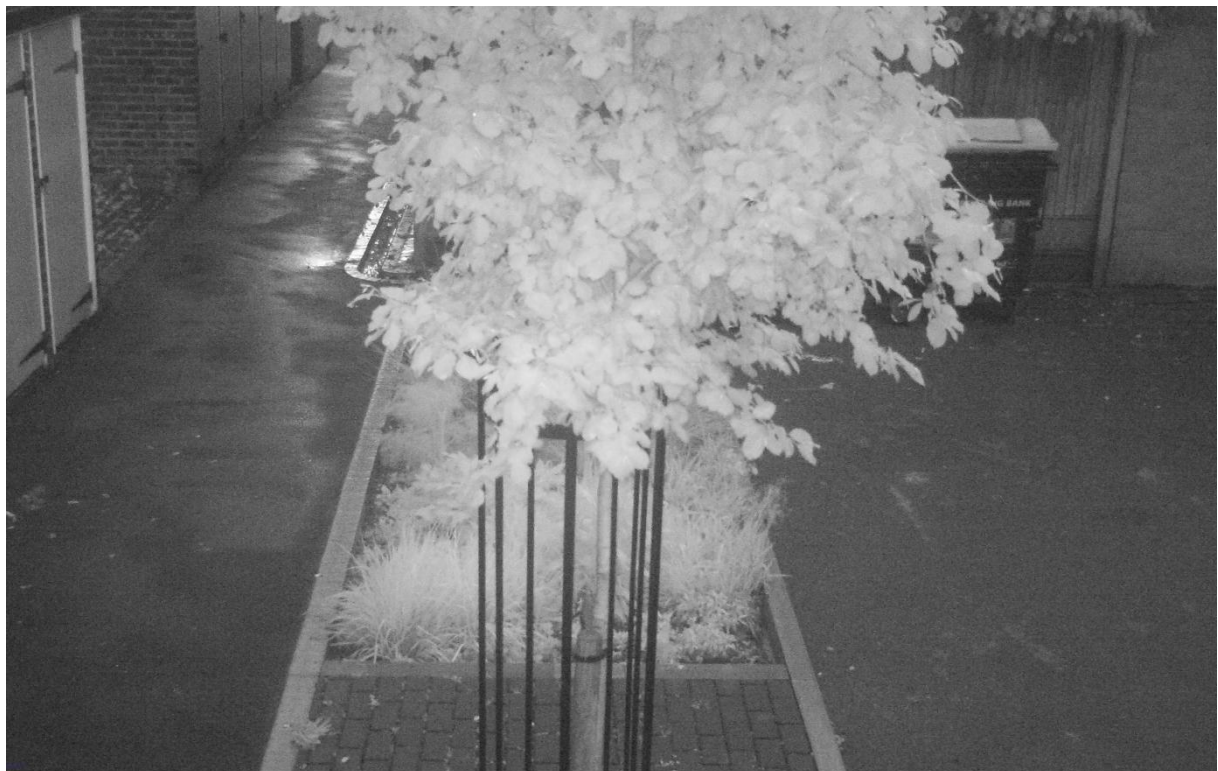
**Figure 24. Time-lapse camera images from Richard Knight House rain garden (FPC5), 17/05/2017.** Images show i) no evidence of overflowing during period of highest rain intensity at 03:28 and ii) evidence of 100% infiltration/conveyance by the end of the rain event at 21:12 on the same day.

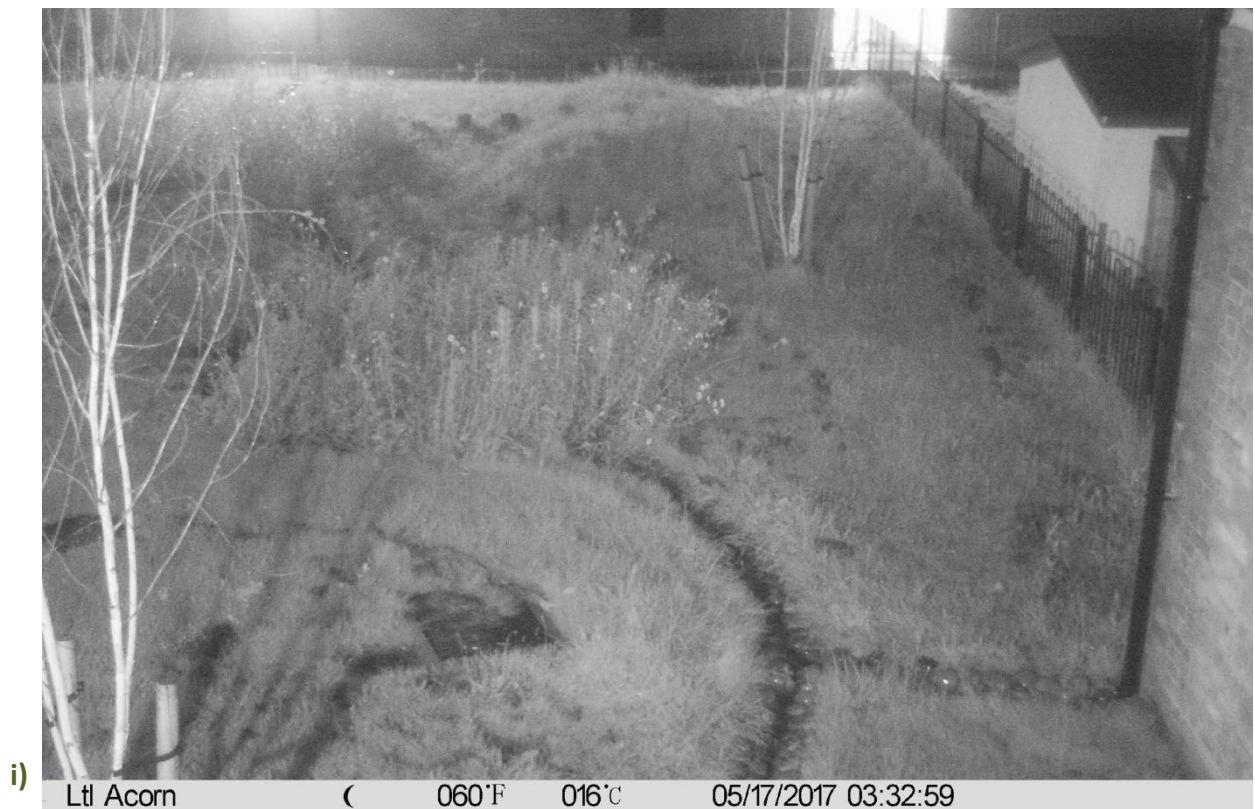
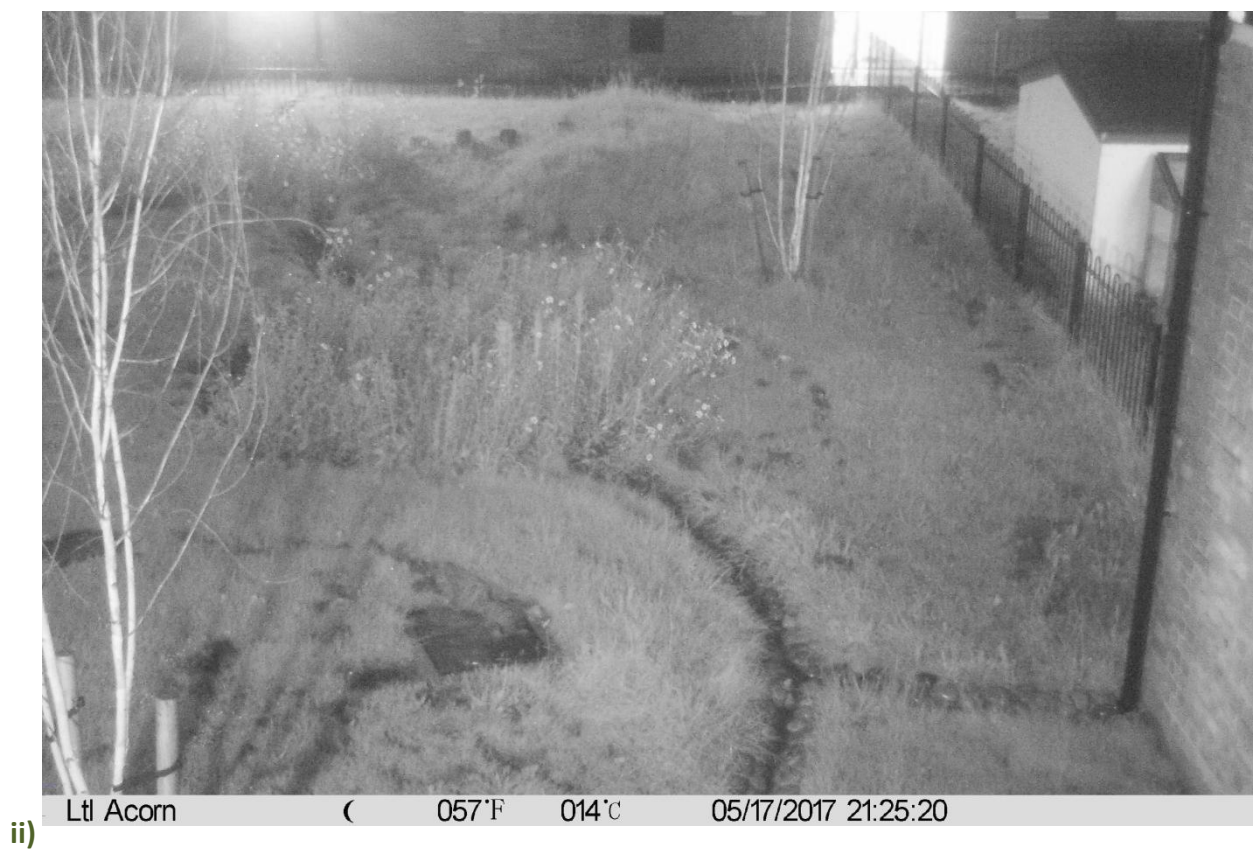
A complete collection of the images from the community hall and Sofia House basins during the rain event from 00:30 to 21:30 on the 17th May 2017 were captured and analysed. They demonstrated that the basins were able to retain and attenuate all of the rainfall that fell directly onto the area and that which was diverted from the neighbouring roofs. The images also demonstrated that at around 03:30 during the peak of the rainfall, despite substantial input from the community hall roof, there was no obvious standing water within or around the basins (Figure 27.i). Following the cessation of the event at 21:25, there was also no obvious pooled water (Figure 27.ii) indicating that the basins were infiltrating all of the stormwater.

**Figure 27. Time-lapse camera images from Community Hall and Sofia House basins (FPC2), 17/05/2017.** Images show i) no evidence of overflowing during a period of high rain intensity at 03:32 and ii) evidence of 100% infiltration/conveyance by the end of the intense rain event at 21:25 on the same day.

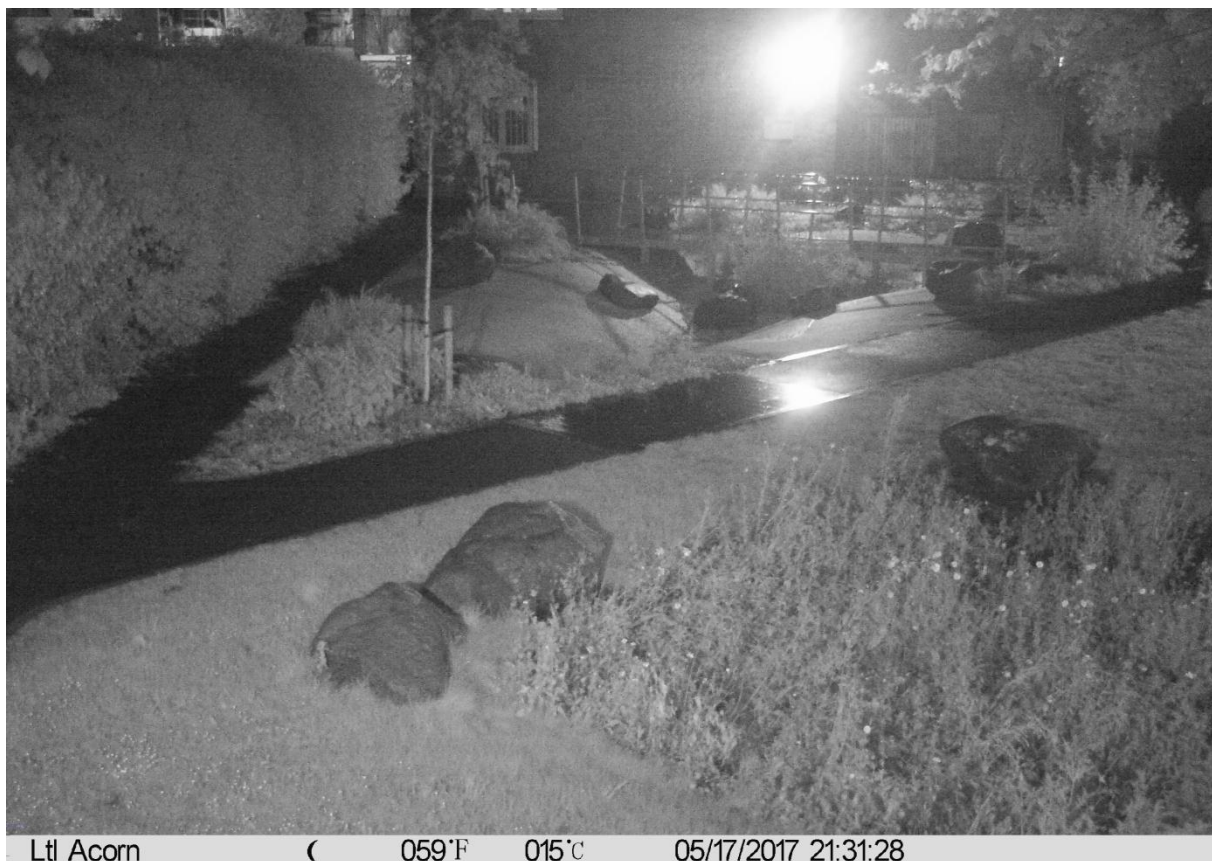
**Figure 28. Time-lapse camera images from Adella House grass and stoney basins (FPC3), 17/05/2017.** Images show i) no evidence of overflowing during a period of high rain intensity at 03:32 and ii) evidence of 100% infiltration/conveyance by the end of the intense rain event at 21:31 on the same day.

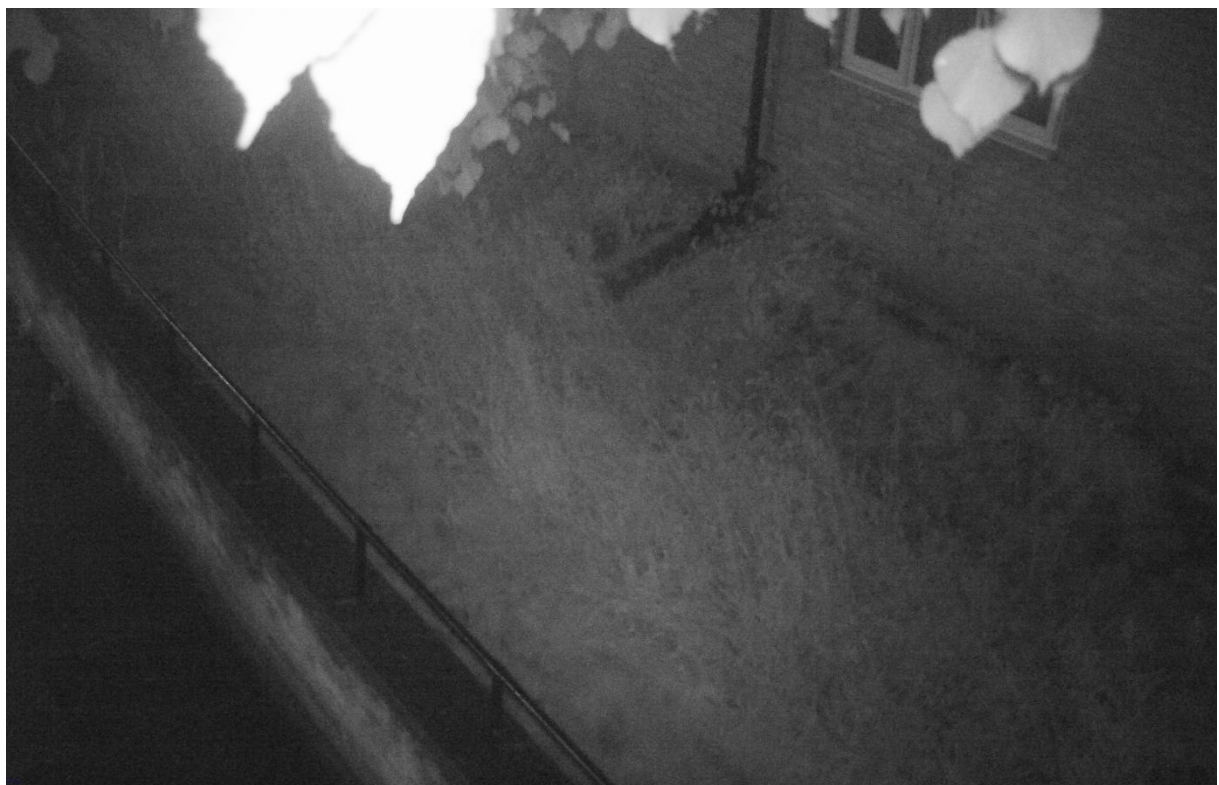
**Figure 29. Time-lapse camera images from Beatrice House swale (FPC4), 17/05/2017.** Images show i) no evidence of overflowing during a period of high rain intensity at 03:24 and ii) evidence of 100% infiltration/conveyance by the end of the intense rain event at 21:26 on the same day.
