**Climate Proofing Housing Landscapes:  
Monitoring Report 3**

**October 2016 to September 2017**

**Authors: Connop, S., Clough, J., Alam, R. and Nash, C.**

H&F Council and Groundwork London worked with local residents to design and implement climate change adaptation measures on three housing estates in the borough, making them more resilient and adapted for the future.

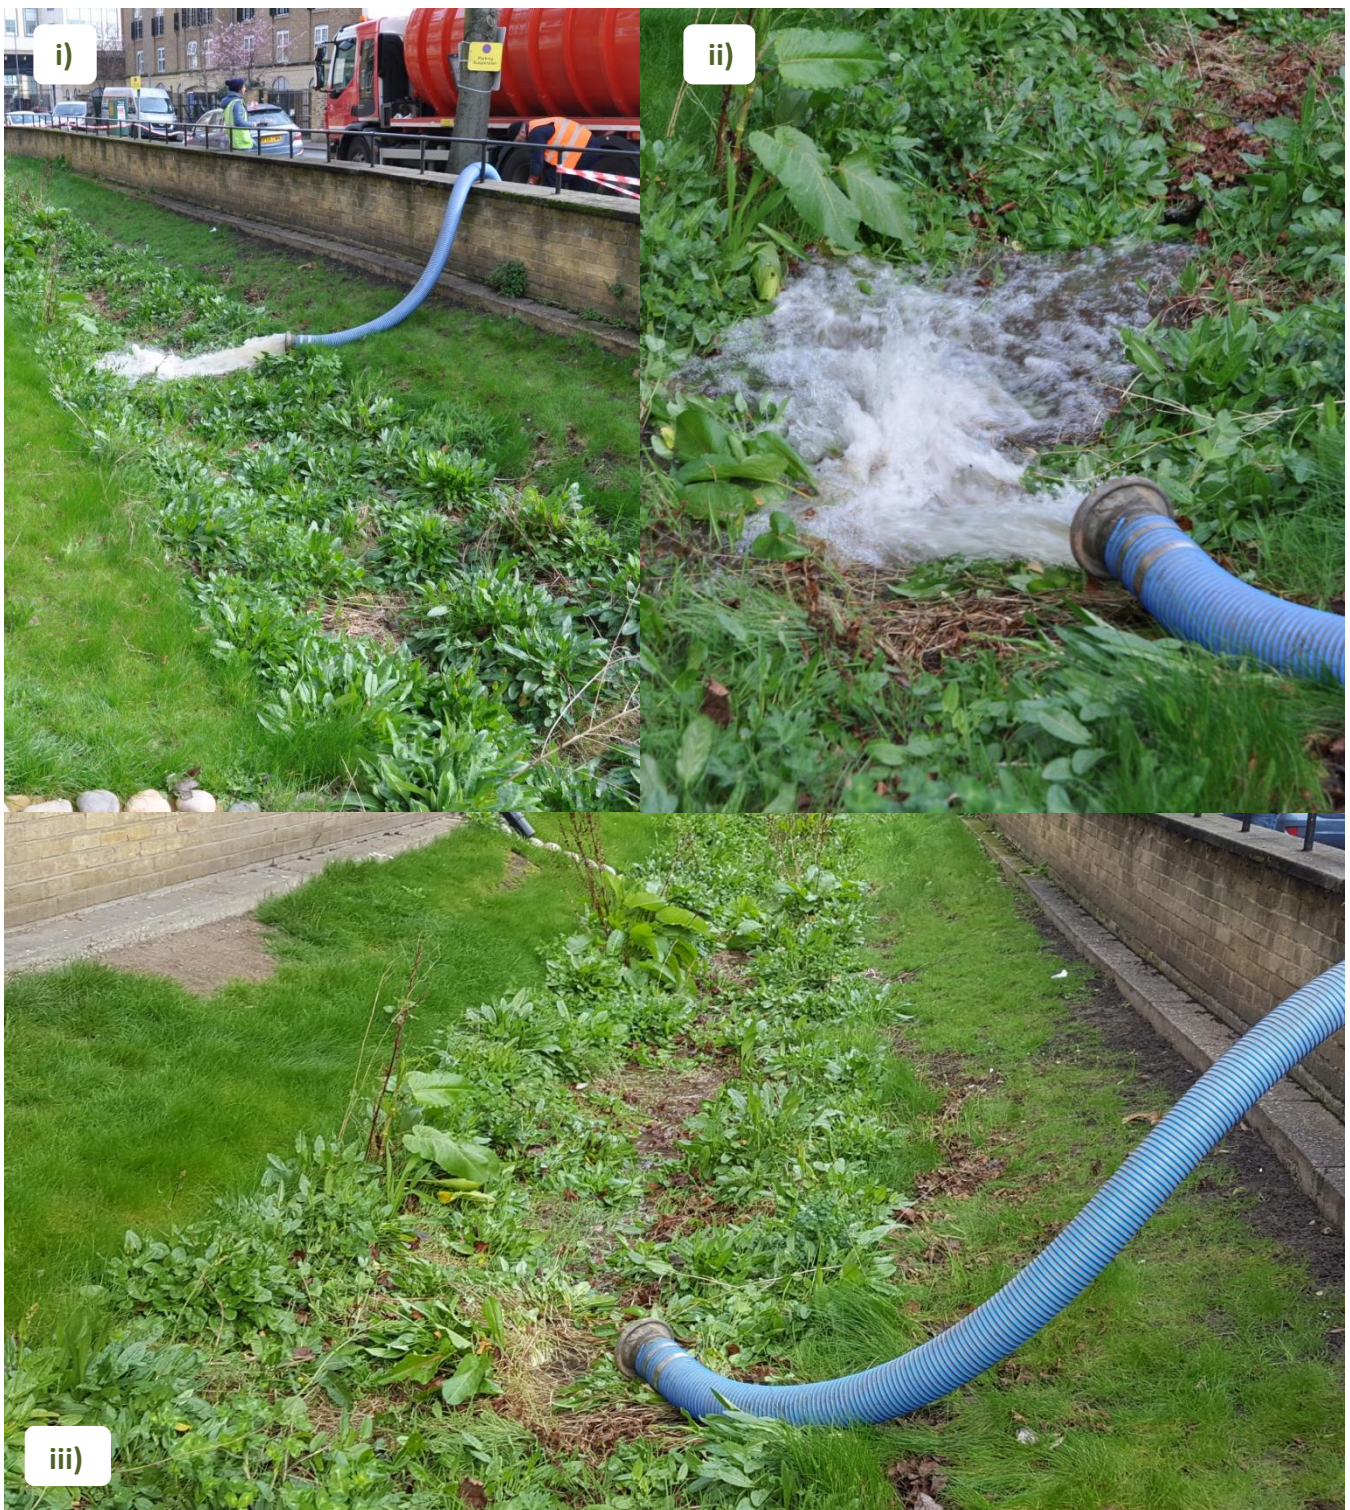
**Figure 64. Images from the storm simulation event at Beatrice House swale, Queen Caroline Estate, 23rd March 2017. Images show i) water release from tanker being timed to release 1000 Litres every six minutes; ii) 1000 Litres entering the centre of the swale; iii) the condition of the swale after the first 1000 Litres.**

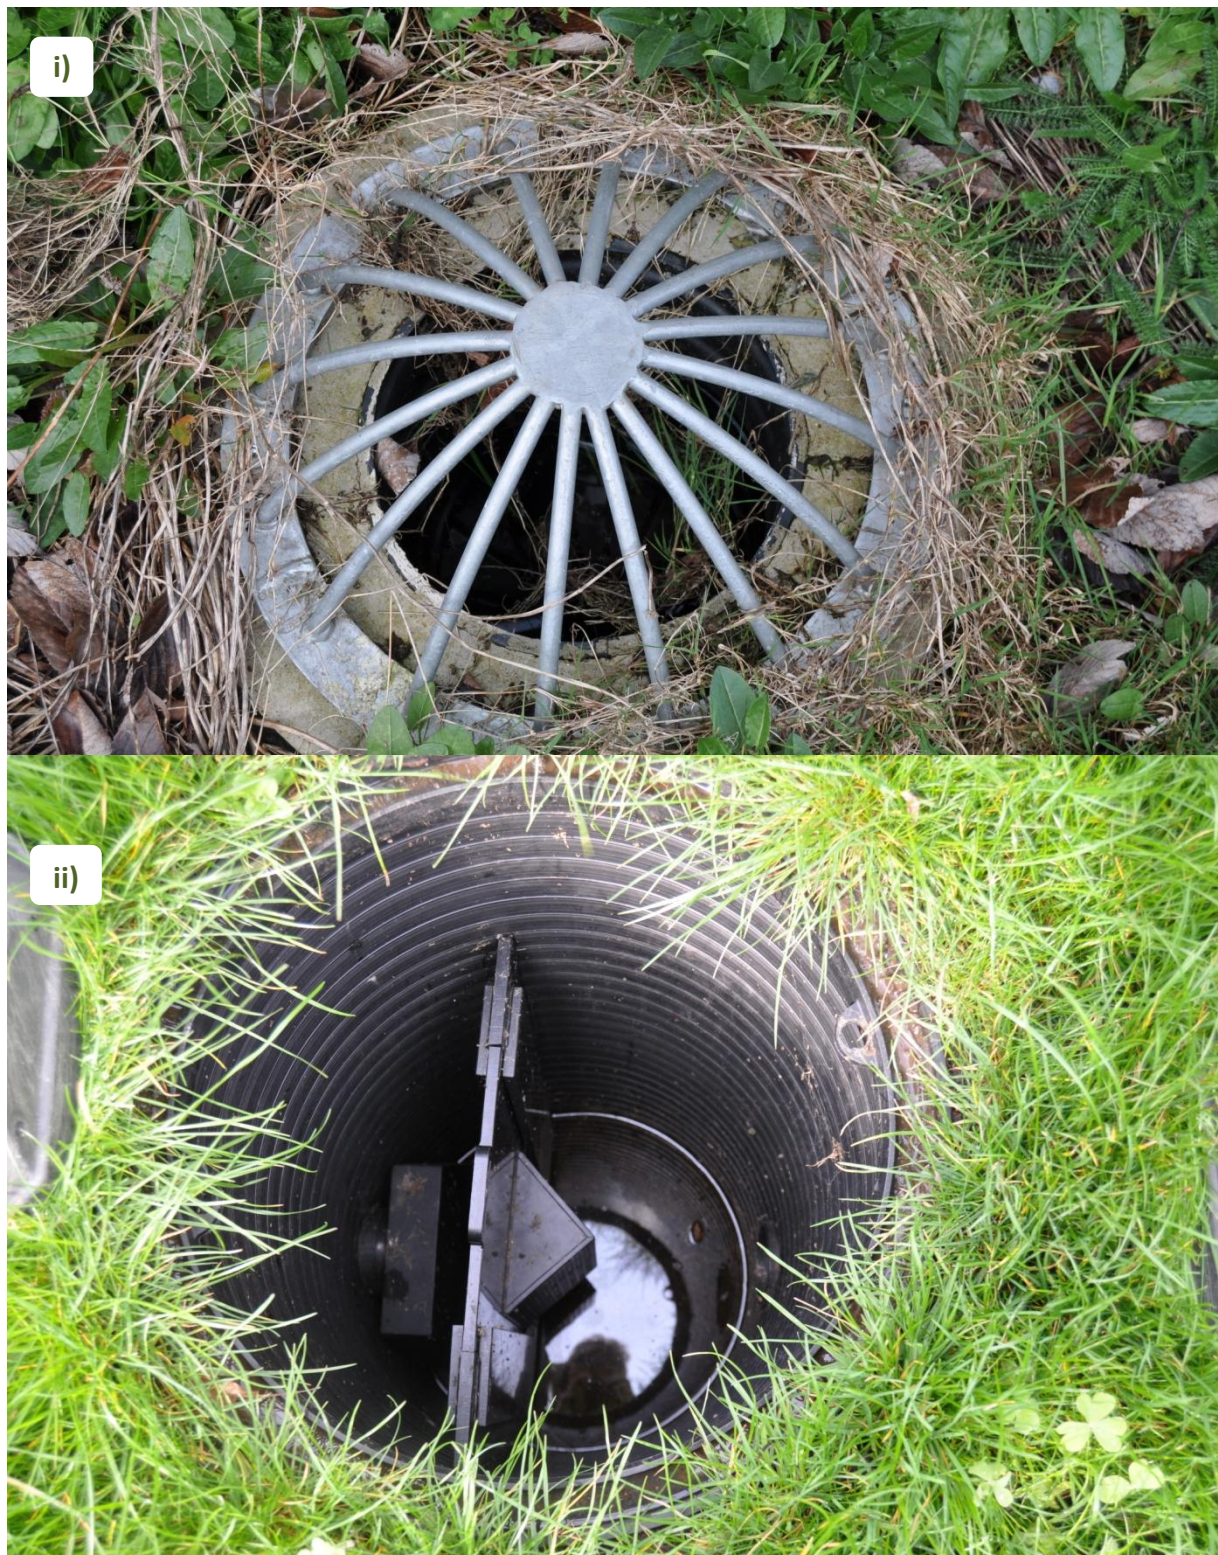
**Figure 65. Images from the storm simulation event at Beatrice House swale, Queen Caroline Estate, 23rd March 2017. Images show that no water was released to the i) swale overflow or ii) the control flow chamber, after the 10,000 Litres of water were pumped into the swale to simulate a 1 in 100 year storm event.**

indicated that the swale was easily able to cope with 1 in 100 year storm events for the current catchment area.

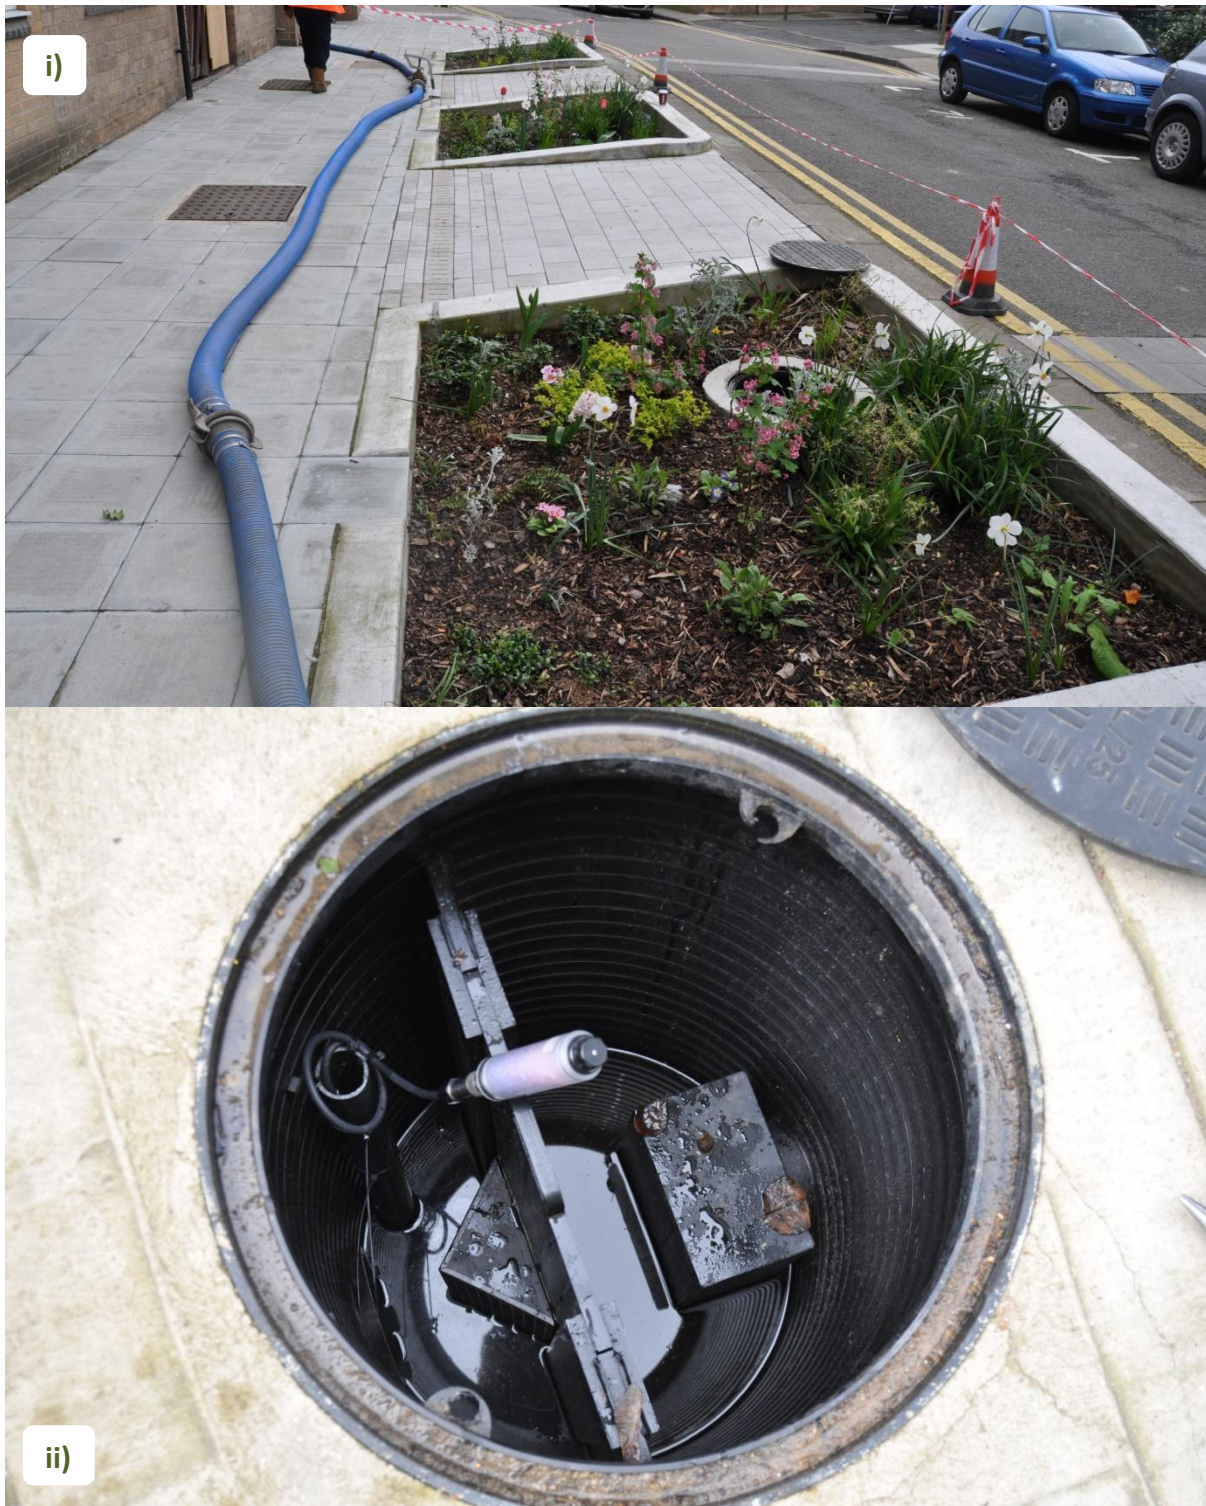
**Figure 70. Images from the storm simulation event at the Sun Road rain gardens, Cheeseman Terrace Estate, 24th March 2017. Images show i) Cheeseman Terrace Estate rain gardens before rain simulation; ii) pressure sensor installed in the control flow chamber in the outlet from the rain garden.**

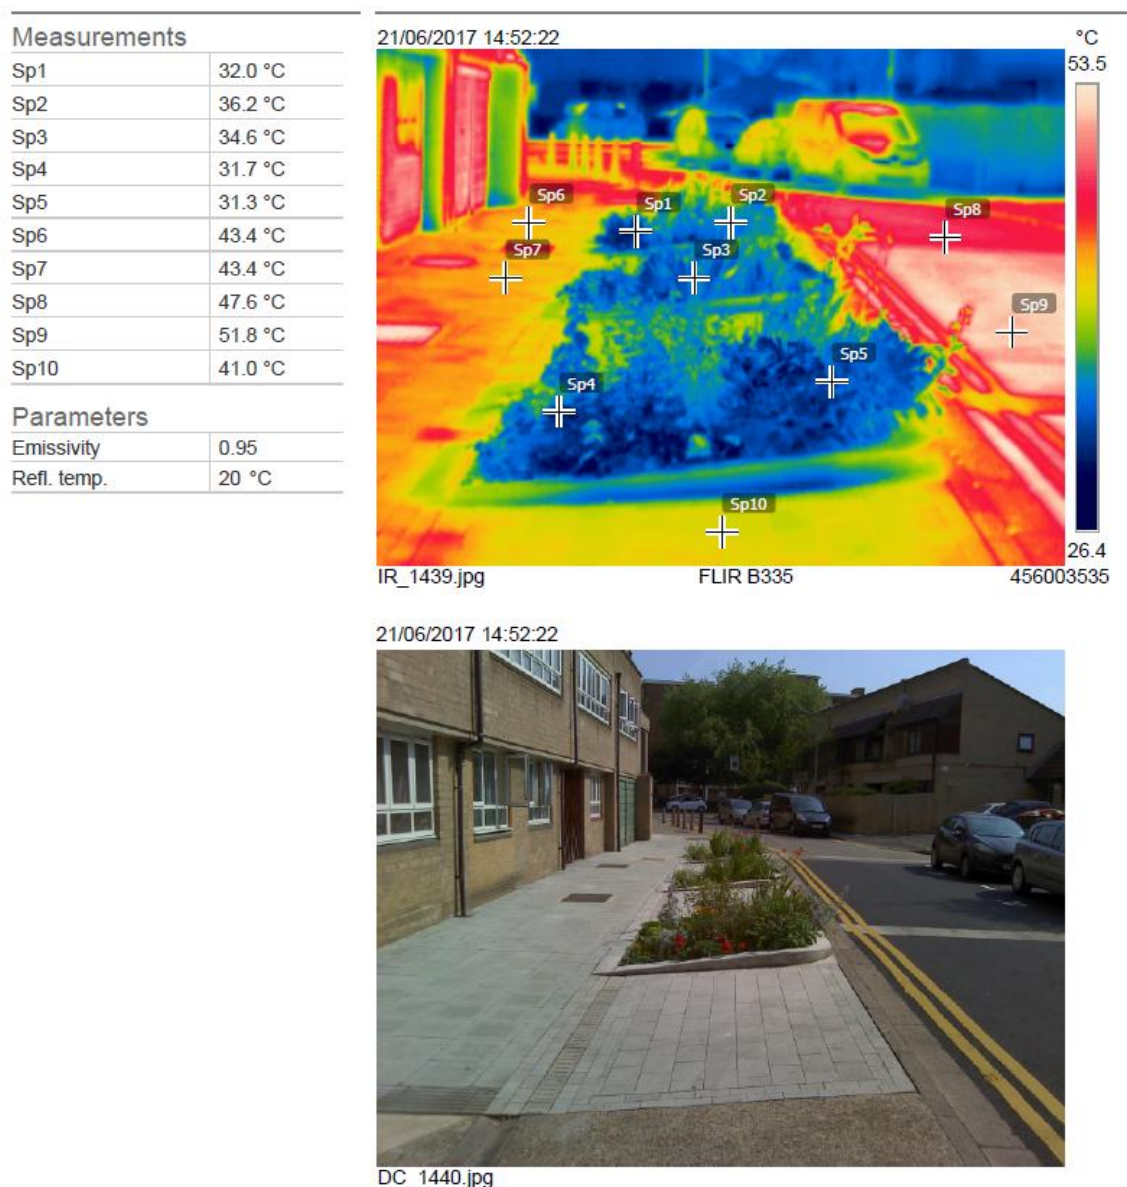
**Figure 79. Photo and infrared image of Cheesemans terrace rain garden and surrounding grey infrastructure on the 21st June 2017.** FLIR tools software was used to identify temperatures at selected points within the field of view. The hottest temperatures (>40 °C) were associated with the surrounding grey infrastructure. These areas were recorded as being substantially hotter than the maximum daily temperature recorded by the nearby weather station (34.1 °C). Temperatures observed in the rain gardens were lower by at least 5 degrees with all temperatures 36°C or less. The coolest areas were observed in the well-established vegetation (sp4 and sp 5 at 31.7°C and 31.2°C respectively).

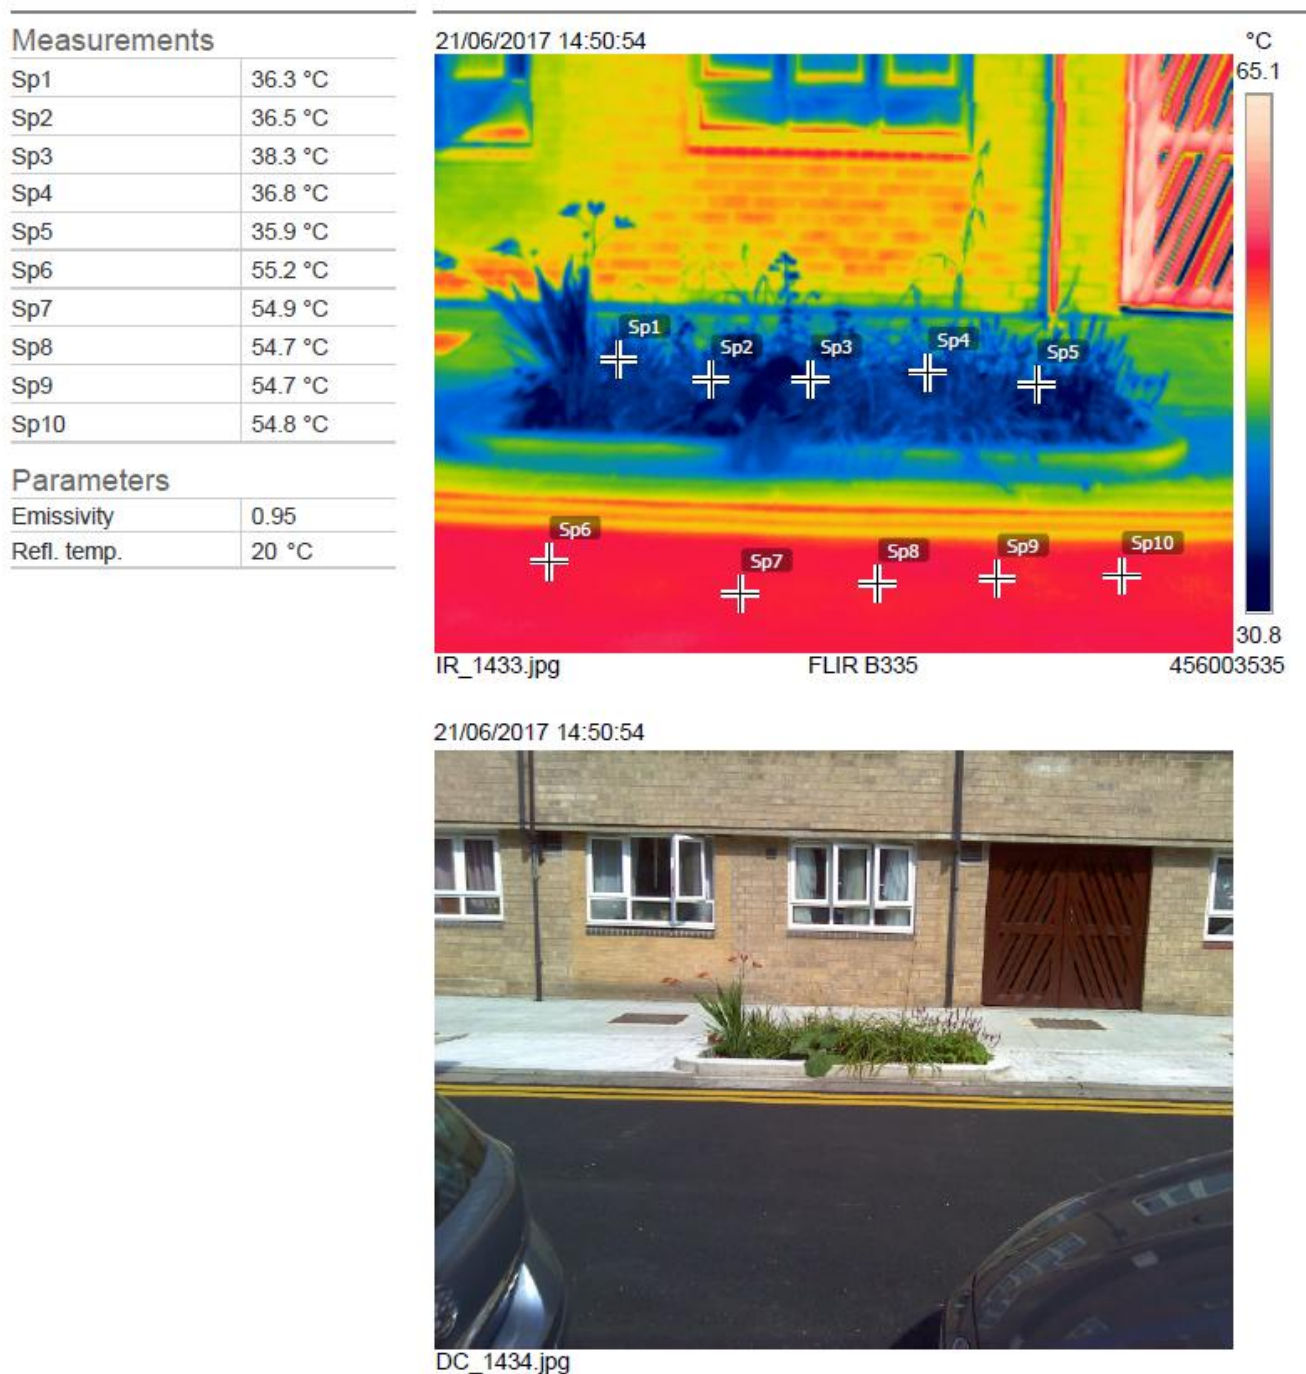
**Figure 80. Photo and infrared image of Cheeseman's terrace rain garden and surrounding grey infrastructure on the 21st June 2017.** FLIR tools software was used to identify temperatures at selected points within the field of view. The hottest temperatures (>50 °C) were associated with the newly lain road. These areas were recorded as being substantially hotter than the maximum daily temperature recorded by the nearby weather station (34.1 °C). Temperatures observed in the rain gardens were lower by almost 20 degrees with all temperatures approximately 38°C or lower. The coolest areas were observed in the well-established vegetation (sp 5 at 35.9°C).

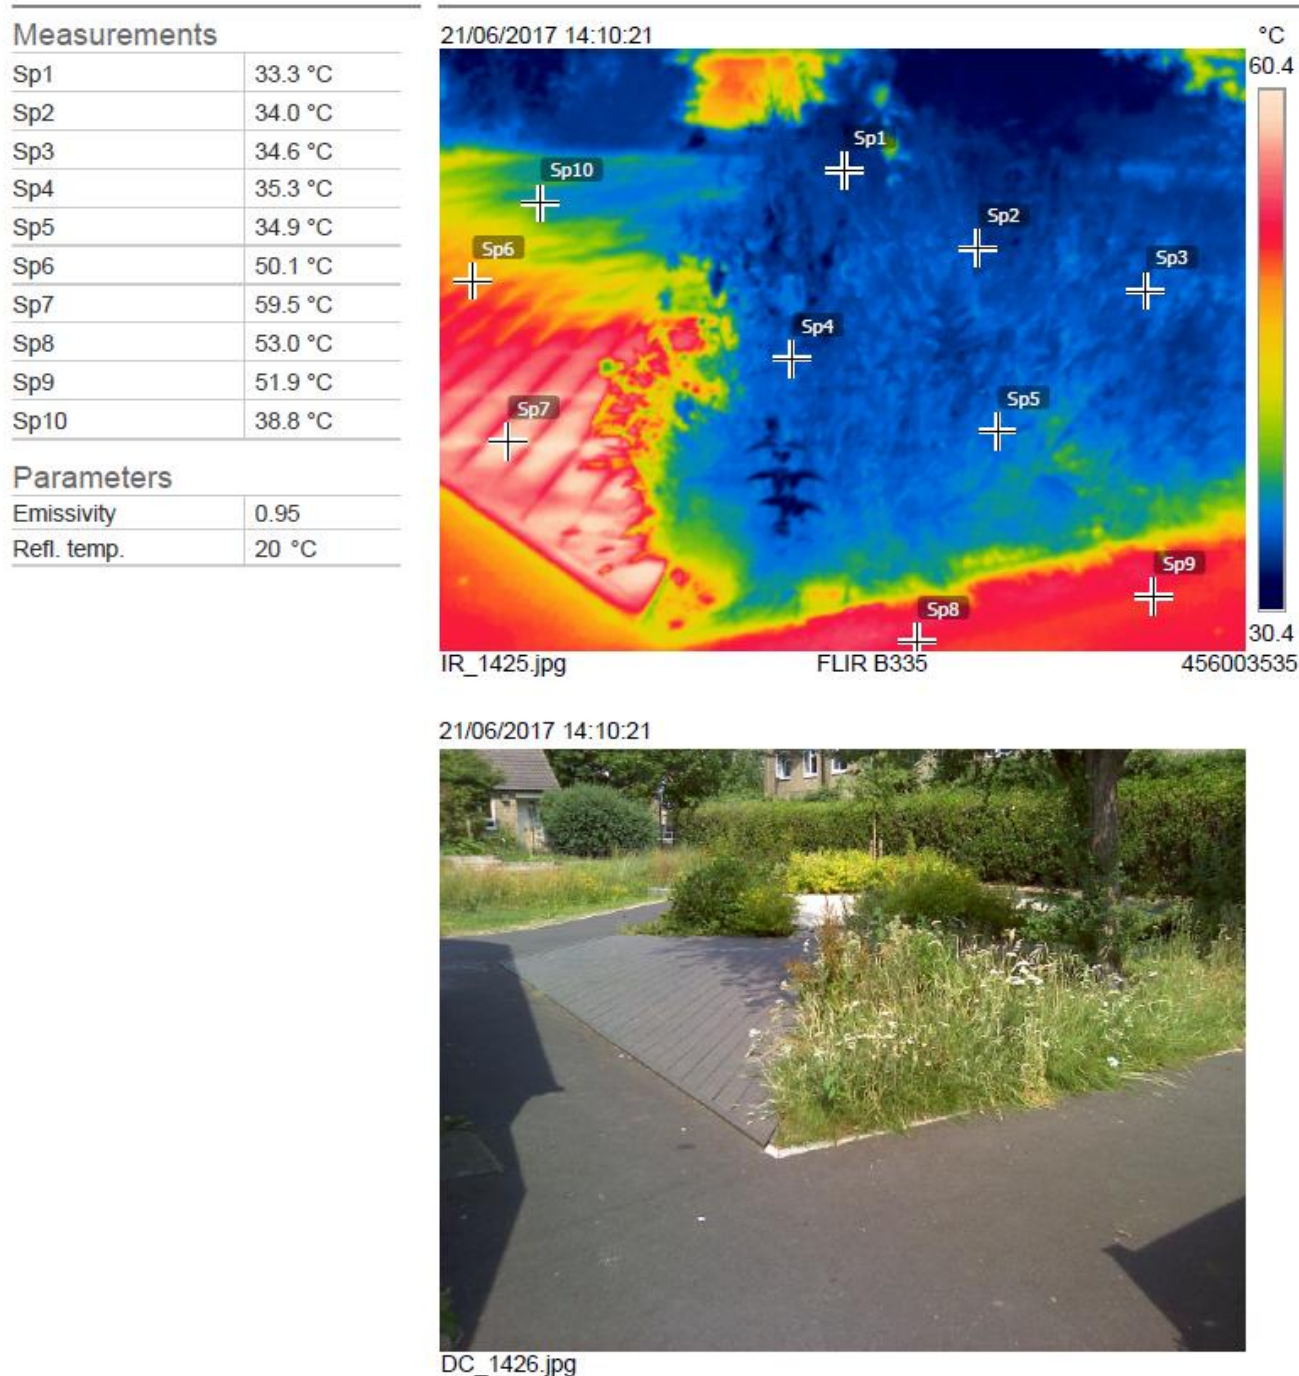
**Figure 81. Photo and infrared image of Austrian gravel lawn at Queen Caroline Estate and surrounding grey infrastructure on the 21<sup>st</sup> June 2017.** FLIR tools software was used to identify temperatures at selected points within the field of view. The hottest temperatures (>50 °C) were associated with the surrounding hard surfaces. These areas were recorded as being substantially hotter than the maximum daily temperature recorded by the nearby weather station (34.1 °C). Temperatures observed in the vegetated gravel lawn were lower by almost 15 degrees with all temperatures around 35°C. The coolest areas were observed in the well-established vegetation (sp 1 at 33.3°C).

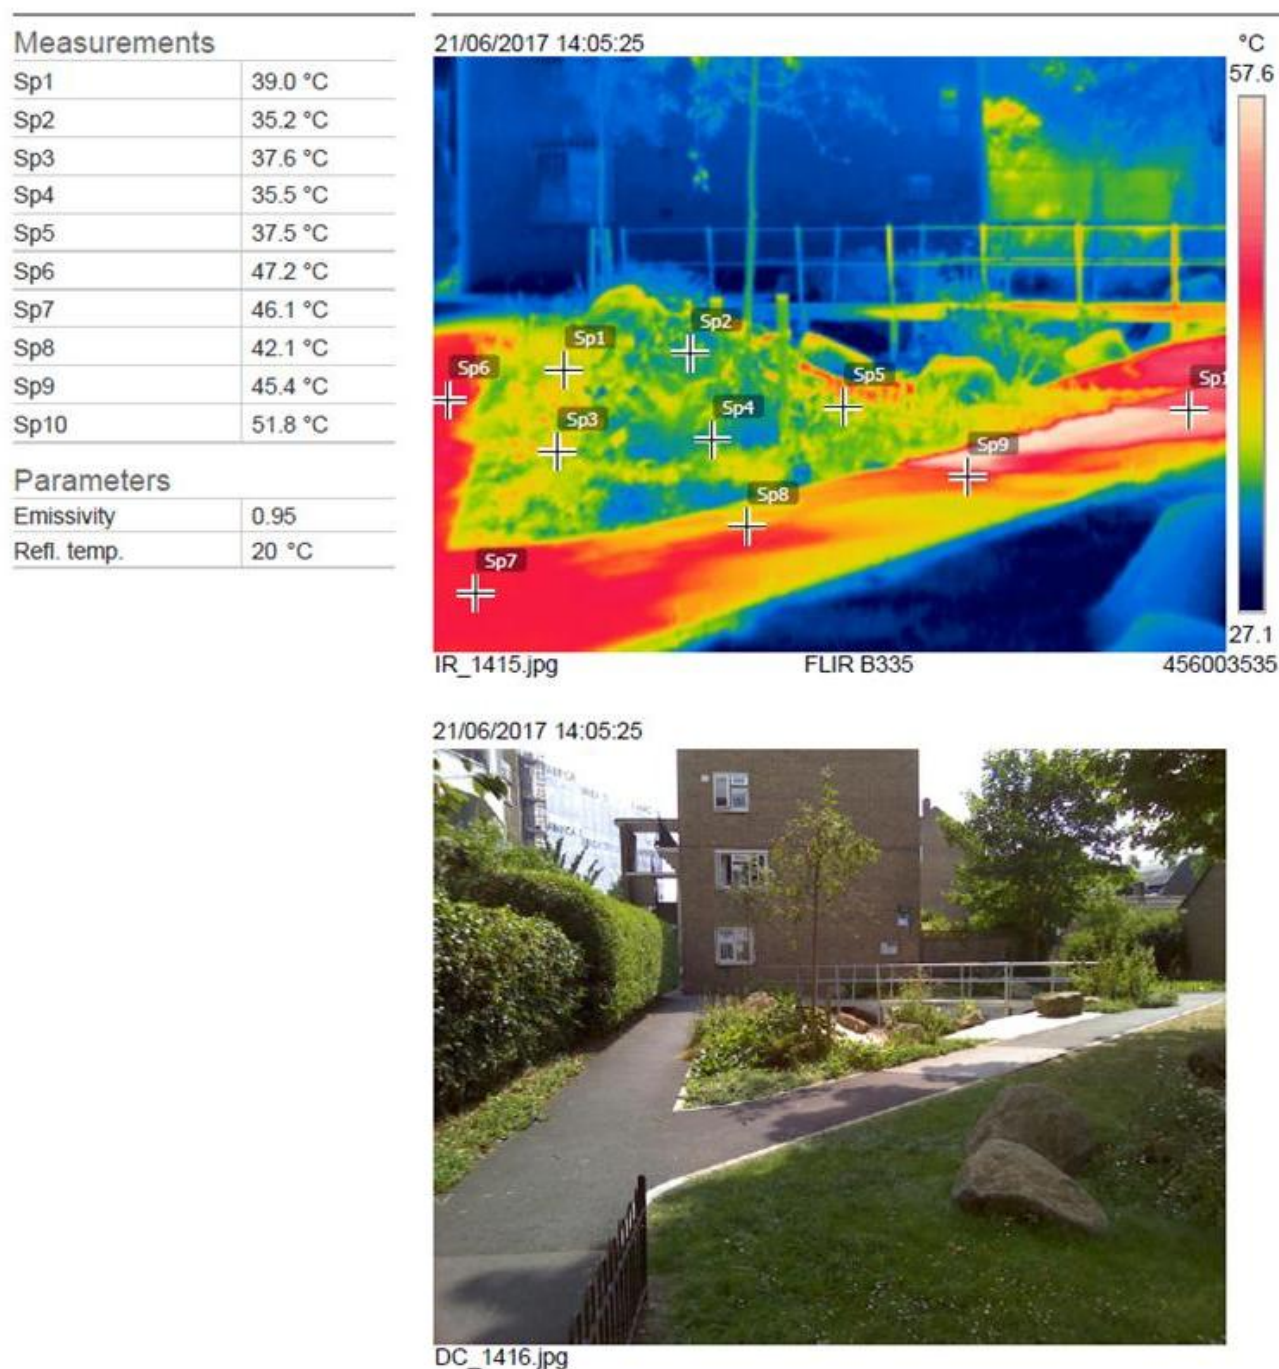
**Figure 83. Photo and infrared image of the combined vegetated and permeable gravel rain garden at Queen Caroline Estate and surrounding grey infrastructure on the 21st June 2017.** FLIR tools software was used to identify temperatures at selected points within the field of view. The hottest temperatures ( $>40^{\circ}\text{C}$ ) were associated with the surrounding hard surfaces. These areas were recorded as being substantially hotter than the maximum daily temperature recorded by the nearby weather station ( $34.1^{\circ}\text{C}$ ). Temperatures observed in the vegetated area vary, but in general were lower with all temperatures  $<38^{\circ}\text{C}$ . The coolest areas were observed in the well-established vegetation (sp 2 at  $35.2^{\circ}\text{C}$ ).

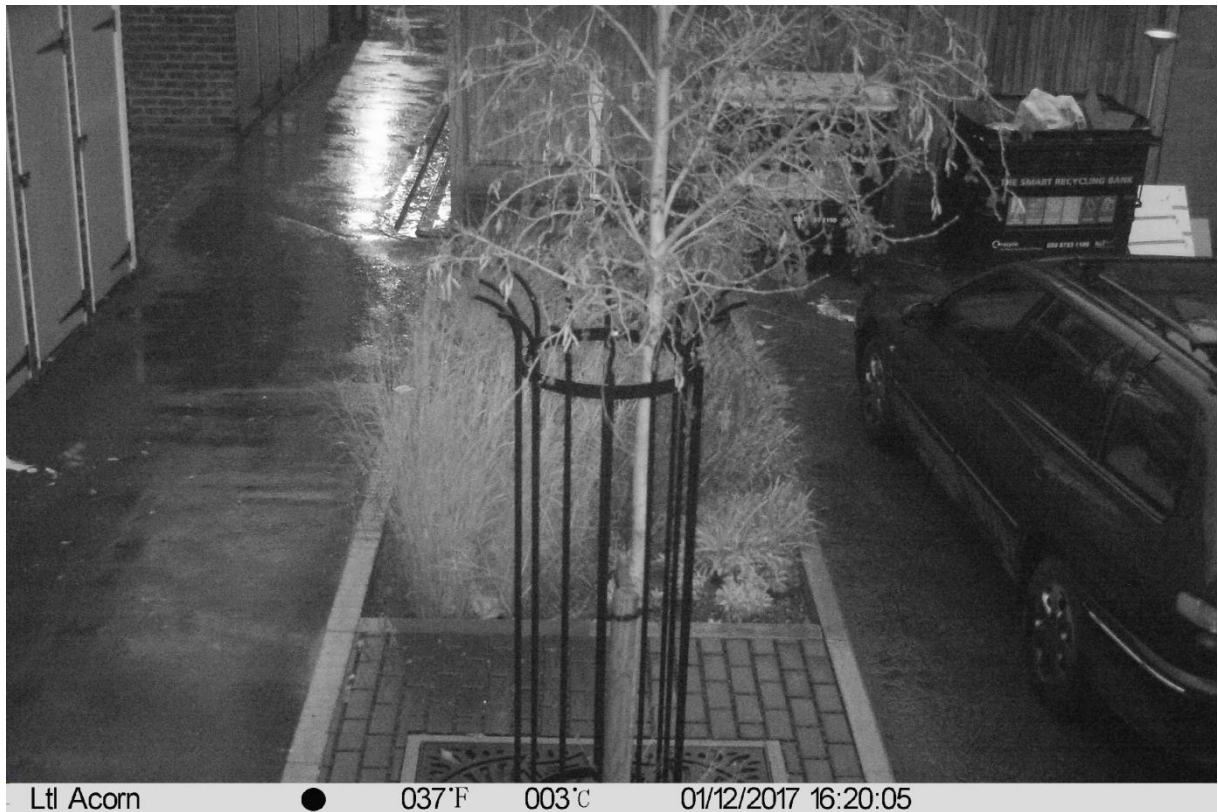
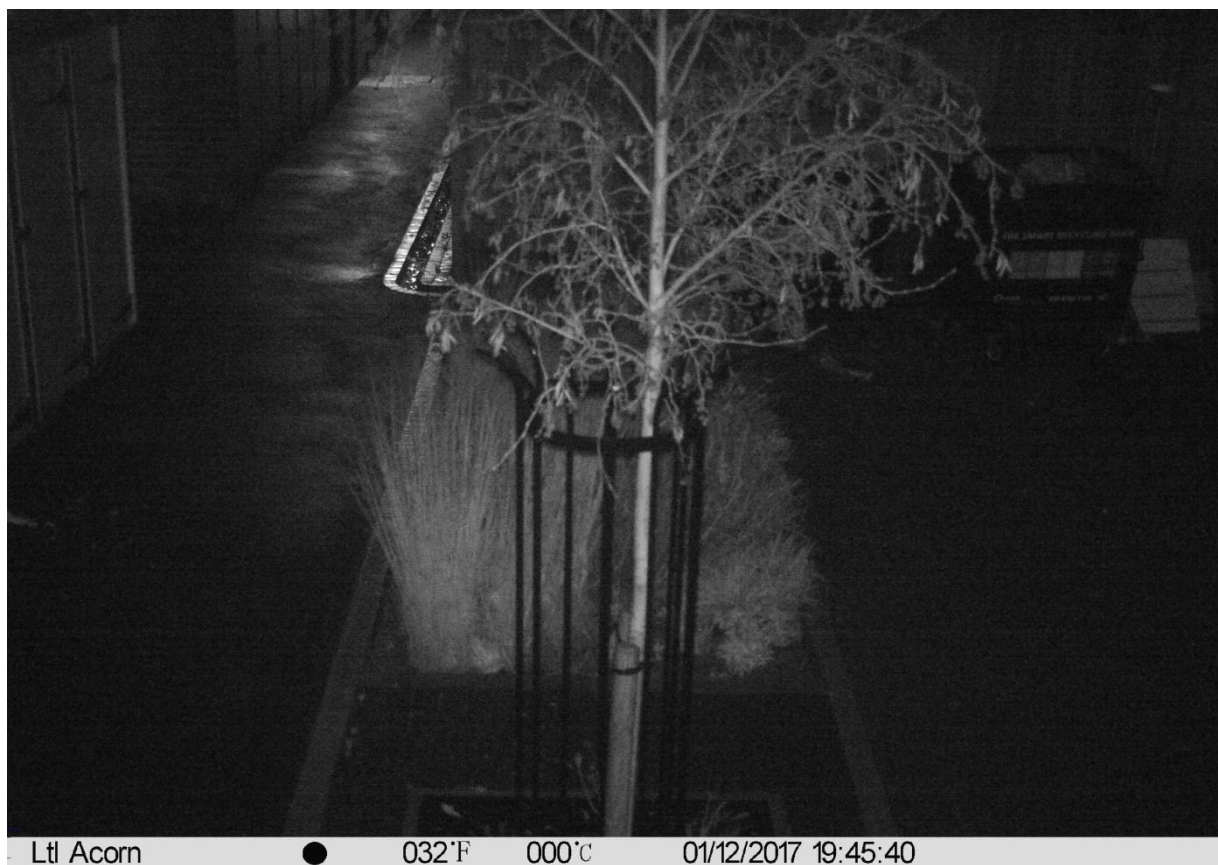
**Figure 115. Time-lapse camera images from Richard Knight House rain garden (FPC5), 12/01/2017.** Images show i) no evidence of overflowing during period of highest rain intensity at 16:20 and ii) evidence of 100% infiltration/conveyance by the end of the intense rain event at 19:45 on the same day.

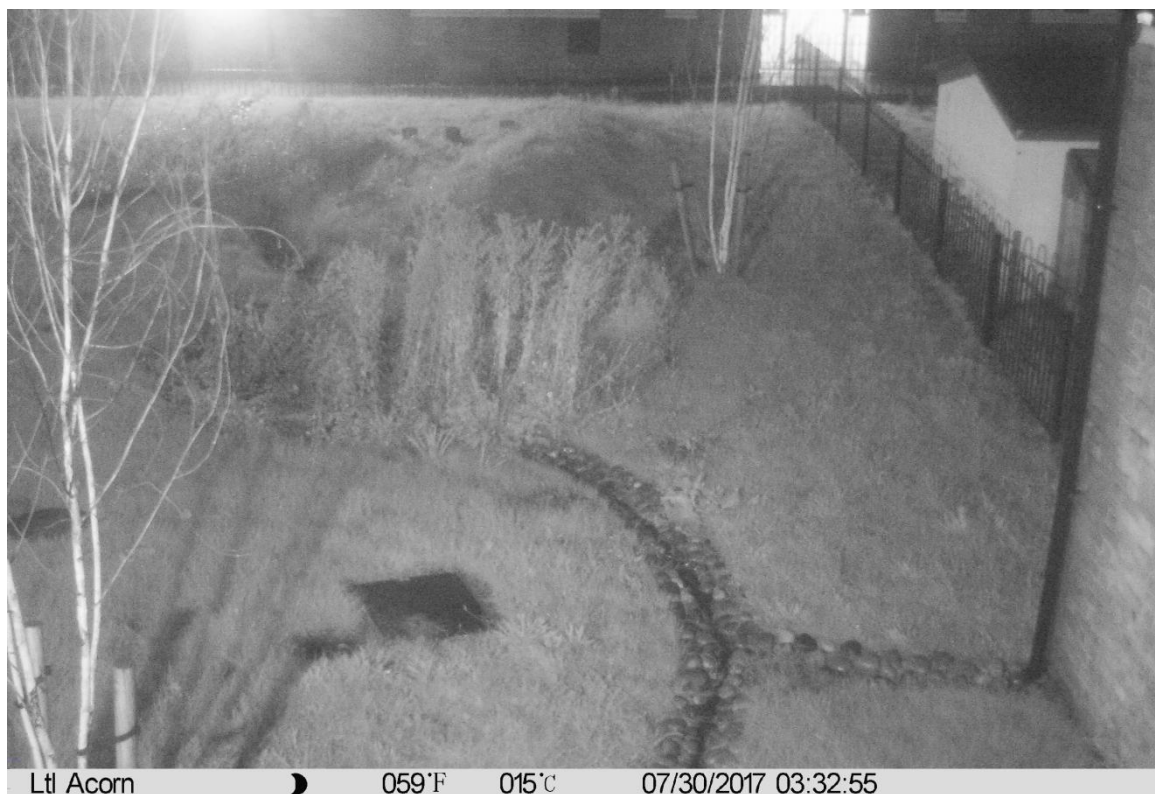
**Figure 138. Time-lapse camera images from Community Hall and Sofia House basins (FPC2), 30/07/2017. Images show i) no evidence of overflowing during a period of high rain intensity at 02:18 and ii) evidence of 100% infiltration/conveyance by the end of the intense rain event at 03:32 on the same day.**

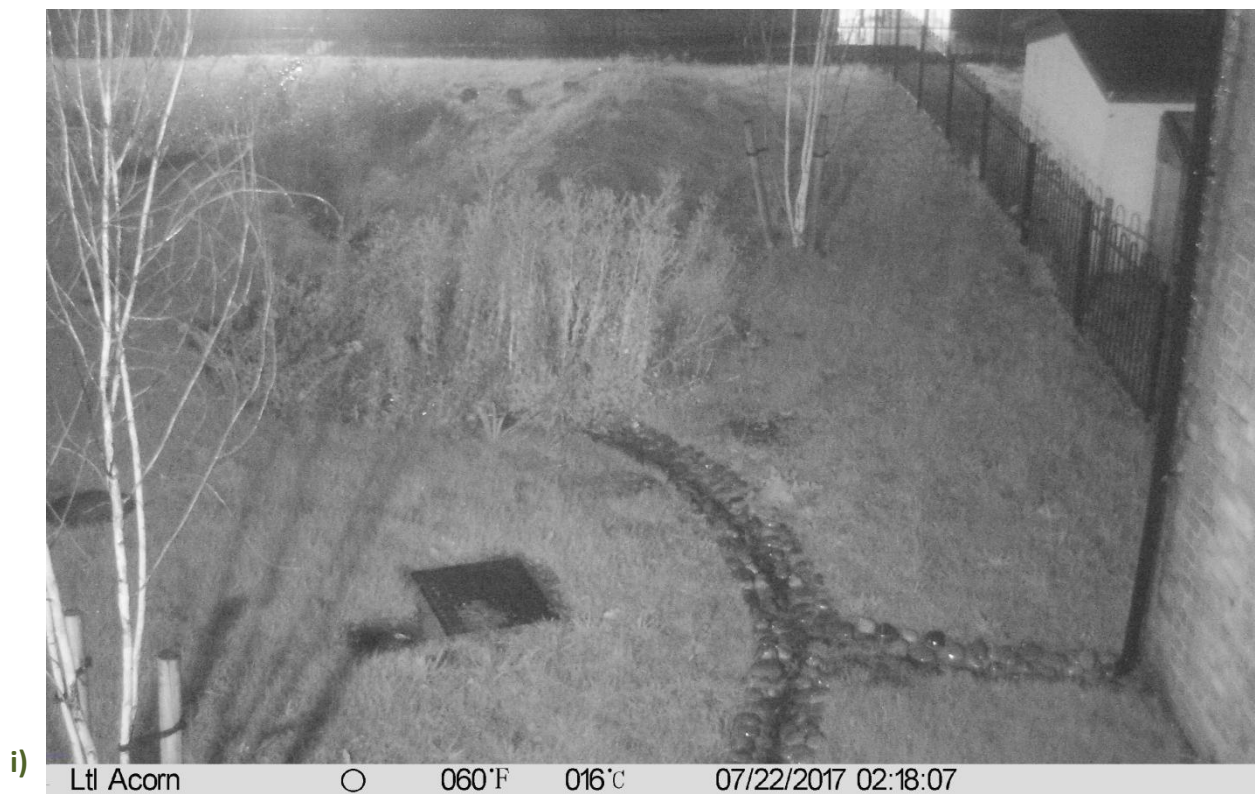
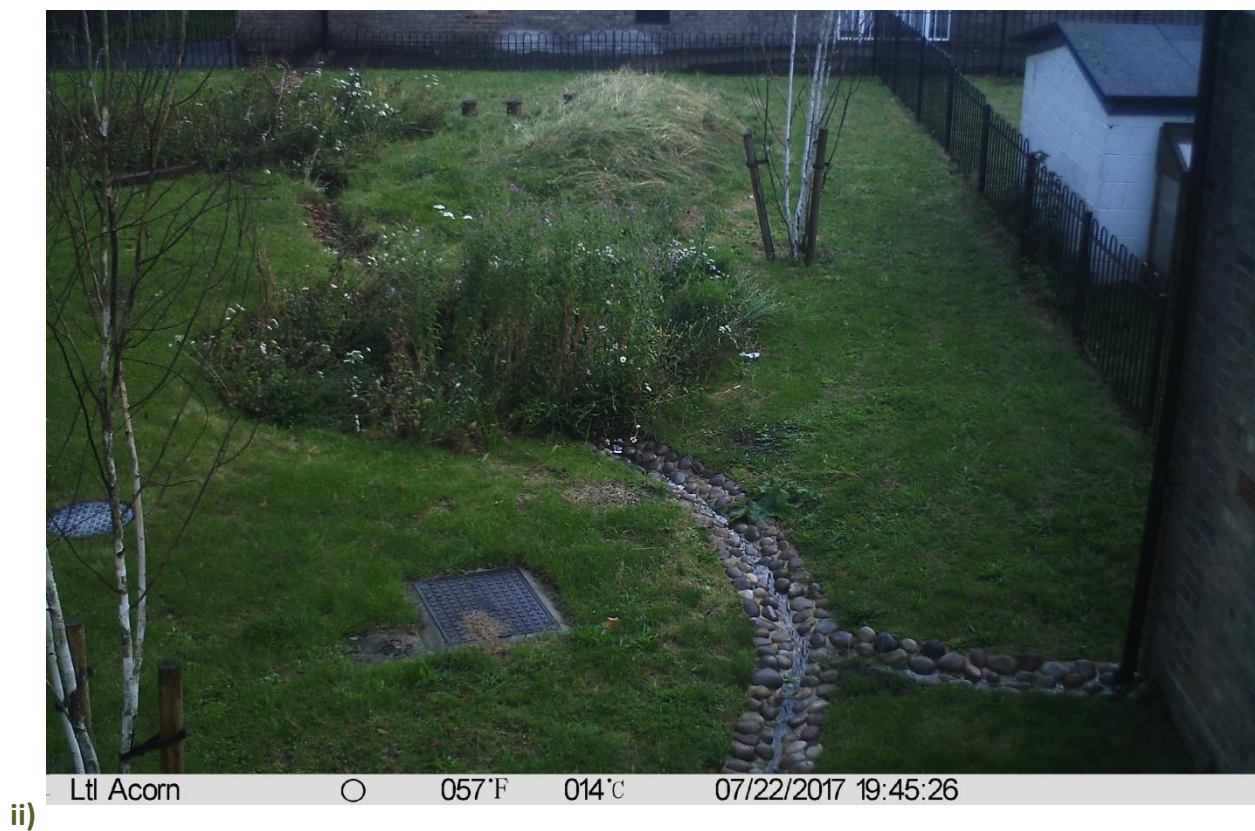
**Figure 146. Time-lapse camera images from Community Hall and Sofia House basins (FPC2), 22/07/2017. Images show i) no evidence of overflowing during a period of high rain intensity at 02:18 and ii) evidence of 100% infiltration/conveyance by the end of the intense rain event at 19:45 on the same day.**

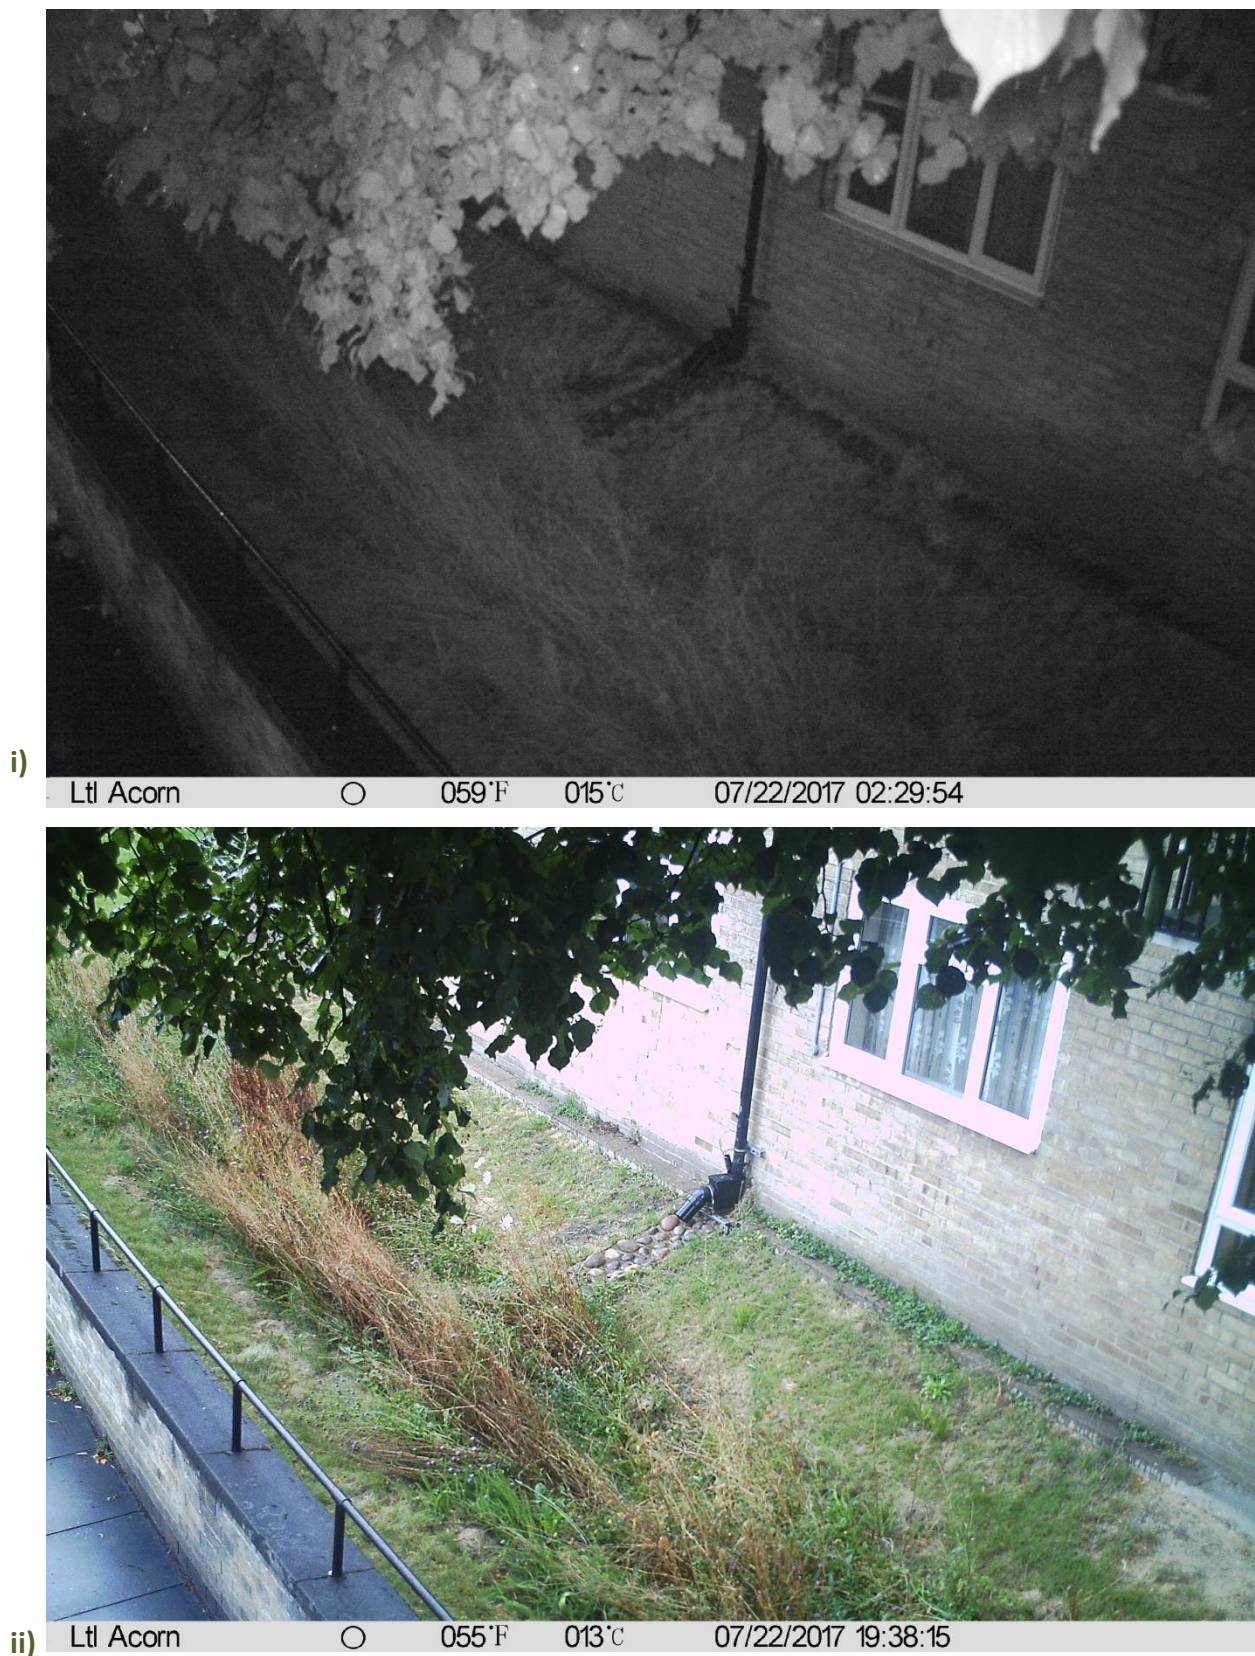
**Figure 148. Time-lapse camera images from Beatrice House swale (FPC4), 22/07/2017.** Images show i) no evidence of overflowing during a period of high rain intensity at 02:29 and ii) evidence of 100% infiltration/conveyance by the end of the intense rain event at 19:38 on the same day.

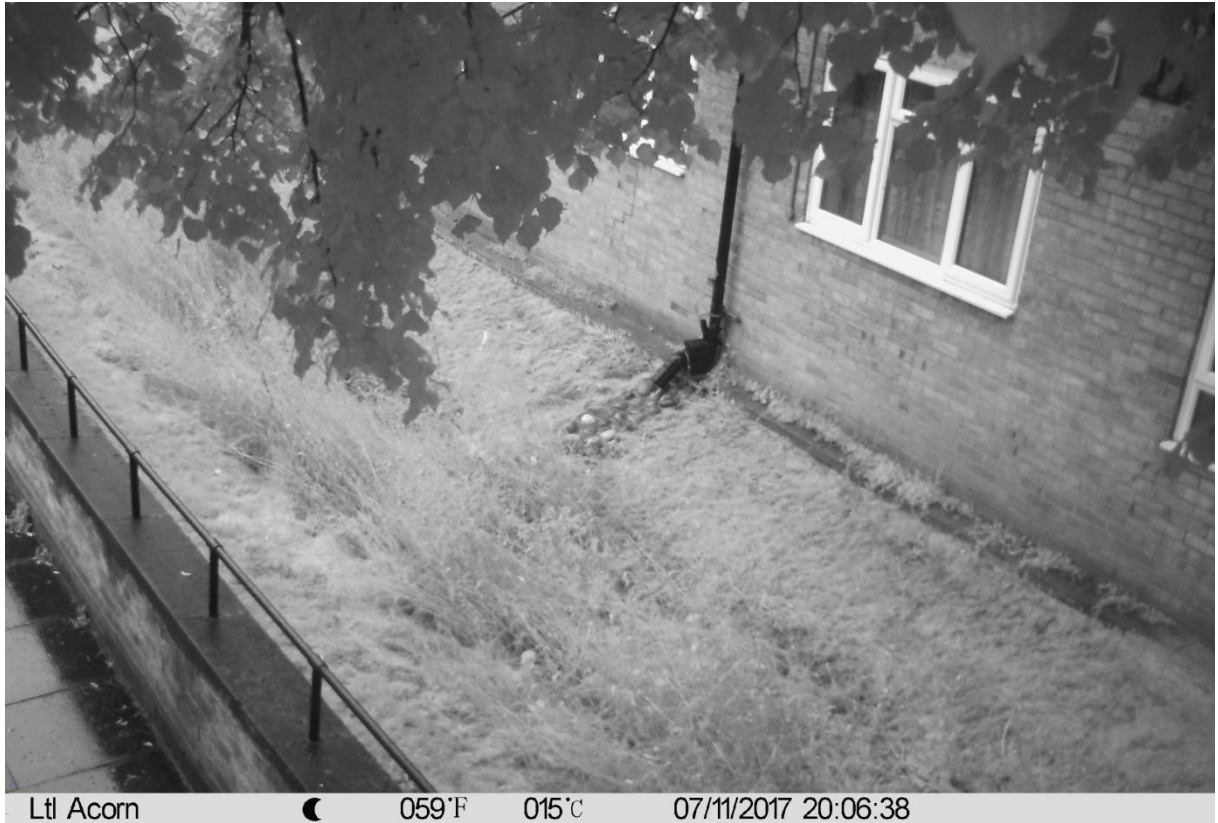
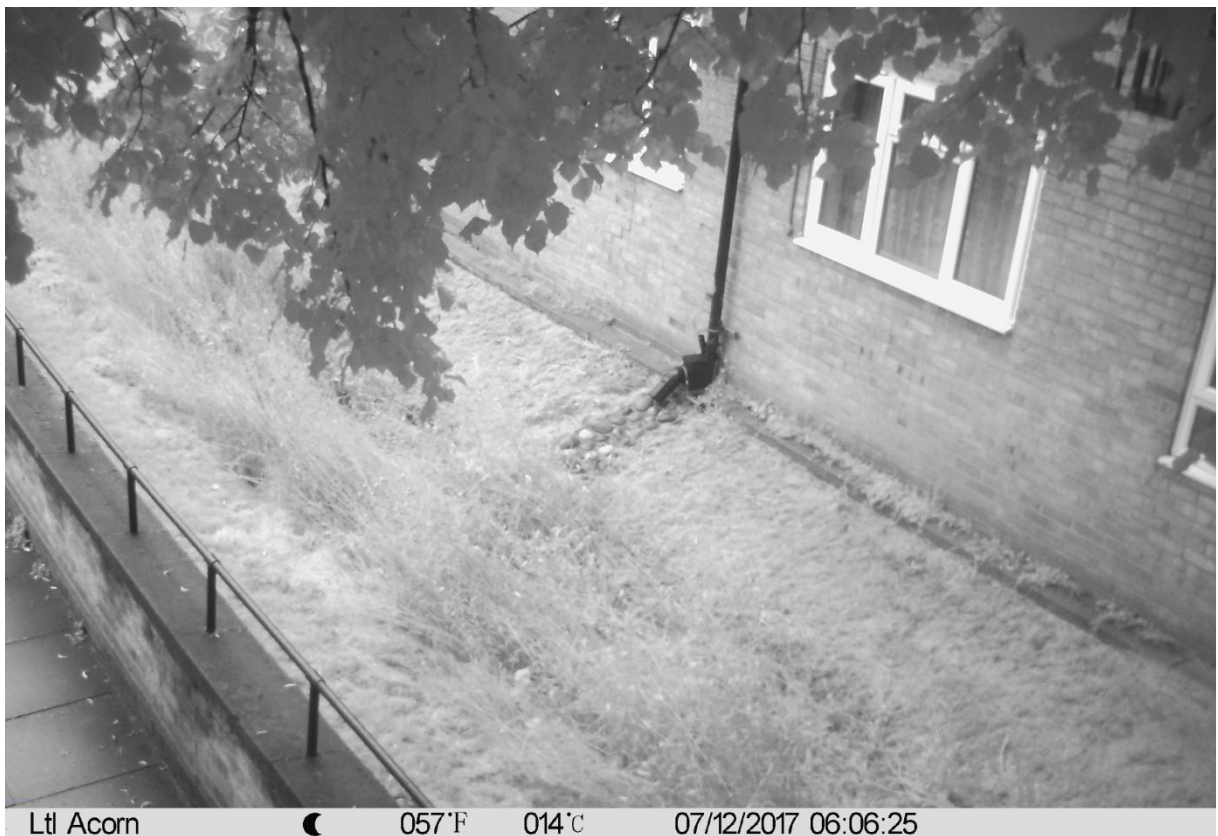
**Figure 156. Time-lapse camera images from Beatrice House swale (FPC4), 11/07/2017 and 12/07/2017.** Images show i) no evidence of overflowing during a period of high rain intensity at 20:06 on the 11th and ii) evidence of 100% infiltration/conveyance by the end of the intense rain event at 06:06 on the 12th.
