UEL Research & Knowledge Exchange Conference 2013

Name & Title of Presenter:	Dr Ravindra Jayaratne, Senior Lecturer in Civil Engineering
School:	Architecture, Computing & Engineering (ACE)
Co investigators:	-
Title of Abstract:	Field Survey of Coastal Dyke Failure due to 2011 Great Eastern Japan Earthquake Tsunami
Key Theme/ Key words:	Post-tsunami field survey, coastal dyke, practicing coastal engineer, numerical modelling, UEL-Waseda research collaboration

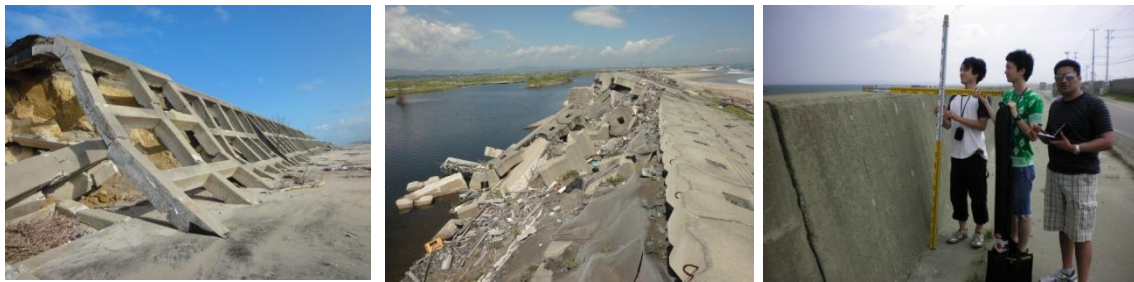
Figure 1. Failure of coastal dykes and the field survey team of UEL-Waseda University research collaboration

The two joint field surveys of UEL-Waseda University (Japan), carried out in summers of 2011 and 2012, covered particularly coastal dikes in Watari, Soma, Higashimatsushima, Ishinomaki, Iwanuma and Yamamoto cities in Miyagi and Fukushima prefectures. According to the surveys, the leeward toe of coastal dikes was scoured in many surveyed areas, though the seaward slope was often not completely washed away. Thus, the tsunami wave appears to first overtop the front face of the wall generating strong turbulence and currents at the leeward toe, creating a large scour hole. Then, due to the large wave pressure and buoyancy forces in the scour-hole area the protection cover in leeward slope is uplifted causing a complete failure of the structure (Fig. 1). The author will highlight the detailed results of two field surveys, general failure modes of coastal dykes and numerical modelling at Waseda University (Jayaratne et al, 2013; Esteban et al., 2013) at the conference.
