# Betjeman Award

# Back on right road

Architect **Alan Chandler** describes the complex and meticulous repairs that impressed the judges of the 2017 John Betjeman Award

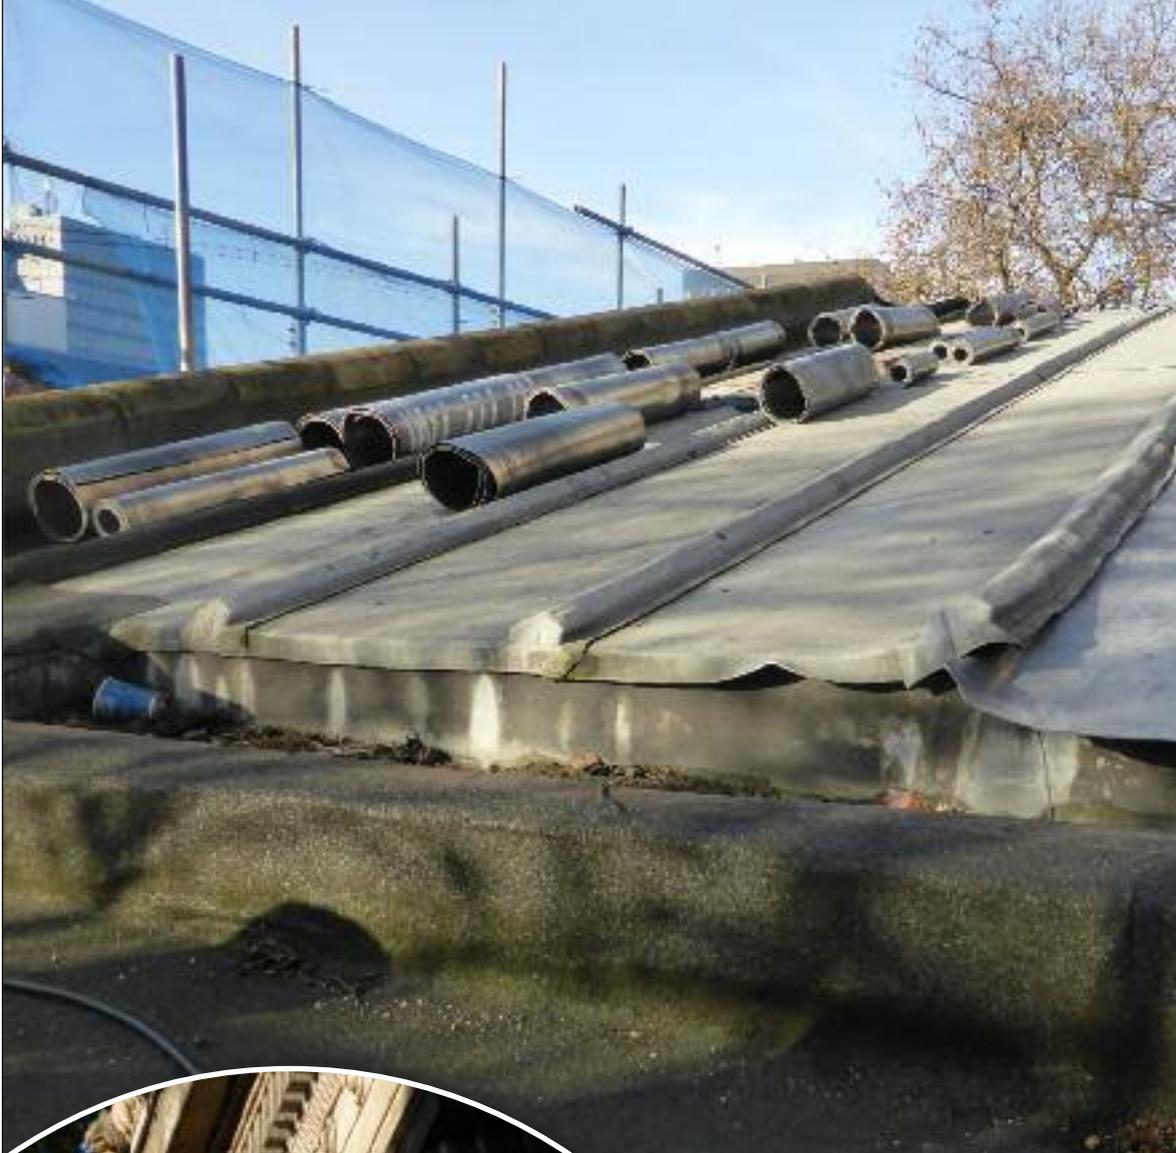
Starting the Portico leadwork – over-length lead bays, asphalt and cement. Note the two fixing holes to the antefix, bottom left

Lead was specified to match the existing (Code 7 sand-cast), re-using the existing timber boarding and rolls where possible. When stripped, the water damage to the timber was allowed to dry out and almost all of the boarding was retained in situ. The new bay lengths conform to Lead Sheet Association guidance, however the distinctive and original (non-compliant) timber roll profile was retained in situ. A good deal of time was spent on the roof assessing the way water was behaving around the antefixes, and devising a lead cloak for each which utilised the rebate for the original lead roll to fix a timber ground, allowing clips to be secured and the cloaks to be restrained. Lead drips were then dressed between the antefixes, even between the final antefix and the lion head enrichments at the corners (which appear to be classical “sima” – upturned classical roof edges – but do not perform the function of water discharge). The development of these details was indicated as part of the contract tendering, but were defined on site in collaboration with expert lead worker Dean Lock, who contributed a great deal to the execution of our ideas. These drips are imperceptible from the ground and will, over time, allow the stonework and terracotta below to dry out – a future and more extensive façade repair programme can then consolidate these areas.

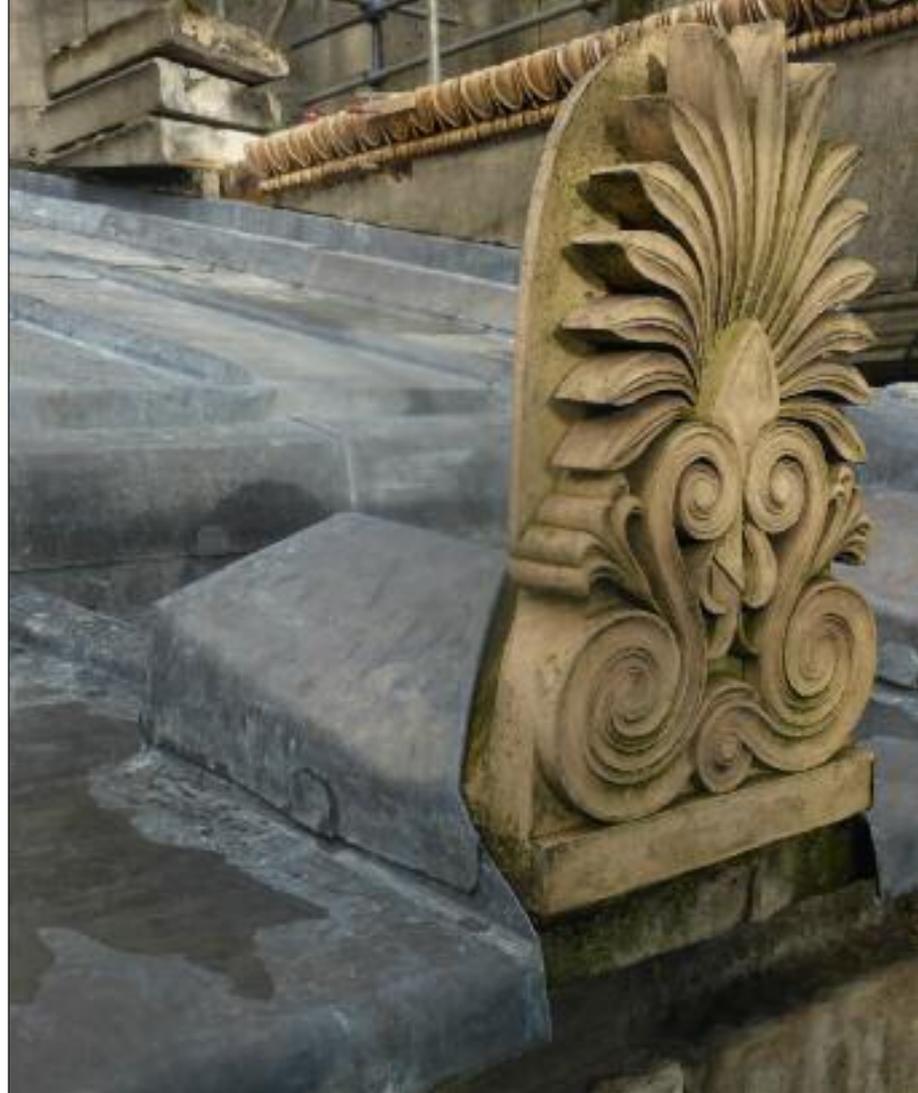
Above: Antefix cloak complete

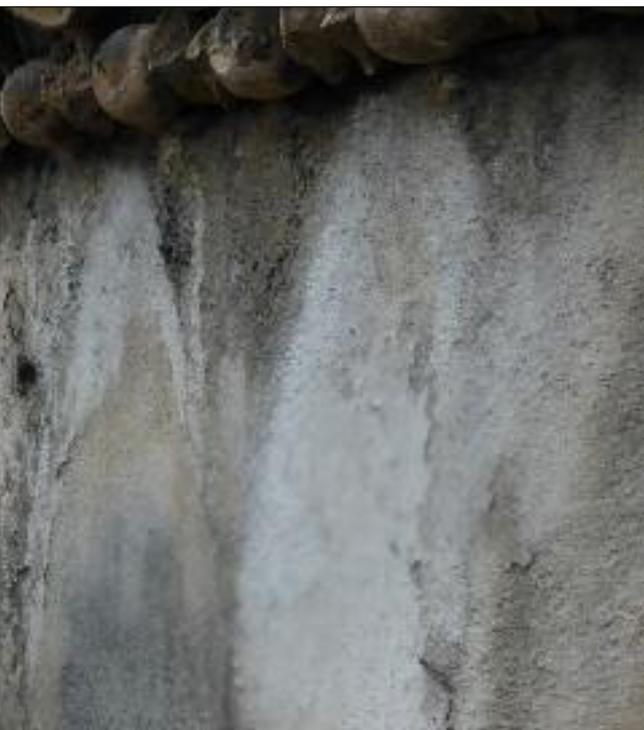
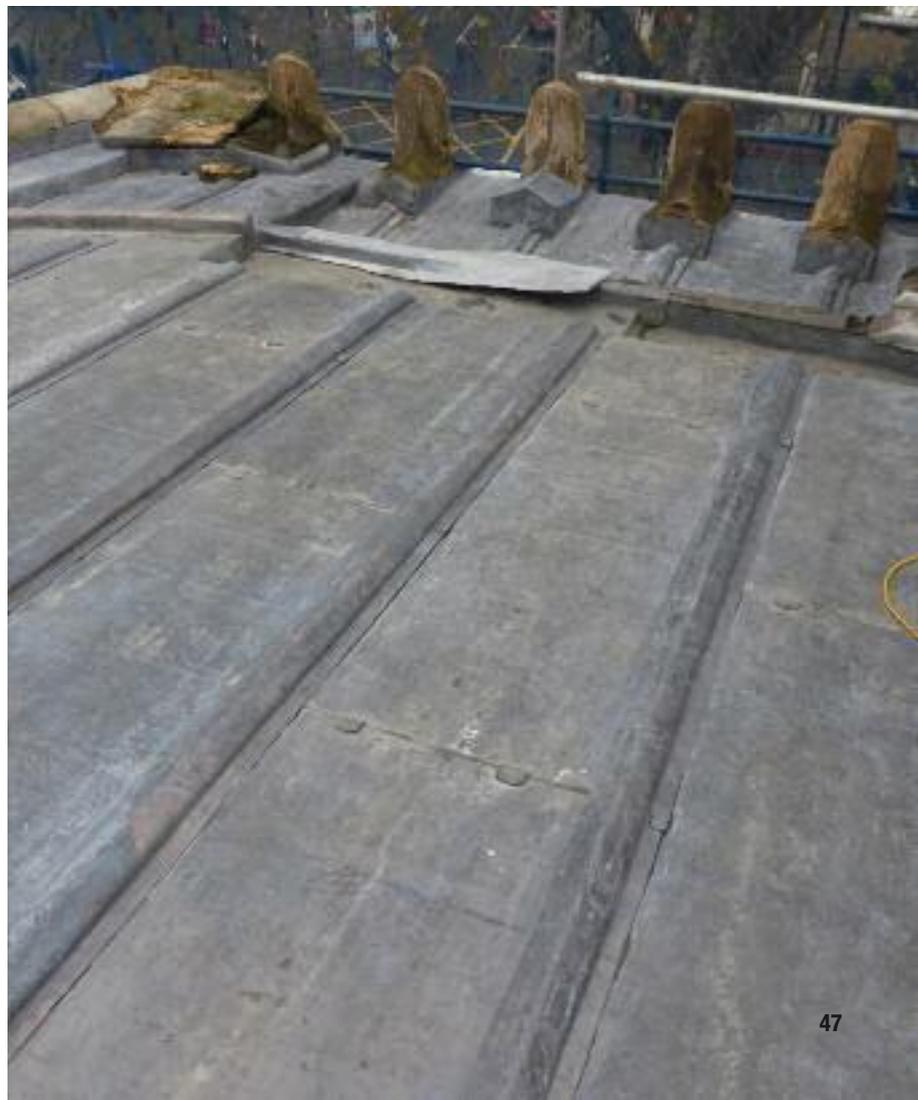
Above: Original larch boarding and lead roll.  
Left: water corrosion to the Portico edge.  
Right: Dressing lead around the antefixes incorporating later gutter detail

It was clear that the roof had been modified at some point after construction, as each of the antefixes along the flank of the portico has a specially detailed rebate with fixing holes to accommodate the end of each timber roll – now unused. With the introduction of a shallow gutter behind the antefixes, they were left to sit in isolation on an asphalt covered cementitious render, allowing for water penetration and unmanaged run-off to corrode the leading edge of stone and the terracotta enrichment directly below.

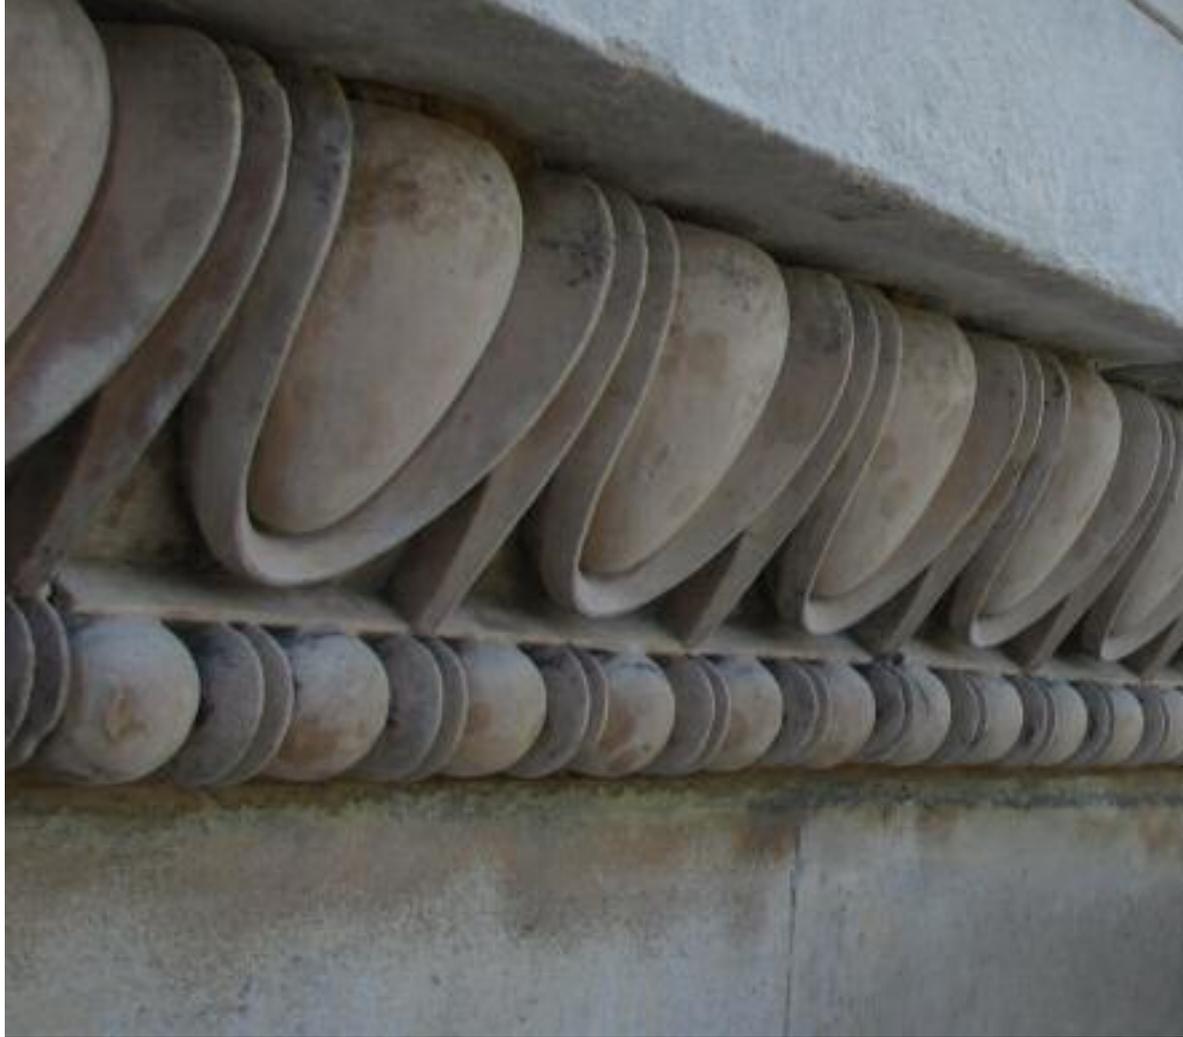
Removal of the cramps and spalling repairs at the top of the inner parapet stonework was directly under the copings, making the minimal removal of stone to affect repair difficult. Our inspection also revealed that iron cramps had been used to restrain the terracotta enrichment below the coping stones, their corrosion leading to the terracotta blocks loosening and occasionally falling to earth (many held by the Church in an “archive” awaiting future reinstatement).

There were a number of cramps holding the inner parapet wall cladding that were yet to corrode to the point where stone was being pressurised by iron expansion. Therefore, only cramps where evidence of localised cracking, iron oxide leaching or spalling would be cut out. Where no evidence of corrosion was evident, iron cramps were left in place.

The presence of a number of original copper cramps in some locations added to the complexity. In addition to facilitating the replacement of cramps that had damaged the stone, resetting the copings allowed for the insertion of a lead drip to the inner face of the parapet. This non-original detail would augment the ability of the eroded copings to throw water clear of the wall, the stone repairs and the remaining iron cramps, prolonging the life of all three. A number of Portland stone edge pieces were reinstated, the location corresponding only to areas where local erosion of the stone created water run-off that threatened or had already made significant damage to the terracotta enrichment

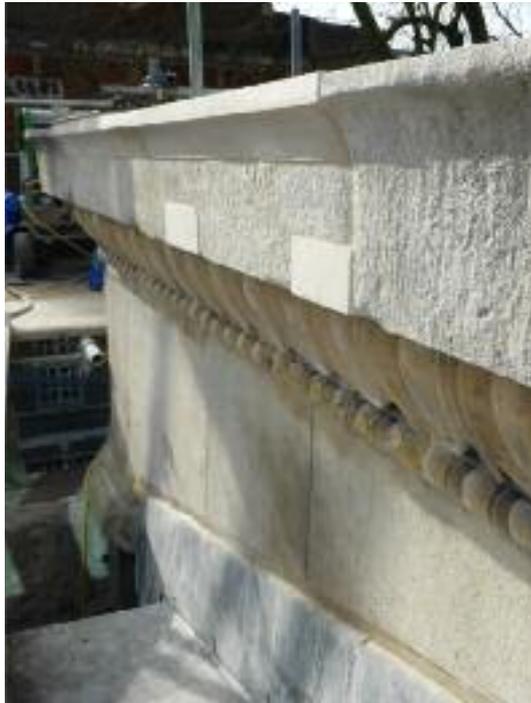
Completed coping edge repair

below it. The eroded profiles were respected but not imitated, the new pieces unmistakably new, sitting slightly proud of the adjoining original material.

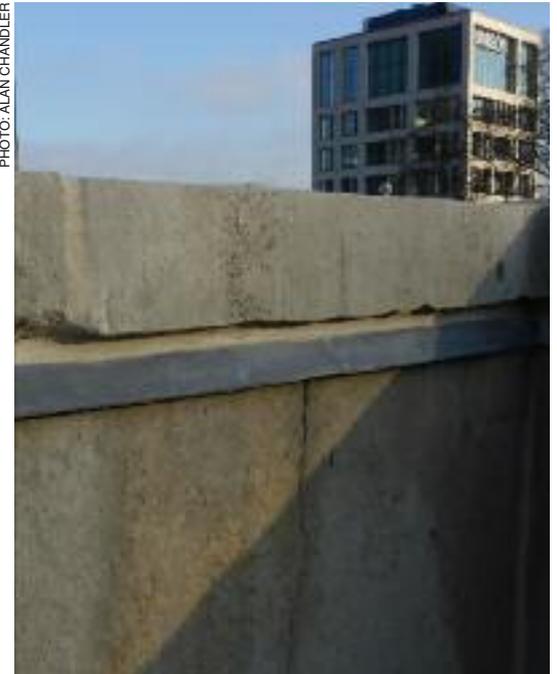
Completed inner parapet walls with cramp repair and lead drip detail

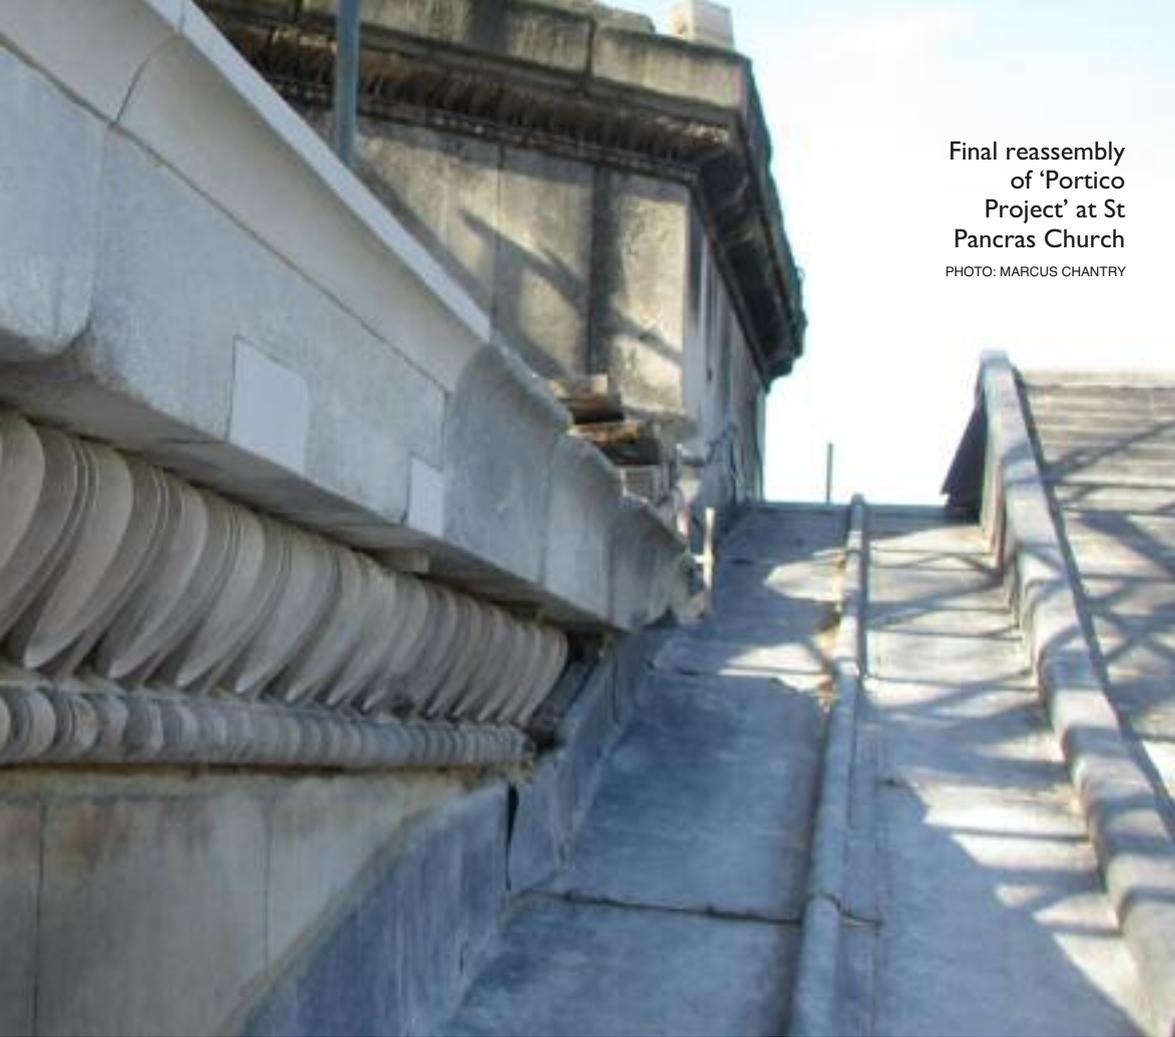
Final reassembly  
of 'Portico  
Project' at St  
Pancras Church

numbering and careful removal of the terracotta elements while the copingstones were being reset, with each piece cleaned as per the trial. The elements were then re-fixed in place using stainless steel cramps with a lime mortar bedding.

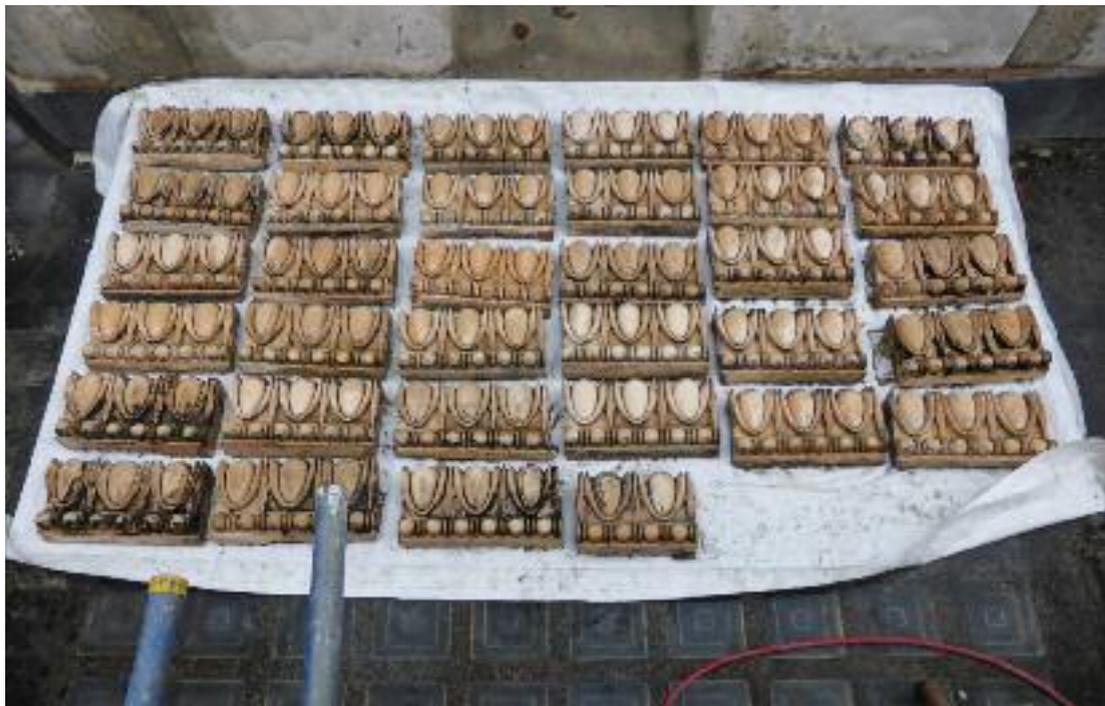
Terracotta elements undergoing cleaning

A sequence of carefully executed cleaning procedures was developed with Sally Strachey Historic Conservation and tested on a terracotta

element that had fallen from its location. Based on the results of this 5 per cent concentration ammonium carbonate poultice and 'Thermatech' cleaning trial, a process was determined which removed the majority of the carbon crust and associated blackening while ensuring that the fire skin was not eroded and the age of the terracotta not erased.
