Article

Environmental Impacts and Embodied Energy of Construction Methods and Materials in Low-Income Tropical Housing

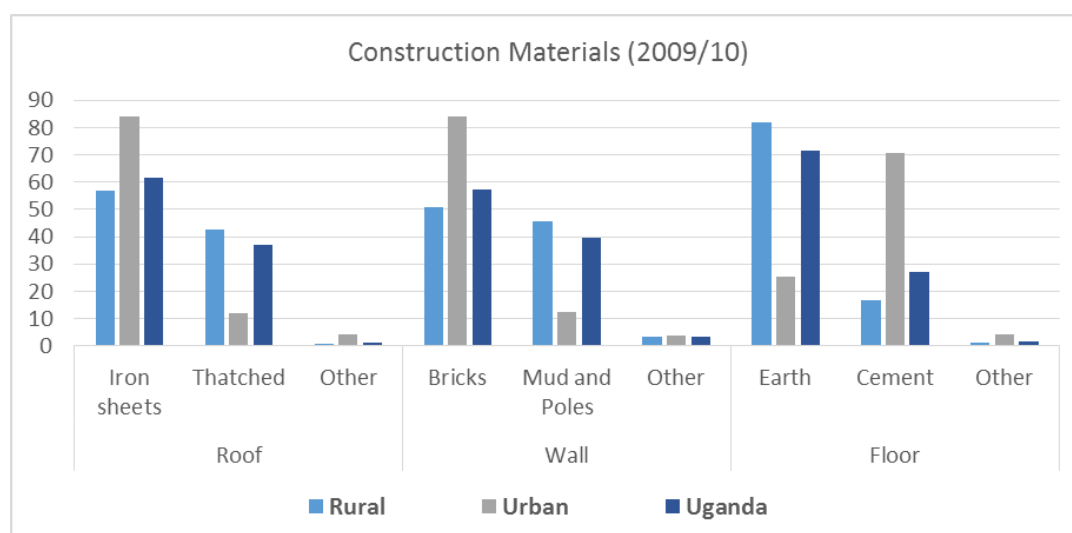
Figure 5. Main types of construction materials in 2009/2010 (%). Source of table: [23].

The major limitations of the construction industries in African countries are high costs and limited access to good quality materials whether imported or produced locally. Moreover, due to the weak transportation infrastructure and limited access to urban factories, particularly in rural areas, material supply cannot cope with the high housing demand [24]. Using locally available materials seems to be an appropriate solution which has already been considered in many parts of Uganda. Figure 5 shows the main construction materials in 2009/2010 in Uganda. Brick and mud and poles are the two most common walling materials/methods in Uganda. Brick walling is the most common system in both urban and rural areas; however, mud and poles walls are much more common in rural than in urban areas. The walling methods are explained in more detail in the following sections.

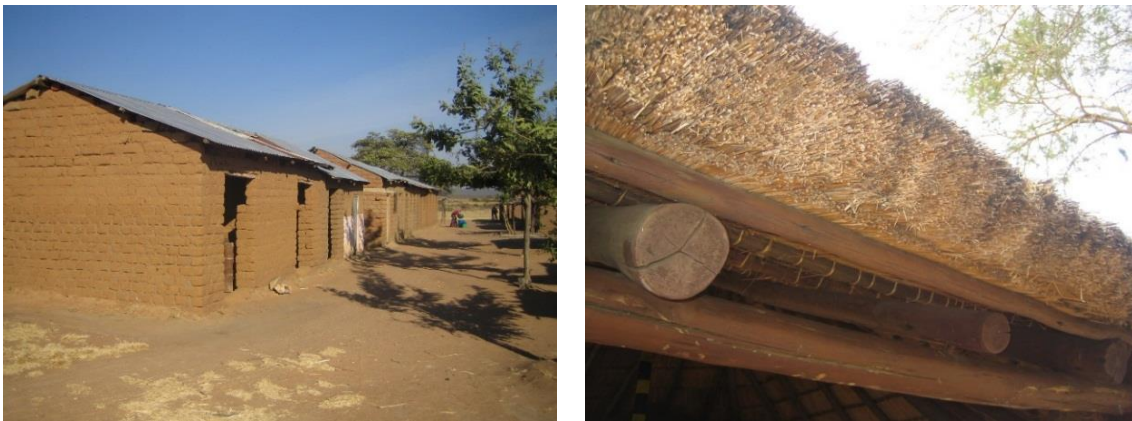
Figure 6. Iron sheet roof (**left**) and thatched roof (**right**). Source: The authors.

Iron sheets and thatched roofs (Figure 6) are the most common roofing systems in Uganda. Around 62% of all roofs in Uganda are covered with iron sheets compared to around 37% which are thatched roofs. Iron sheet roofing is much more common in both rural and urban areas. Around 84% of roofs in urban areas are covered with iron sheets compared to 57% in rural areas. This figure for thatched roofs is 43% in rural areas compared to 12% in urban areas. Earth flooring is dominant method/material particularly in rural areas. More than 70% of all floors in Ugandan homes are made out of earth. The share of rural areas is 82% compared to around 25% for urban areas. Cement/concrete flooring is the next most common flooring methods in Uganda. Nearly 30% of all floors in Ugandan homes are made from cement. The share of cement flooring is much higher in urban areas. More than 70% of floors in urban areas are made out of cement/concrete compared to around 17% in rural areas [23].

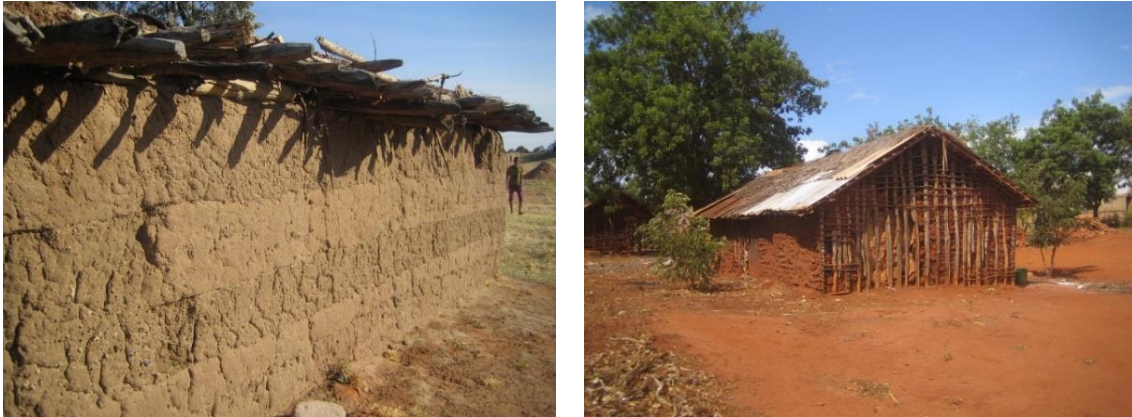
Figure 7. Cob (**left**); Mud and Poles (**right**). Source: The authors.

Mud and poles is a very common construction method in Uganda (Figure 7). In 2010, more than 39% of all dwellings in Uganda were made with mud and poles. This figure was 46% for houses in rural areas compared to 12% in urban areas [23]. Mud and poles construction consists of wooden structure (poles) and the space/gap between the poles is filled with mud. Thanks to the local availability of its materials, mud and poles is very economical, making it suitable for low-cost housing; however, it is structurally weak and needs constant maintenance as it cracks easily due to the shrinking/swelling of the wood [25]. Although mud and poles construction can be considered as a sustainable environmentally friendly

method of construction (thanks to the application of local unprocessed materials and its negligible embodied energy), it contributes to deforestation due to the use of local wood in its structure [12]. This makes mud and poles construction less environmentally friendly compared to other methods and materials such as adobe, explained below.

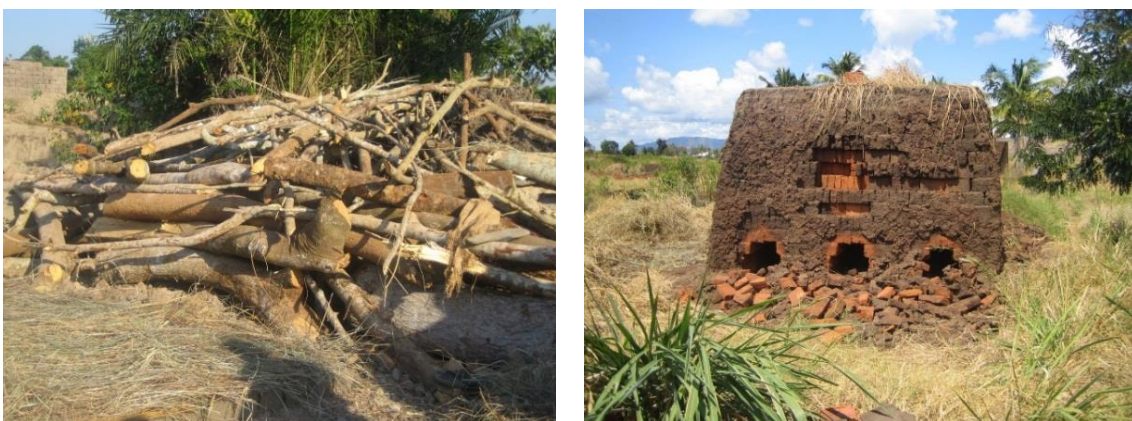
Figure 8. Inefficient production processes of burned bricks and use of local wood contribute to deforestation. Source: The authors.

Burned brick is considered as a durable material; however, it is environmentally harmful due to its low quality, very inefficient production processes and the use of local wood in brick kilns which contribute to deforestation and air pollution [12,13] (Figure 8).

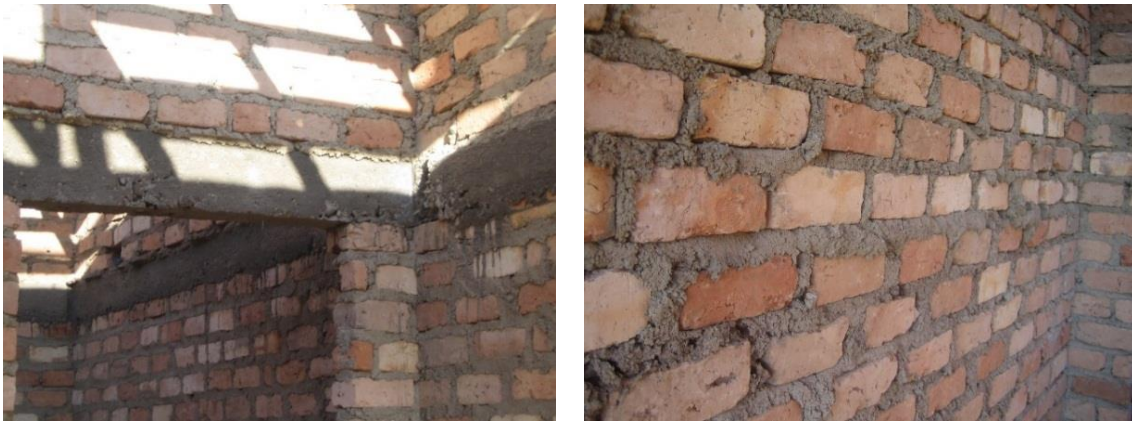
Figure 9. Excessive use of mortar increases the environmental damage as well as the overall construction costs. Source: The authors.

Excessive use of mortar (Figure 9) during construction is another major issue associated with burned brick walls. According to Perez [12], this is due to the uneven sizes of burned bricks; however, considering disproportionate mortar thicknesses of up to 30 mm, it seems that other reasons such as poor construction skills also contribute to this phenomenon. The unpleasant appearance of brick walls also necessitates plastering [12]. These issues may increase the overall cost of brick walling, making it rather inappropriate for low-cost housing. It is therefore necessary to improve the quality, production and construction processes of burned bricks not only to reduce the overall costs but also to mitigate their environmental impacts.

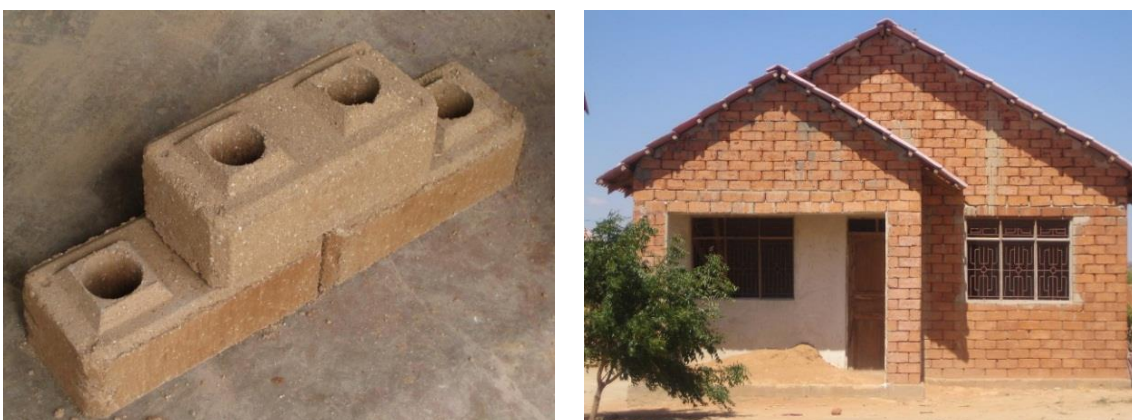
Figure 10. Interlocking bricks can be an alternative for burned bricks. Source: The authors.

Alternative construction methods and materials such as interlocking blocks/bricks (Figure 10) have been developed to reduce/eliminate the use of mortar in the construction processes of brick walls. Interlocking bricks, however, are not structurally stable against horizontal and/or earthquake forces. Vertical reinforcement elements may be used to improve their resistance against earthquakes [25].

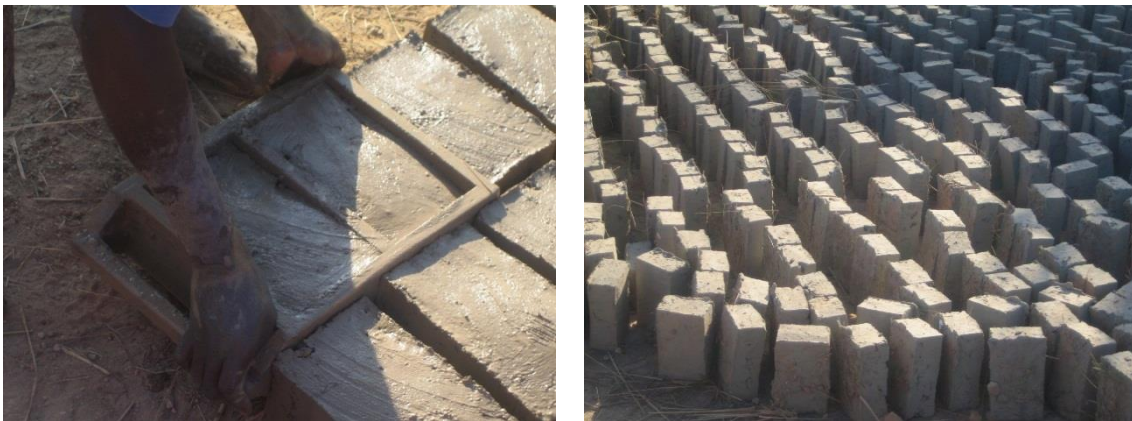
Figure 11. Adobe is one of the most environmentally friendly construction materials.
Source: The authors.

Thanks to its very low embodied energy, adobe is an environmentally friendly construction material (Figure 11). Adobe, however, is not as structurally stable and durable compared to burned bricks and requires regular maintenance. The greatest disadvantage of adobe is its vulnerability to water and rain [24]. Internal/external plastering/rendering may improve the appearance and performance of adobe walls reducing the need for maintenance [25]. Despite its environmental advantages, adobe is locally regarded as the “material of the poor” [13], which may restrict its application in Uganda. Educating people about the environmental benefits of adobe and other similar construction materials may help to increase the share of these materials in East African countries. Improving the quality and structural stability of such methods and materials such as mud and poles and adobe to reduce the extent and frequency of maintenance would also improve the public attitudes and encourage the public to consider these methods and materials in their building.

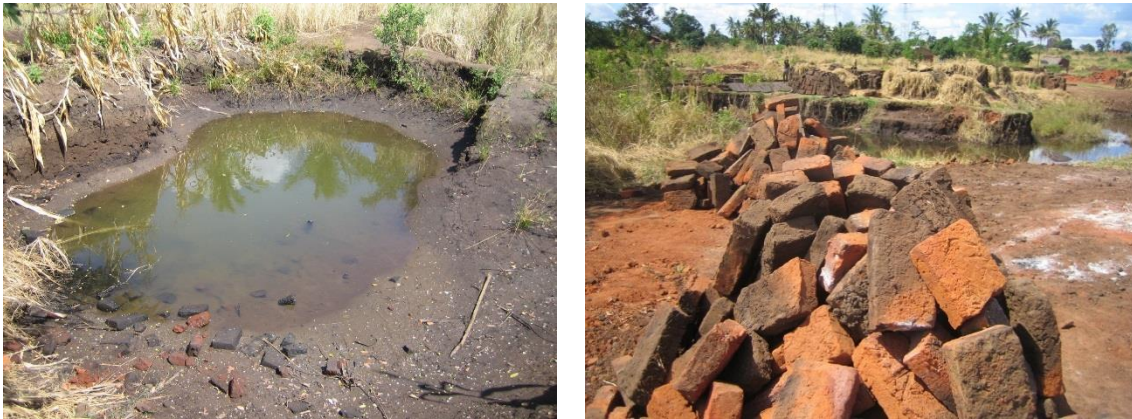
Figure 12. Excessive soil extraction damages agriculture and may affect people's health.
Source: The authors.

The excessive extraction of fertile agricultural soil is a negative issue associated with bricks and similar construction materials (Figure 12). Extensive and excessive soil removal may also affect people's health by creating pools and still water which provides suitable environment for mosquitoes and malaria [12]. This also applies to other local construction methods and materials such as mud and poles, which heavily rely on the earth as their major source of raw material. However, compared to burned bricks, adobe and mud and poles are less environmentally damaging as they do not need firewood in their production processes.

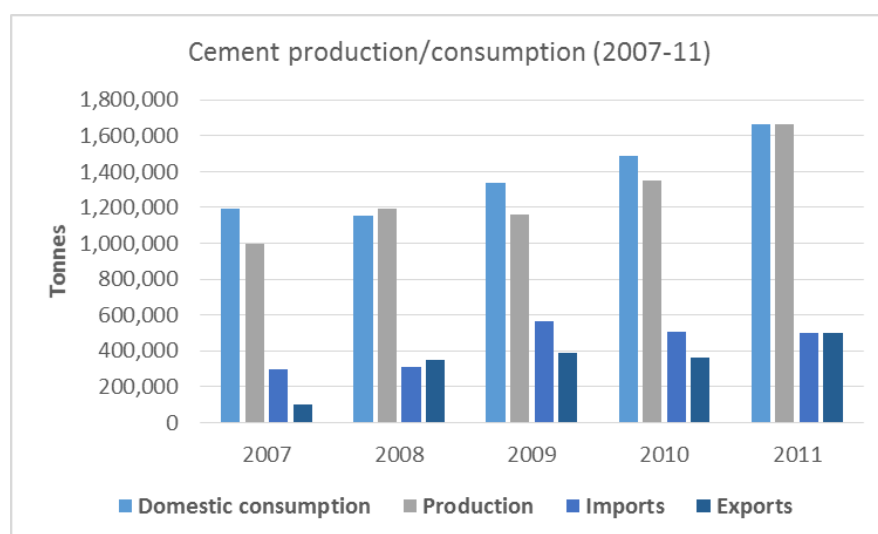
Figure 13. Cement production/consumption during 2007–2011. Source of table: [20].

The local production and consumption of cement in Uganda have been increasing during the last decade. The local production of cement and its net domestic supply in 2011 respectively increased by around 12% and 24% compared to 2010 [20]. Figure 13 shows the cement production, consumption, imports and exports during 2007–2011. Living in concrete homes represents a higher social status in Uganda (Figure 14); however, there are concerns over the thermal comfort of the occupants living in concrete homes due to its weak thermal resistance (Table 1) [12]. This requires more investigation to evaluate the effects of different construction methods and materials on the thermal comfort conditions. Moreover, relatively higher costs of concrete [12] may raise questions over its suitability for low-income housing.

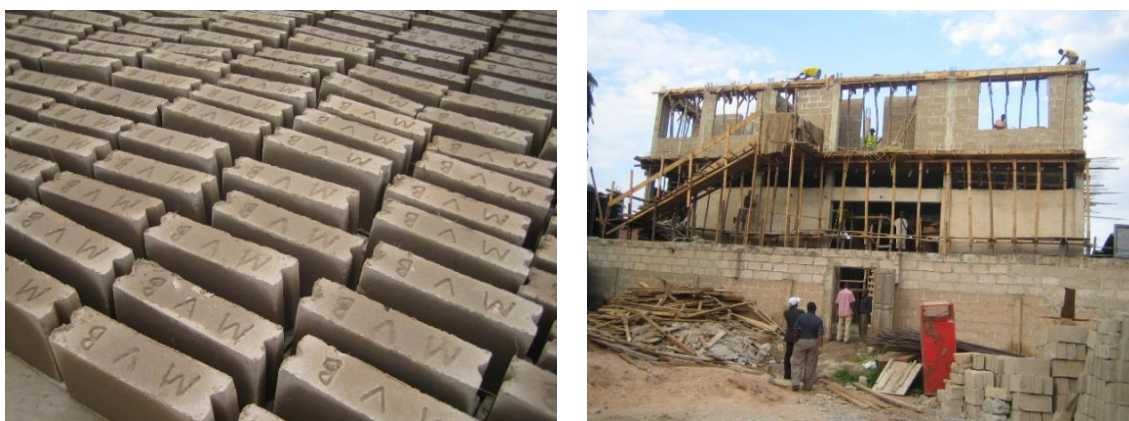
Figure 14. The share of concrete construction is increasing rapidly. Source: The authors.
