## Building Foundation Instability Induced by Tsunami Scour

Mara Jauane Nicholas, J. Murphy & Sons Ltd, [maranicholas@murphygroup.co.uk](mailto:maranicholas@murphygroup.co.uk)

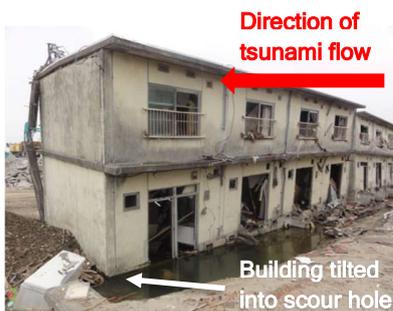
Figure 1 - Apartment block scouring at the seaward end in Yuriage, Japan due to the 2011 Tohoku tsunami (Fraser et al., 2013)

Soil weakening following a tsunami wave can result in foundation failure for shallow foundation buildings, mainly due to bearing failure which causes undermining and subsequently, tilting, as seen in Fig. 1 (taken from Fraser et al., 2013). Tsunami scour can cause the reduction in foundation depth. As a result, loading from the building

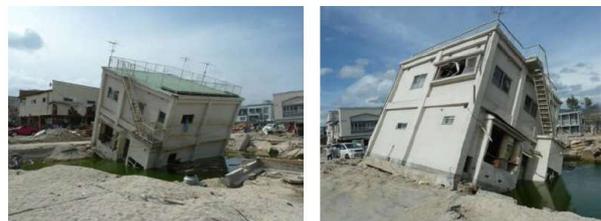
Figure 3 - The failure mode of building foundations shows tilting leading to rotation and collapsing due to a large scour hole

The severity of failure of the foundations is dependent on the foundation depth, scour depth and its extent. In the 2004 Tohoku tsunami, less severe failure (light undermining and tilting) was found in areas where there was shallow localized scour around the foundations, small scour extents and where foundation depths were equivalent or deeper than the scour depth (Fig. 1). More severe failure such as complete collapse or rotation of foundations was observed in areas where there was deeper scouring, wider scour extents and where foundation depths were relatively shallow compared to depths of scour holes (Fig. 3).
