Seismic retrofitting of URM masonry piers with helical steel reinforcement

Abstract: Past earthquakes revealed that brittle nature of unreinforced masonry (URM) structural walls often leads to extensive cracking and shear damage, which can seriously affect structural integrity and thus compromise the safety of the entire building. Hence, finding an effective seismic retrofitting solution that can increase the safety of existing masonry building stock is of great importance. This paper explores the potential of alternative seismic retrofitting solutions for URM masonry walls - near-surface mounted austenitic stainless-steel helical bars. Being cold rolled from a plain round wire and subsequently tensioned through a free-twisting process, such a reinforcement can not only offer high durability, but also superior mechanical and bond properties, as well as effective redistribution of loads through the retrofitted masonry. In addition, the relatively high flexibility of the bars allows them to be mounted continuously along the joints of the wall, leaving the aesthetic of the retrofitted masonry intact. A total of nine single-leaf clay brick walls were tested under cyclic displacement r

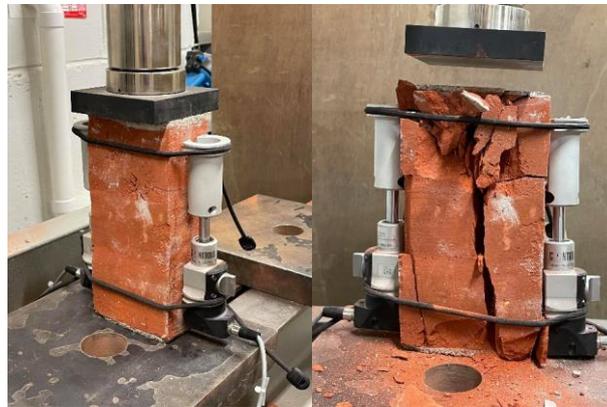
units, with three units per set to account for the variability in the materials: (i) with the load applied normal to the brick headers; (ii) with the load applied normal to the beds. The loaded surfaces had a 5 mm gypsum capping to ensure that load will be distributed uniformly across the loading area. The average compressive strength was equal to 23.8 MPa (COV 9 %) for the direction normal to the headers and 28.9 MPa (COV 7 %) for the direction normal to the beds. The Young's modulus was measured during the compressive strength tests, where the units were tested in an upright (soldier) orientation, based on the readings of two LVDTs attached to the stretchers (Fig. 3). The base length of the gauges was set at 150 mm and a constant displacement rate of 0.2 mm/min was used. The elastic modulus was estimated between the stress levels corresponding to 30-60% of the failure stress as an average across the three specimens. The mean value of the experimental elastic modulus of the bricks was equal to 5691.1 MPa (COV 20%) with a maximum mean strain of 0.0039 (COV 6 %).

Fig. 3. Masonry unit tested under compression before and after failure.

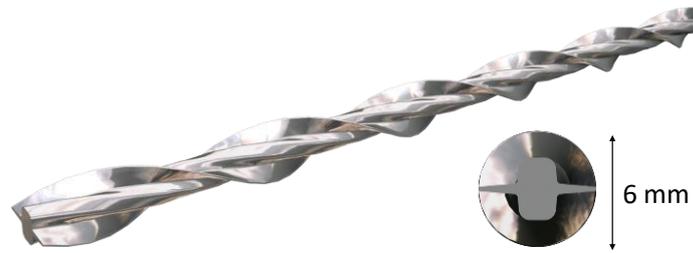
The retrofitting system consisted of helical bar with an overall diameter of 6 mm (Fig. 7) and a cement-based pumpable and thixotropic bonding agent (grout). The shape of the helical bar offers great flexibility, thus allowing for easy bending and installation in masonry joints. The mechanical properties of the helical bars were determined with standard tensile tests on three bar samples using the provisions set out in ISO 6892 [40].

Fig. 7. Geometry of the helical bars
