Behaviour of pultruded beam-to-column joints using steel web cleats

Jawed Qureshi [a] * and J Toby Mottram [b]

ABSTRACT

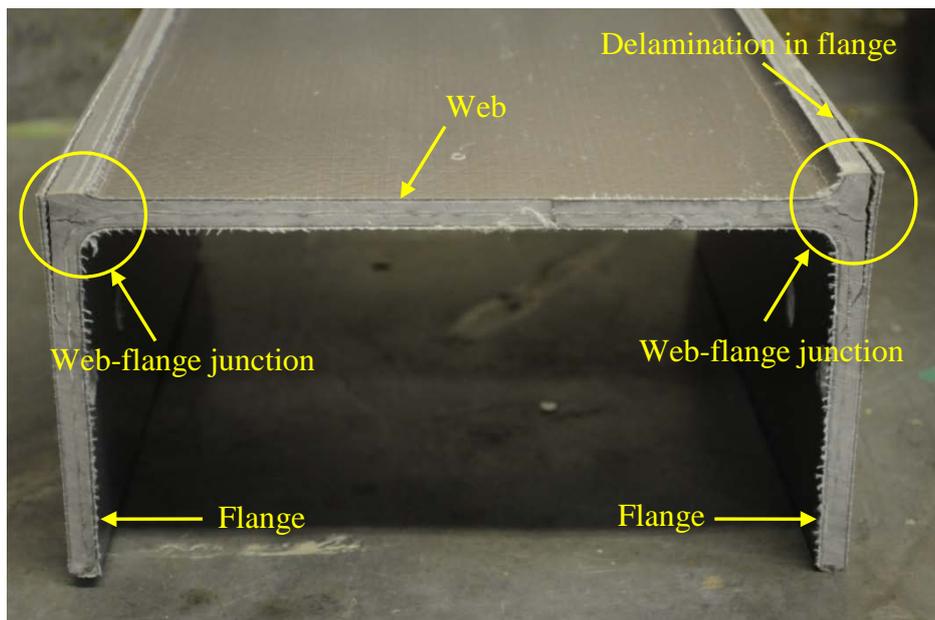
Fig. 5 shows the extent of this flange deformation (h_{prying} (TOP) – h (TOP)) and (h_{prying} (BOTTOM) – h (BOTTOM)) when ϕ in test Wmj254_3M16_ST1.2 had reached 50 mrad. All specimens failed by cracking in web-flange junction of the column near top bolt level and progressed downwards to bottom bolt level. Due to prying action, column flange outstands deflect outwards at the top bolt level and there was no change in the section's depth at the bottom bolt level. It is found that the steel cleats did not noticeably deform or have yielding. To establish the extent of permanent damage, one of the

Fig. 5. Close-up of Left and Right joints in Wmj254_3M16_ST1.2 when M_{max} is applied.

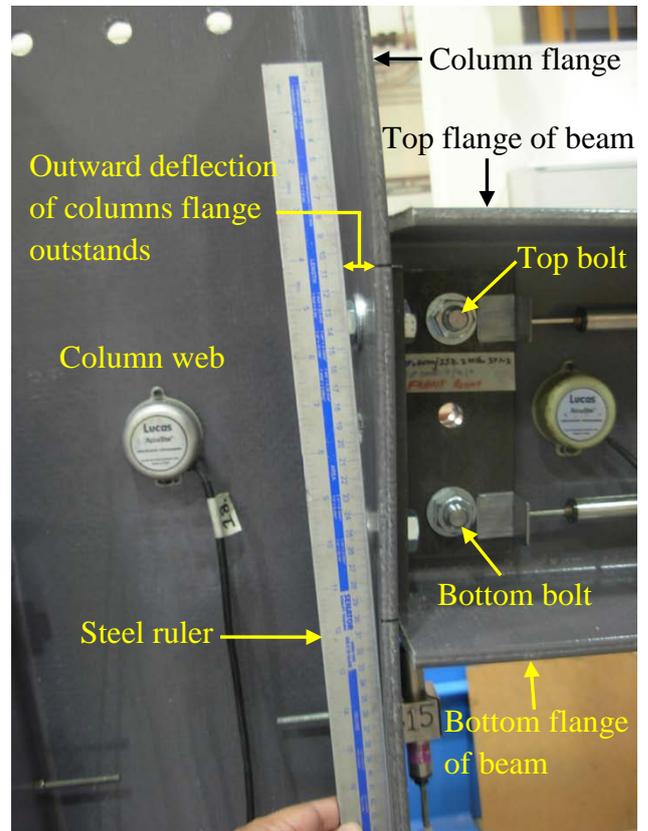
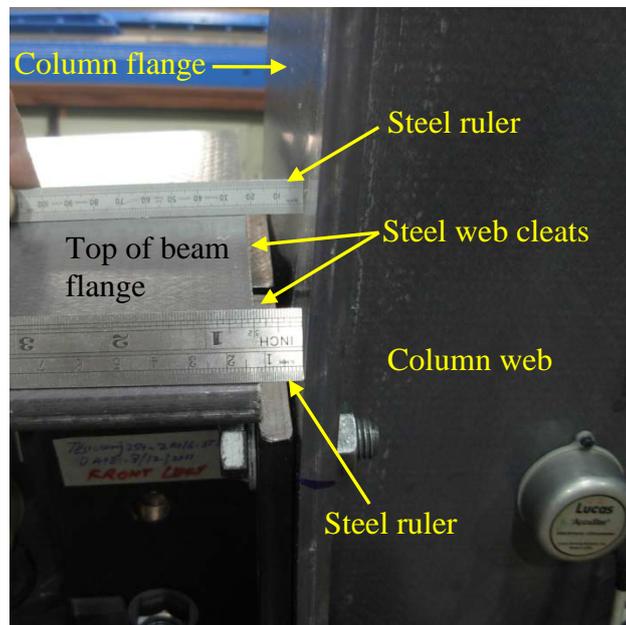
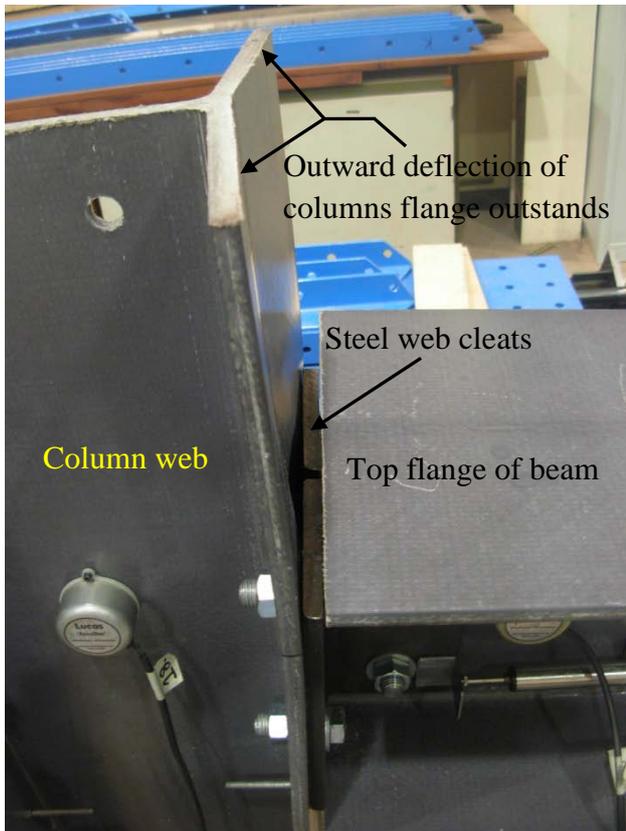
The extent of flexure in the column flange outstands is shown in Figs 10(a) to 10(c). Fig. 10(a) indicates the localised nature of this column deformation. With respect to a steel ruler, pressed against the undeformed flange below the bottom bolt level, Fig. 10(b) shows the degree of deformation for the geometric test property h_{prying}. Because the steel cleats possess relatively high strength and stiffness, their deformation from transmitting moment and shear force is not discernable. Owing to the layered construction of pultruded material, cleats of FRP are susceptible to delamination failure caused by prying where tensile stresses in the through-thickness direction are highest [10]. As this study shows when steel replaces pultruded FRP, joint failure is shifted from the web cleating [10] into the column. At M_{max} the flanges deflected outwards resulting in 20 to 24 mm increase in overall depth of the column at top bolt level. This can be seen in Fig. 10(c) and this localised column deformation represents an 8 to 9% increase in overall column depth.

Fig. 10. Different views of localised column deformations when joints had failed: (a) Outward flexure of column flanges; (b) Flexure of column flanges with respect to a vertically placed ruler; (c) Extent of column deformation for ϕ_{max}.
