Article title: Rocker Pipe Solution to Alleviate Settlement Induced Distress in Flexible Pipes

ROCKER PIPE SOLUTION TO ALLEVIATE SETTLEMENT INDUCED DISTRESS IN FLEXIBLE PIPES

D. C. Wijeyesekera and J.T.Reginold

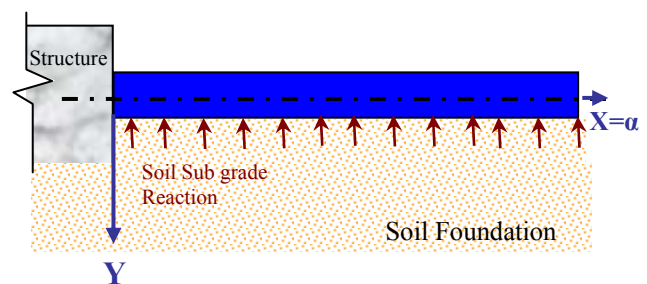
Figure 11. Semi-infinite beam on elastic foundation

Failure to design pipelines to accommodate, or avoid differential settlements is one of the more common causes of structural failure, and design should therefore be carried out, based On an analysis which permits verification against criteria established. A prismatic beam (figure 11) connected to a structure and supported continuously along its length by a foundation, itself assumed to experience elastic deformation. Sub grade reaction to be linearly proportional to the beam deflection at any point. Under such conditions the reaction per unit length of the beam can be represented by the expression ky , in which y is the deflection and k is a constant usually called the modulus of the soil foundation. This constant denotes the

reaction per unit length when deflection is equal to unity. This assumption not only leads to equations amenable to solution, but represents an idealization closely approximating many real situations. Beam behaviour of pipeline is analysed according to the theory of beams on elastic foundations, a theory validated by the results of many field studies and experiments (Olliff, 2003).

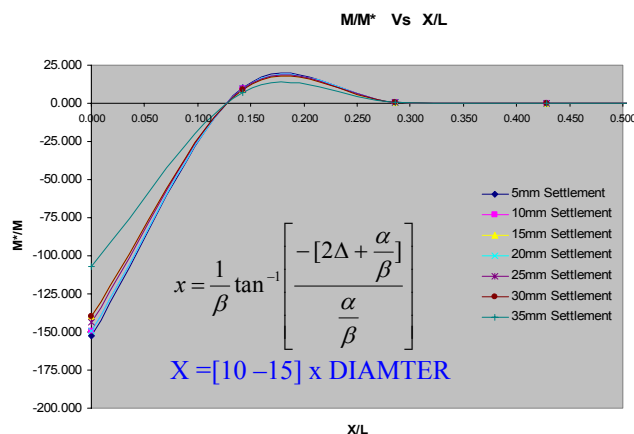
Figure 12: Design graph for Rocker pipe location

X represents the location of maximum bending movement measured from the settling structure position. The analysis described above will establish the minimum length required to ensure that the allowable joint rotation is not exceeded, and knowing this length, the bending moments in the rocker pipe, and the shear forces at its ends, can be calculated. If these are excessive, they must be reduced to below the allowable limits, but this cannot of course, be done by reducing the length of the 'rocker pipe', otherwise the joint rotation criteria would not be met.
