**Climate Proofing Housing Landscapes:  
Monitoring Report 3**

**October 2016 to September 2017**

**Authors: Connop, S., Clough, J., Alam, R. and Nash, C.**

H&F Council and Groundwork London worked with local residents to design and implement climate change adaptation measures on three housing estates in the borough, making them more resilient and adapted for the future.

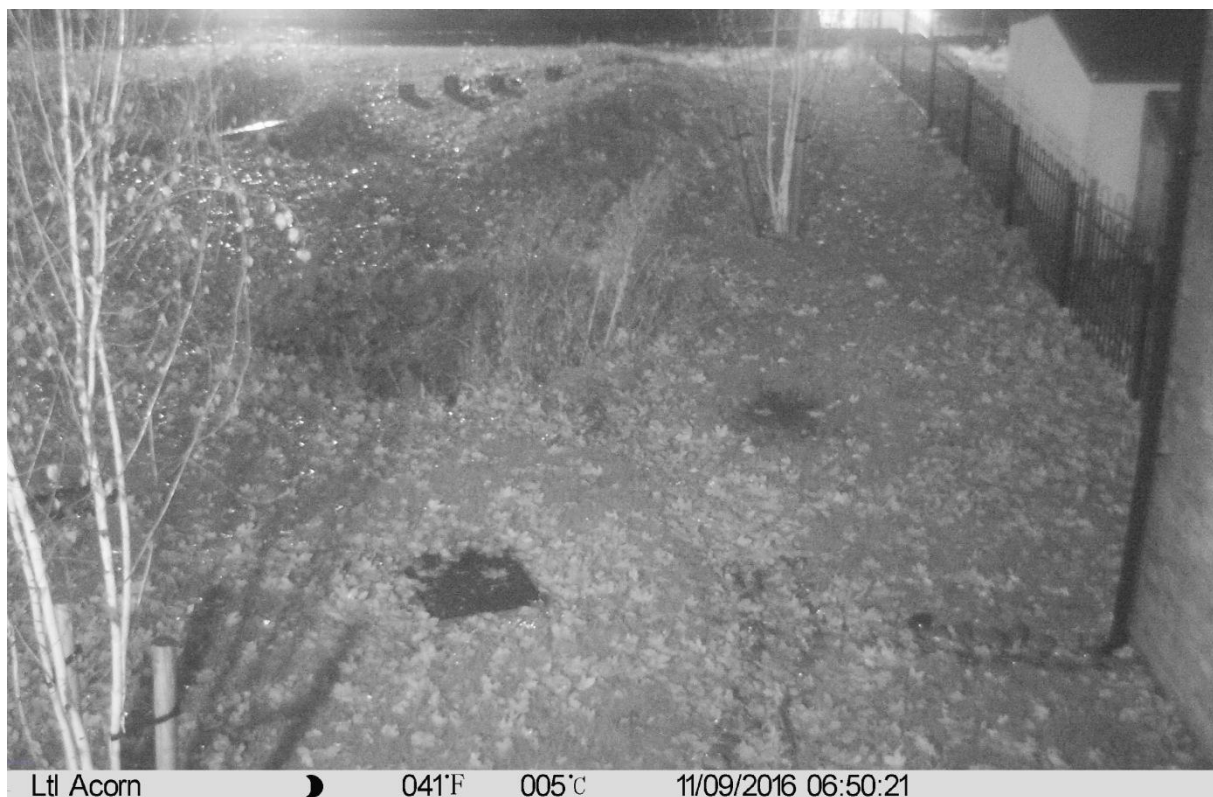
i)      **Figure 8. (see below)**

A complete collection of the images from the community hall and Sofia House basins during the rain event from 00:30 to 10:30 on the 9th November 2016 were captured and analysed. They demonstrated that the rain garden was able to retain and attenuate all of the rainfall that fell directly onto the area and that which was diverted from the neighbouring roofs. The images also demonstrated that at around 06:30 during the peak of the rainfall, despite substantial input from the community hall roof, there was no obvious standing water within or around the basin (Figure 8.i). By the time of the first daylight images at 09:00, towards the end of the prolonged rain event, there was also no obvious pooled water (Figure 8.ii) indicating that the basins were infiltrating all of the stormwater.

**Figure 8. Time-lapse camera images from Community Hall and Sofia House basins (FPC2), 09/11/2016.** Images show i) no evidence of overflowing during period of highest rain intensity at 06:50 and ii) evidence of 100% infiltration/conveyance by the end of the intense rain event at 09:06 on the same day.

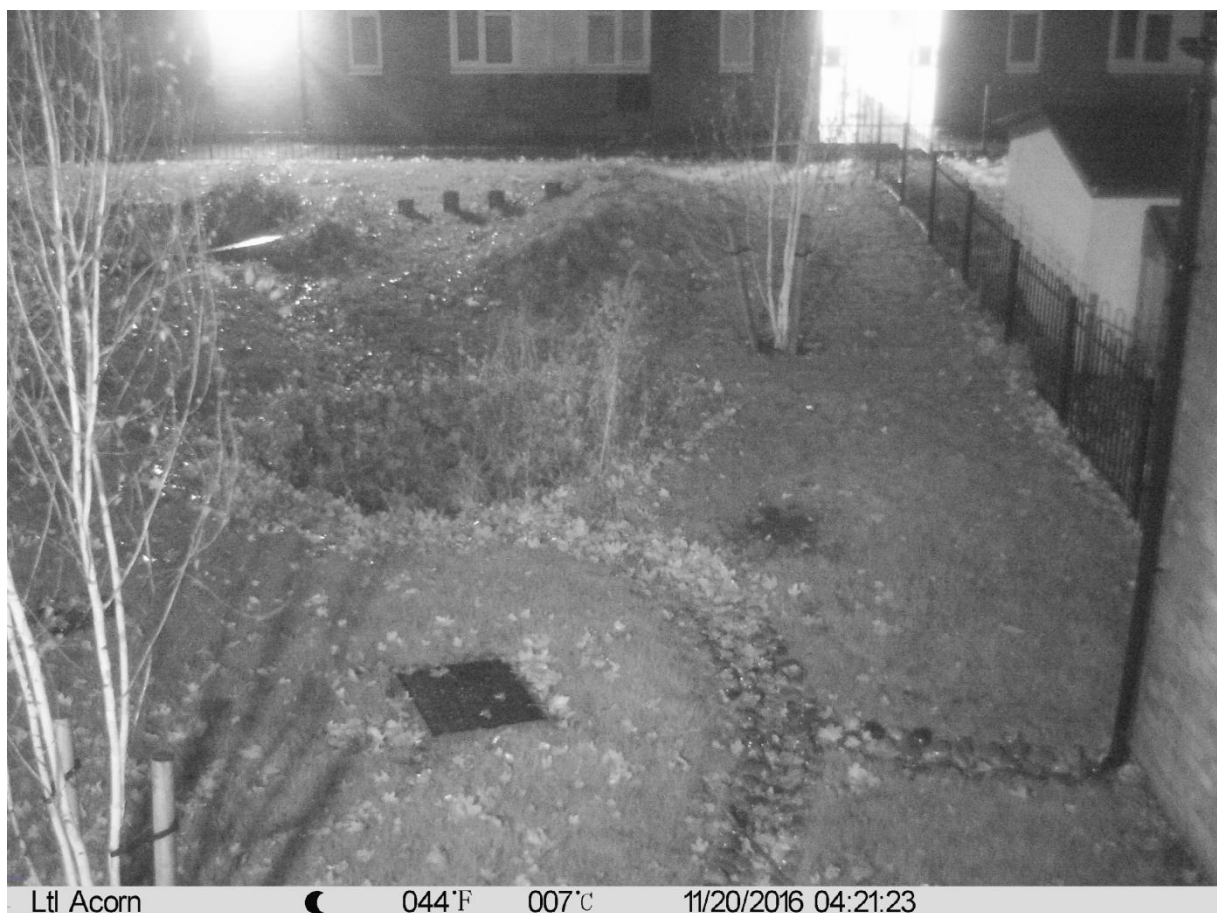
i) **Figure 13. (see below)**

A complete collection of the images from the community hall and Sofia House basins during the rain event from 00:30 to 23:30 on the 20th November 2016 were captured and analysed. They demonstrated that the basins were able to retain and attenuate all of the rainfall that fell directly onto the area and that which was diverted from the neighbouring roofs. The images also demonstrated that at around 04:30 during the peak of the rainfall, despite substantial input from the community hall roof, there was no obvious standing water within or around the basin (Figure 13.i). By the time of the first daylight images at 08:30, following the more substantial part of the prolonged rain event, there was also no obvious pooled water (Figure 13.ii) indicating that the basins were infiltrating all of the stormwater.

**Figure 13. Time-lapse camera images from Community Hall and Sofia House basins (FPC2), 20/11/2016.** Images show i) no evidence of overflowing during a period of high rain intensity at 04:21 and ii) evidence of 100% infiltration/conveyance by the end of the intense rain event at 08:41 on the same day.

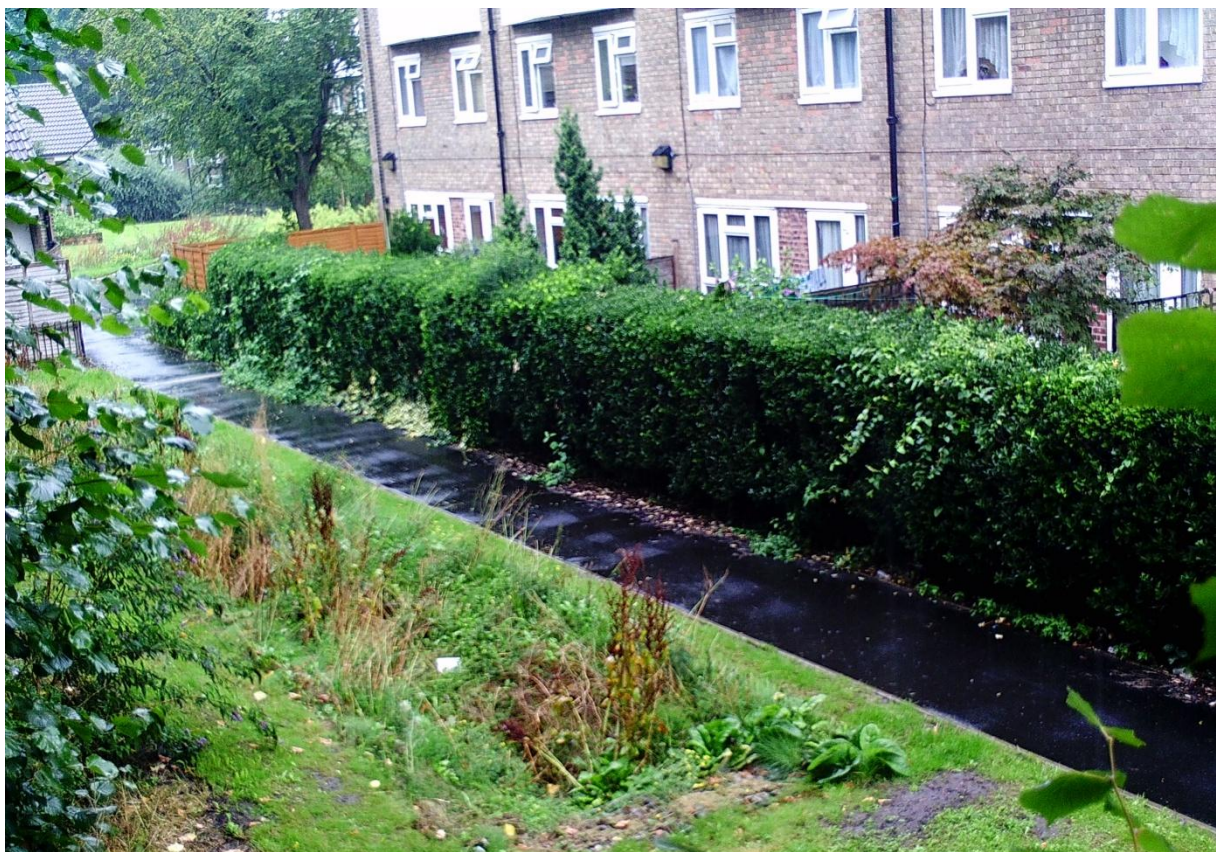
i)

A complete collection of the images from the Alexandra House swale during the rain event from 06:30 to 23:59 on the 9th August 2017 were captured and analysed. They demonstrated that the swale was able to retain and attenuate all of the rainfall that fell directly onto the area and that which was diverted from the neighbouring roof. The images also demonstrated that at around 10:40 during the peak of the rainfall, despite substantial input from the neighbouring roof, there was no obvious standing water within or around the rain garden (Figure 18.i). By the time of the end of the rain event at 23:54, there was also no obvious pooled water (Figure 18.ii) indicating that the swale was infiltrating all of the stormwater.

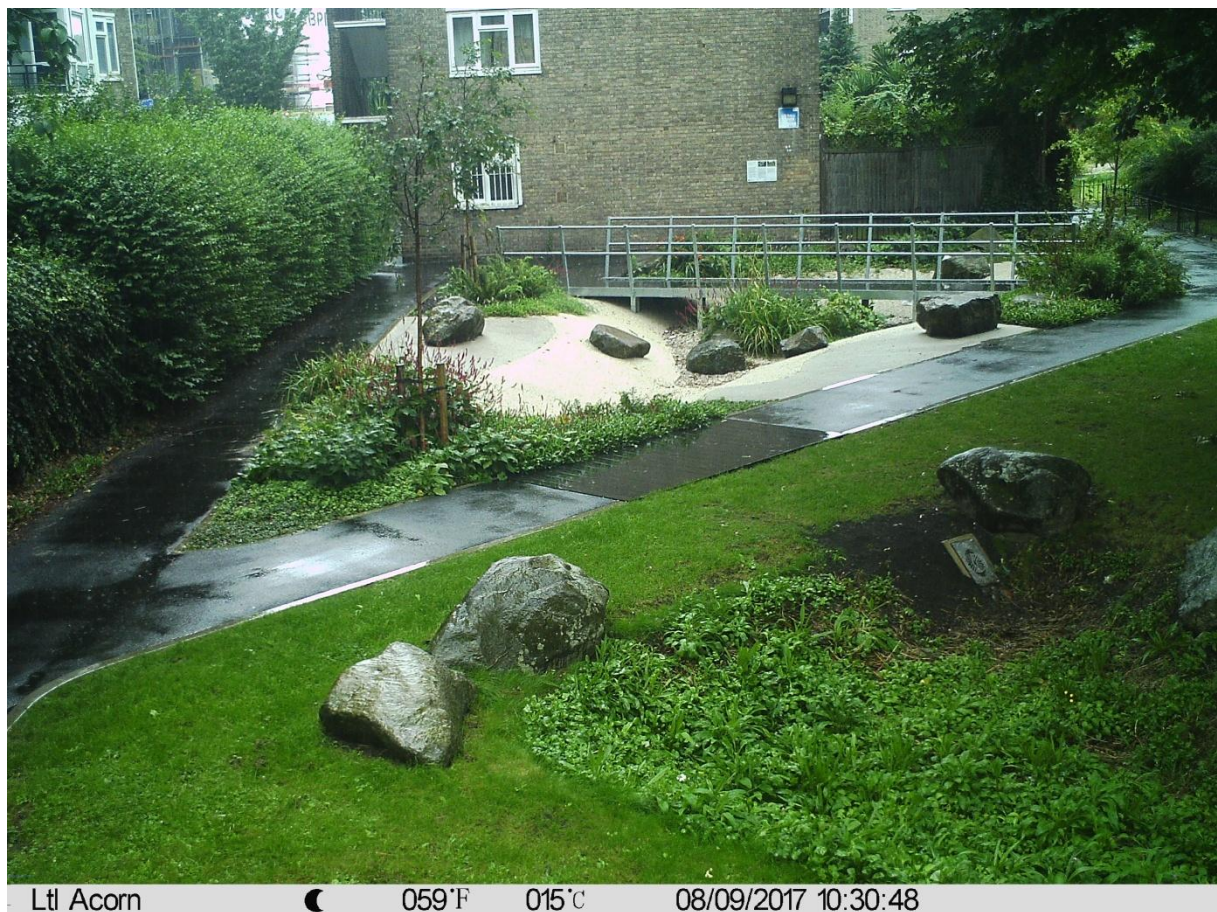
A complete collection of the images from the Adella House basins during the rain event from 07:00 to 23:59 on the 9th August 2017 were captured and analysed. They demonstrated that the basins were able to retain and attenuate all of the rainfall that fell directly onto the area and that which was diverted from the neighbouring roofs. The images also demonstrated that at around 10:30 during the peak of the rainfall, despite substantial input from the Adella House roof, there was no obvious standing water within or around the basins (Figure 20.i). Following the cessation of the event at 23:48, there was also no obvious pooled water (Figure 20.ii) indicating that the basins were infiltrating all of the stormwater.

**Figure 20. Time-lapse camera images from Adella House grass and stoney basins (FPC3), 09/08/2017.** Images show i) no evidence of overflowing during a period of high rain intensity at 10:30 and ii) evidence of 100% infiltration/conveyance by the end of the intense rain event at 23:48 on the same day.

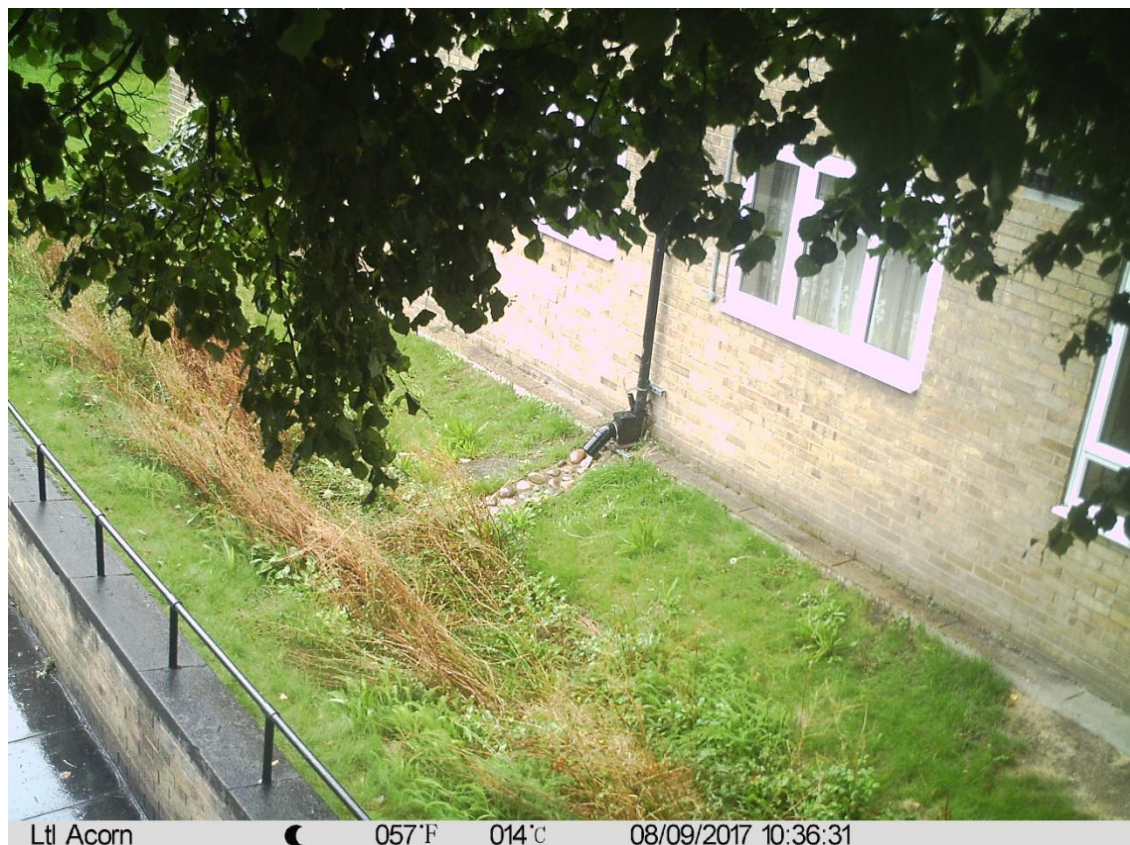
i)

A complete collection of the images from Beatrice House swale during the rain event from 07:00 to 23:59 on the 9th August 2017 were captured and analysed. They demonstrated that the swale was able to retain and attenuate all of the rainfall that fell directly onto the area and that which was diverted from the neighbouring roof. The images also demonstrated that at around 10:36 during the peak of the rainfall, despite substantial input from the Beatrice House roof, there was no obvious standing water within or around the swale (Figure 21.i). Following the cessation of the event at 23:54, there was also no obvious pooled water (Figure 21.ii) indicating that the swale was infiltrating all of the stormwater.

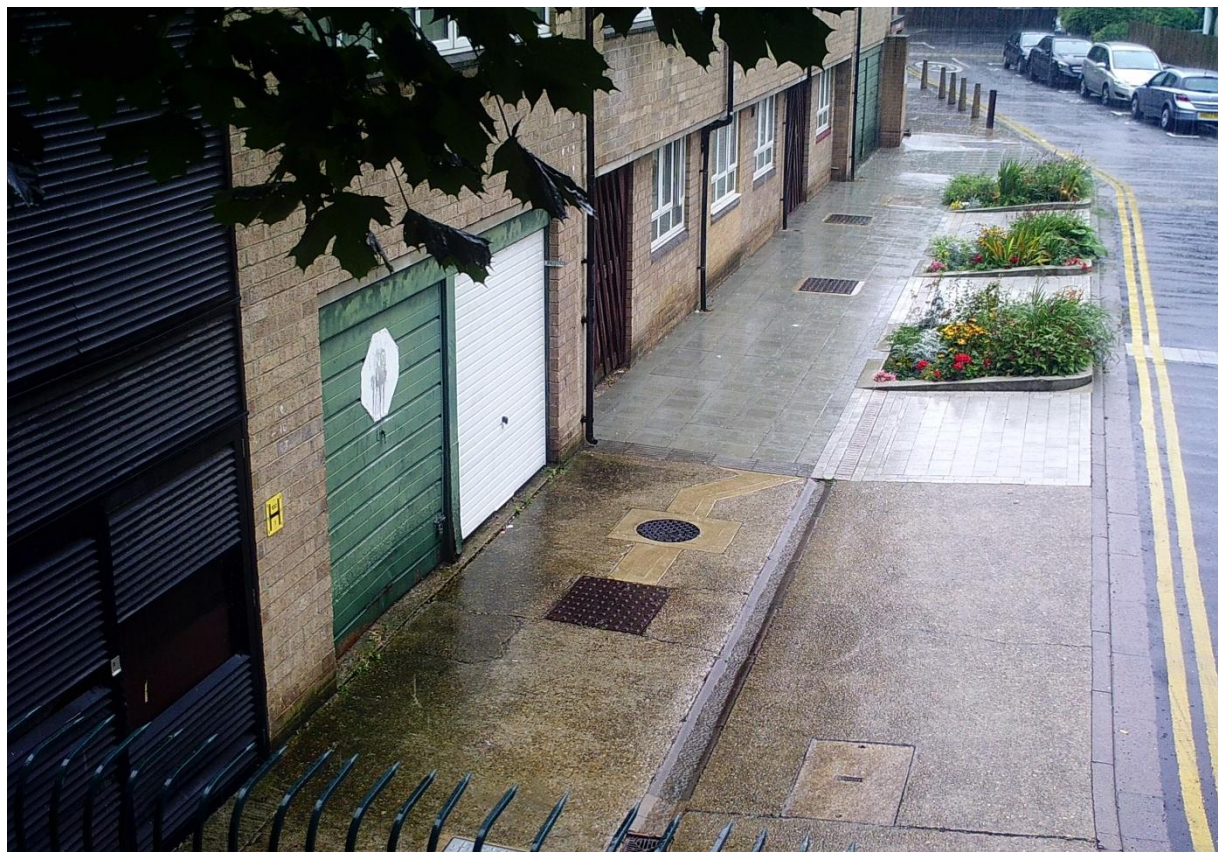
A complete collection of the images from Cheeseman Terrace rain gardens during the rain event from 07:00 to 23:59 on the 9th August 2017 were captured and analysed. They demonstrated that the rain gardens were able to retain and attenuate all of the rainfall that fell directly onto the area. Due to the design of the underdrainage from the road, analysis of pressure sensor data is required in order to establish whether all of the runoff from the road was also managed. Nevertheless, the images also demonstrated that at around 10:37 during the peak of the rainfall, there was no obvious standing water within or around the rain gardens (Figure 22.i). Following the cessation of the event at 23:52, there was also no obvious pooled water (Figure 22. ii) indicating that the rain gardens were not becoming saturated with stormwater.

**Figure 22. Time-lapse camera images from Cheeseman Terrace rain gardens (FPC6), 08/09/2011.** Images show i) no evidence of overflowing during a period of high rain intensity at 10:37 and ii) evidence of 100% infiltration/conveyance by the end of the intense rain event at 23:52 on the same day.

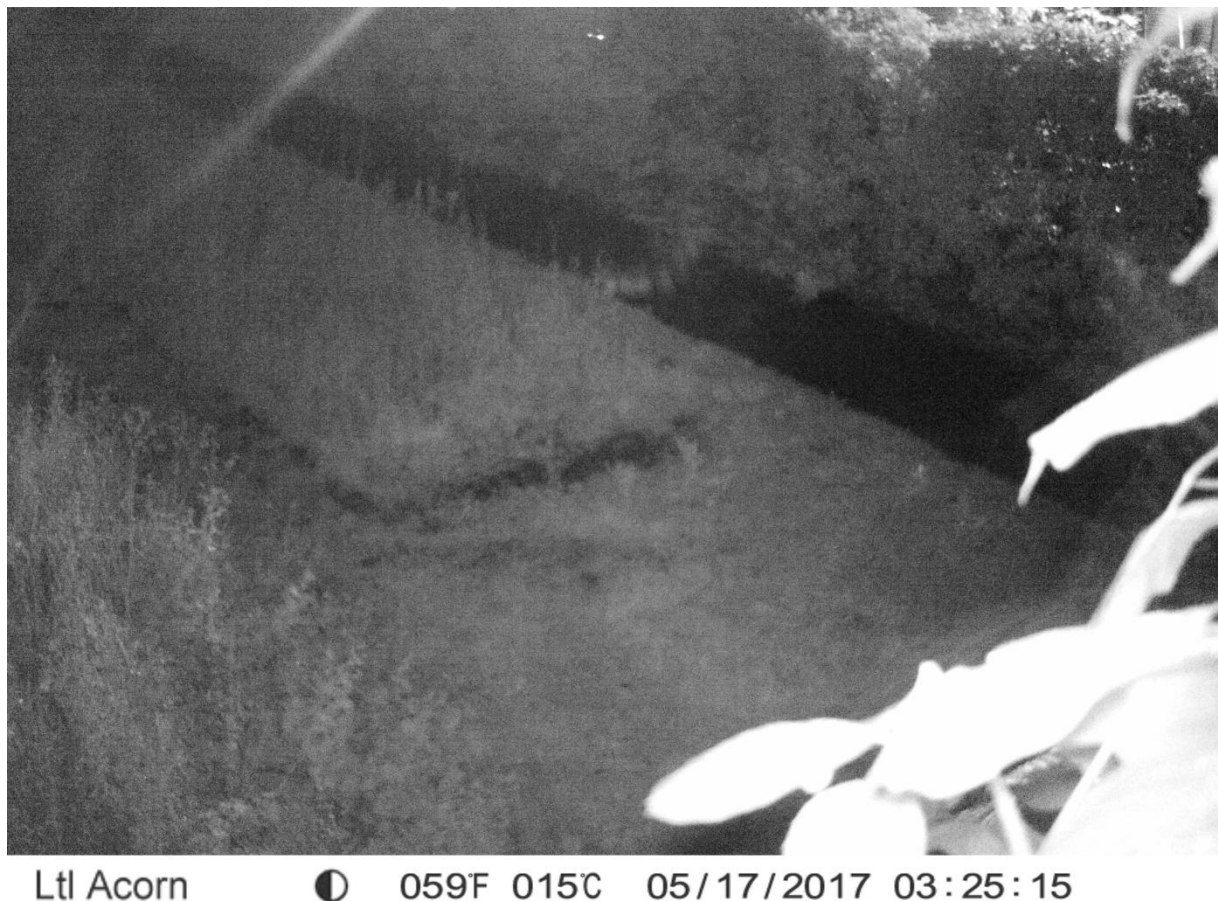
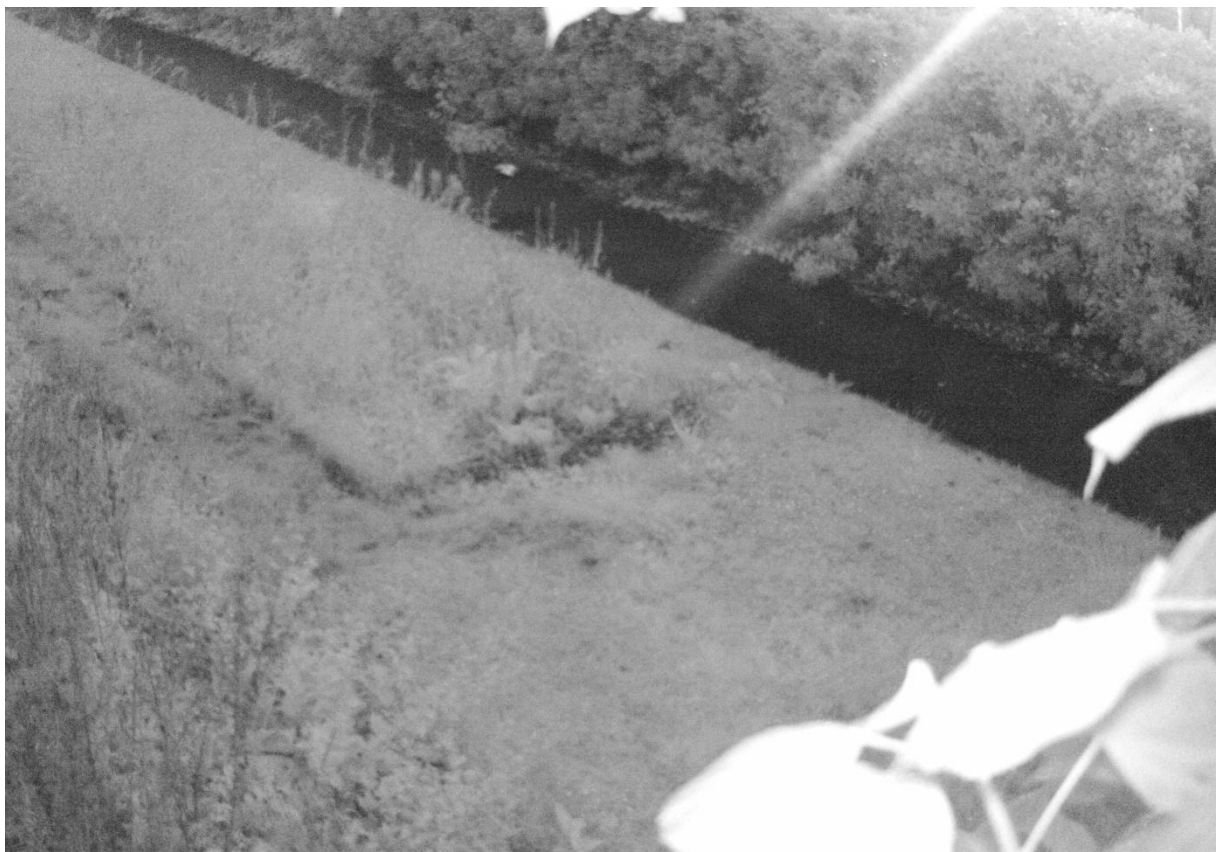
A complete collection of the images from the Alexandra House swale during the rain event from 00:30 to 21:30 on the 17th May 2017 were captured and analysed. They demonstrated that the swale was able to retain and attenuate all of the rainfall that fell directly onto the area and that which was diverted from the neighbouring roof. The images also demonstrated that at around 03:25 during the peak of the rainfall, despite substantial input from the neighbouring roof, there was no obvious standing water within or around the rain garden (Figure 26.i). By the time of the end of the rain event at 21:10, there was also no obvious pooled water (Figure 26. ii) indicating that the swale was infiltrating all of the stormwater.

**Figure 26. Time-lapse camera images from Alexandra House swale (FPC1), 17/05/2017.** Images show i) no evidence of overflowing during a period of high rain intensity at 03:25 and ii) evidence of 100% infiltration/conveyance by the end of the intense rain event at 21:10 on the same day.

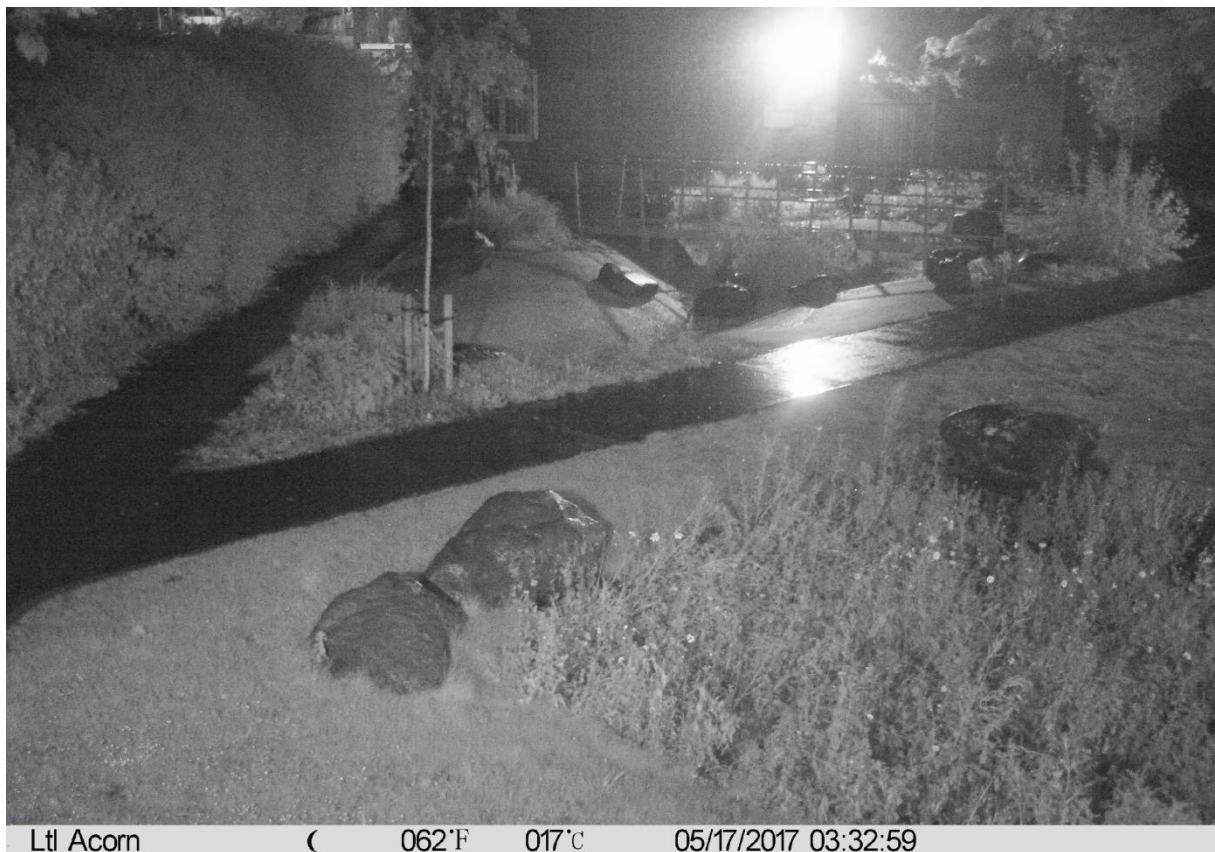
A complete collection of the images from the Adella House basins during the rain event from 00:30 to 21:30 on the 17th May 2017 were captured and analysed. They demonstrated that the basins were able to retain and attenuate all of the rainfall that fell directly onto the area and that which was diverted from the neighbouring roofs. The images also demonstrated that at around 03:30 during the peak of the rainfall, despite substantial input from the Adella House roof, there was no obvious standing water within or around the basins (Figure 28.i). Following the cessation of the event at 21:30, there was also no obvious pooled water (Figure 28.ii) indicating that the basins were infiltrating all of the stormwater.

**Figure 28. Time-lapse camera images from Adella House grass and stoney basins (FPC3), 17/05/2017.** Images show i) no evidence of overflowing during a period of high rain intensity at 03:32 and ii) evidence of 100% infiltration/conveyance by the end of the intense rain event at 21:31 on the same day.

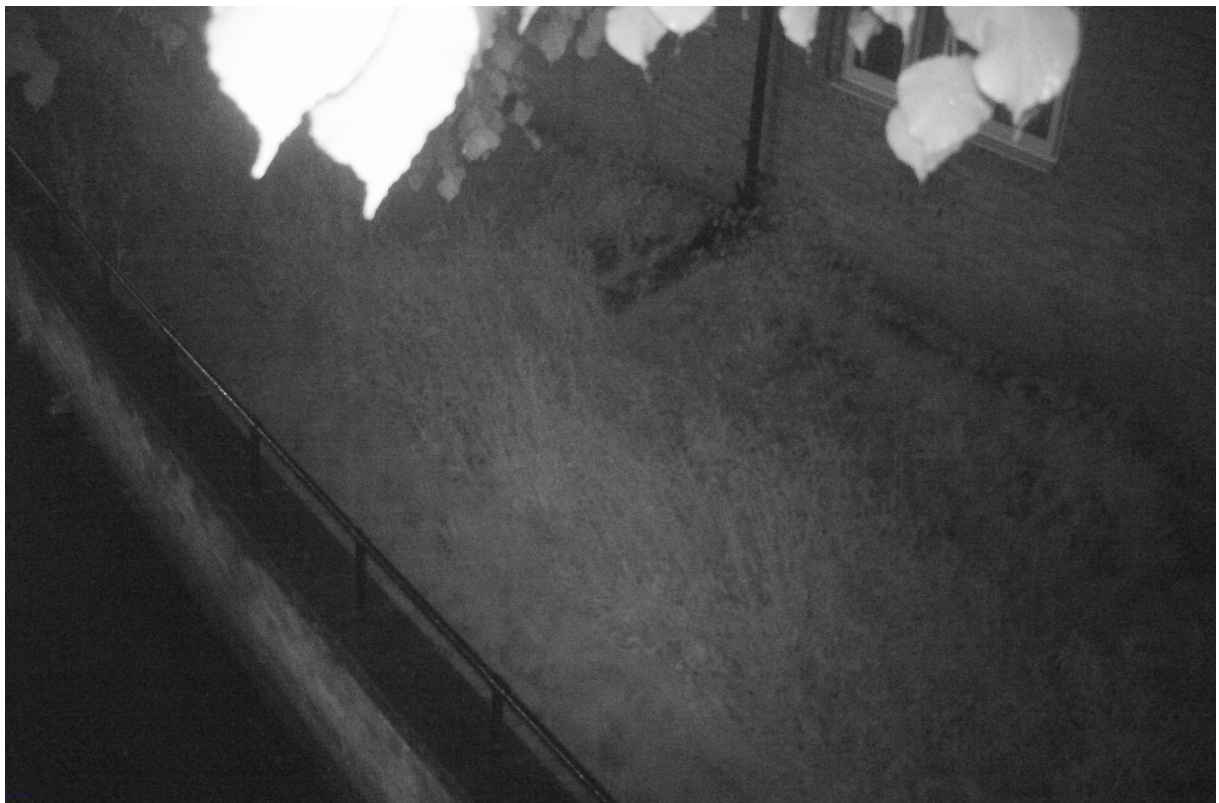
A complete collection of the images from Beatrice House swale during the rain event from 00:30 to 21:30 on the 17th May 2017 were captured and analysed. They demonstrated that the swale was able to retain and attenuate all of the rainfall that fell directly onto the area and that which was diverted from the neighbouring roof. The images also demonstrated that at around 03:24 during the peak of the rainfall, despite substantial input from the Beatrice House roof, there was no obvious standing water within or around the swale (Figure 29.i). Following the cessation of the event at 21:26, there was also no obvious pooled water (Figure 29.ii) indicating that the swale was infiltrating all of the stormwater.

**Figure 29. Time-lapse camera images from Beatrice House swale (FPC4), 17/05/2017.** Images show i) no evidence of overflowing during a period of high rain intensity at 03:24 and ii) evidence of 100% infiltration/conveyance by the end of the intense rain event at 21:26 on the same day.

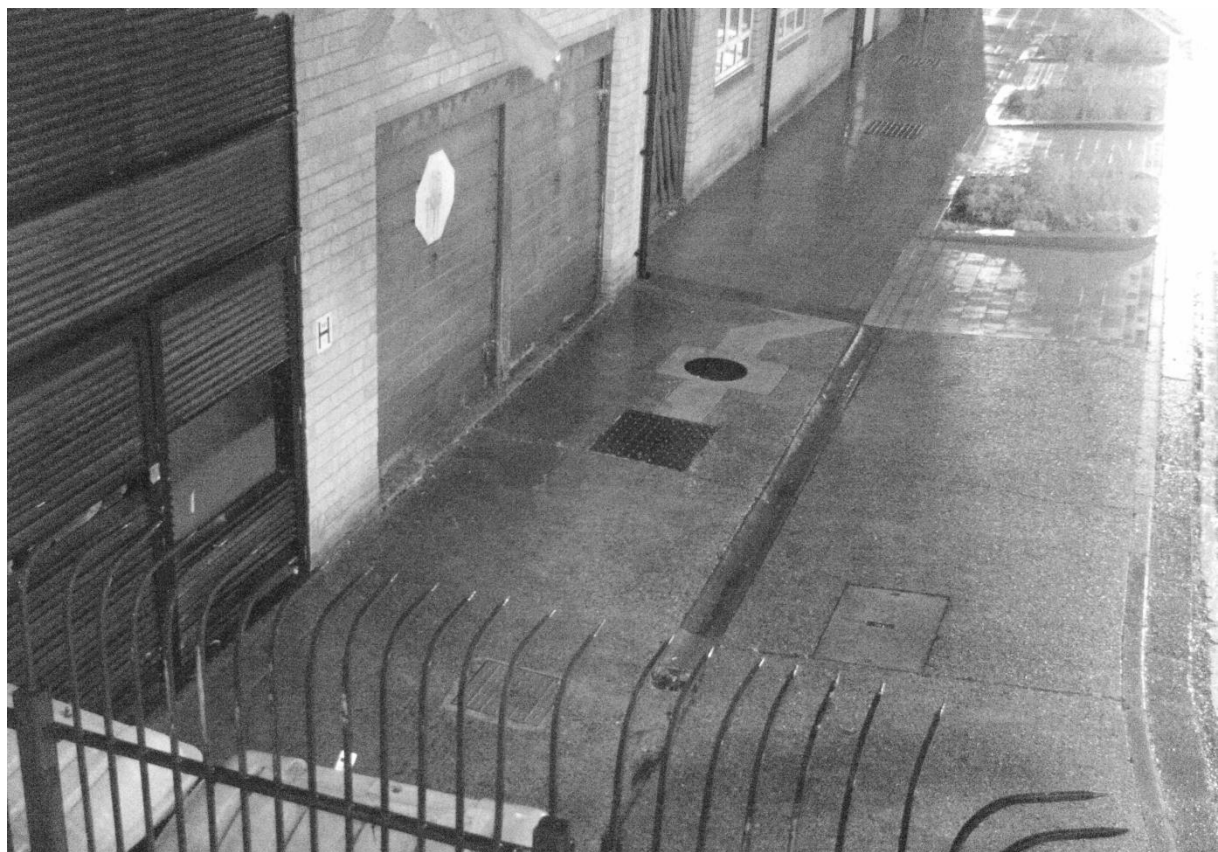
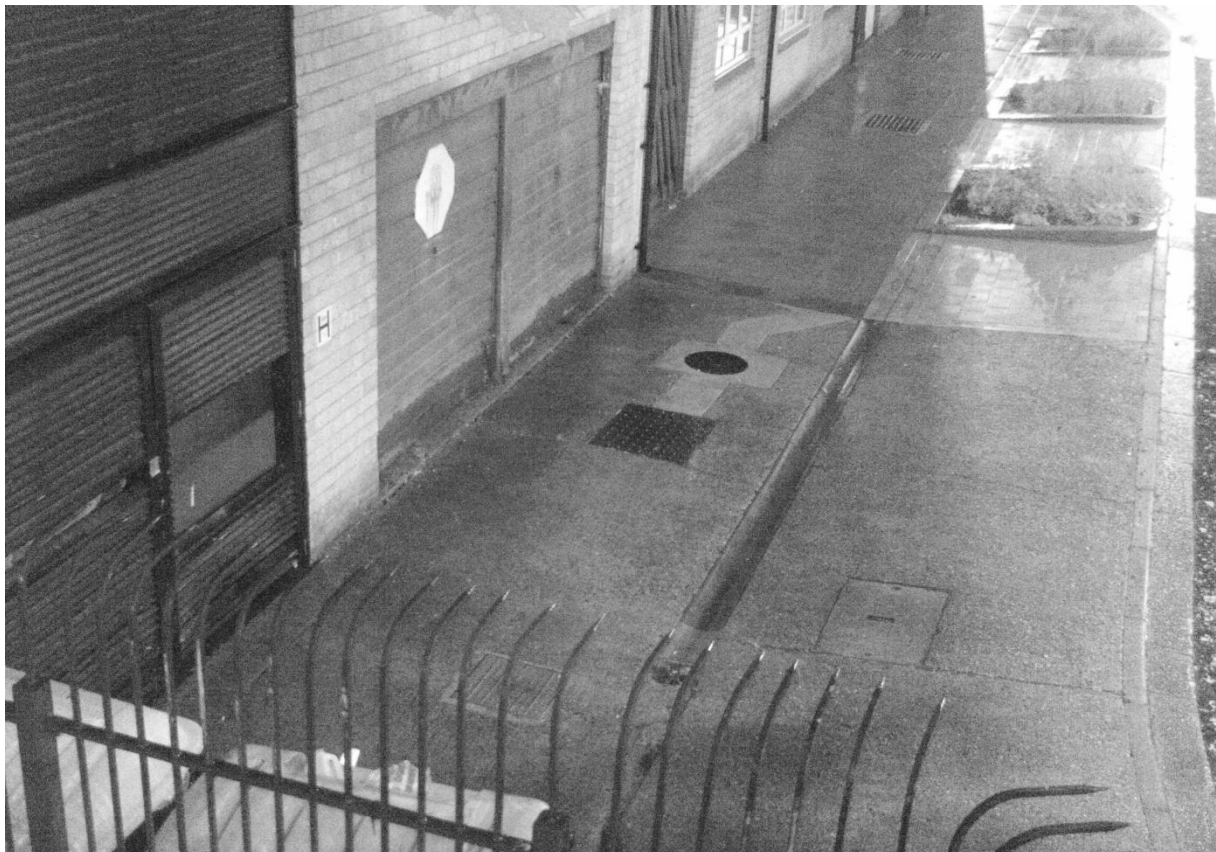
A complete collection of the images from Cheeseman Terrace rain gardens during the rain event from 00:30 to 21:30 on the 17th May 2017 were captured and analysed. They demonstrated that the rain gardens were able to retain and attenuate all of the rainfall that fell directly onto the area. Due to the design of the underdrainage from the road, analysis of pressure sensor data is required in order to establish whether all of the runoff from the road was also managed. Nevertheless, the images also demonstrated that at around 03:35 during the peak of the rainfall, there was no obvious standing water within or around the rain gardens (Figure 30.i). Following the cessation of the event at 21:20, there was also no obvious pooled water (Figure 30.ii) indicating that the rain gardens were not becoming saturated with stormwater.

**Figure 30. Time-lapse camera images from Cheeseman Terrace rain gardens (FPC6), 17/05/2011.** Images show i) no evidence of overflowing during a period of high rain intensity at 03:37 and ii) evidence of 100% infiltration/conveyance by the end of the intense rain event at 21:22 on the same day.

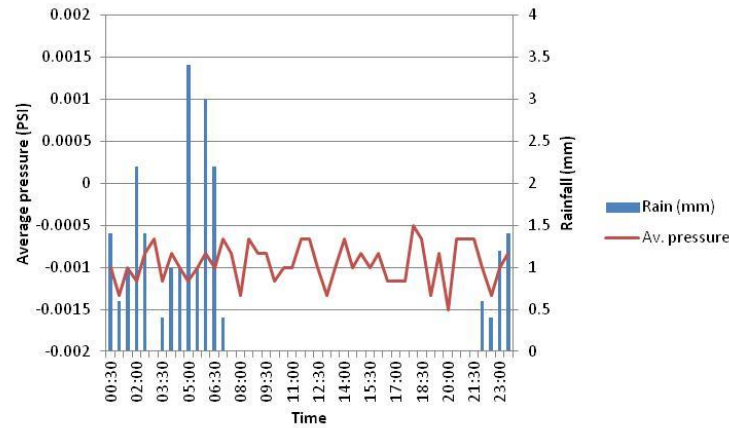
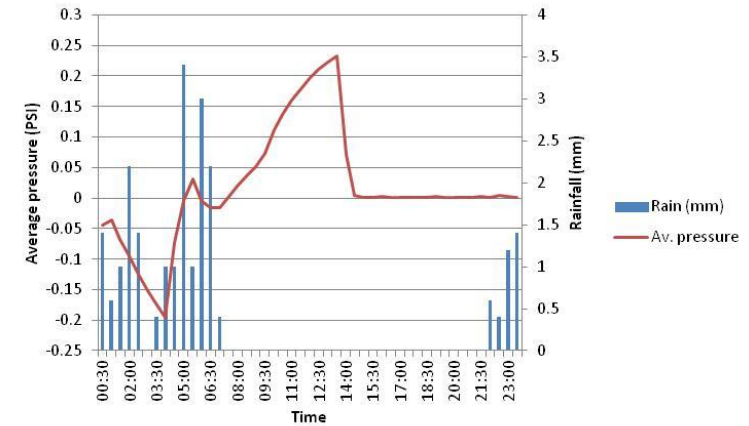
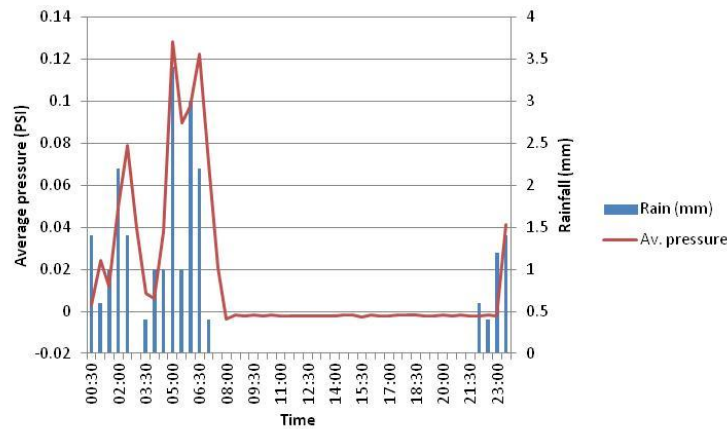
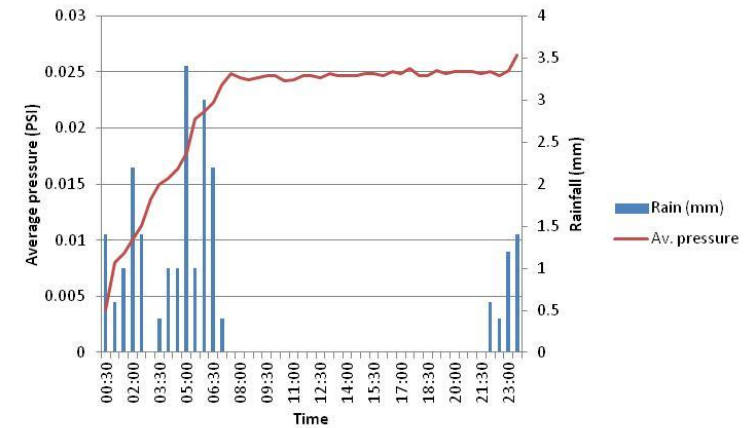
**Figure 33. Cheeseman Terrace rain gardens monitoring 20th November 2016.** Graphs show the records of pressure sensors positioned in i) first rain garden (PS2), ii) middle rain garden (PS3), iii) last rain garden (PS4) and iv) controlled release overflow chamber (PS5). Blue bars represent the pattern of rainfall, the red line indicates the pressure measured by the pressure sensor. Increase in pressure therefore corresponds with an increase in water level within chambers (PS 2, 4 and 5) or water saturation within the soil (PS3).

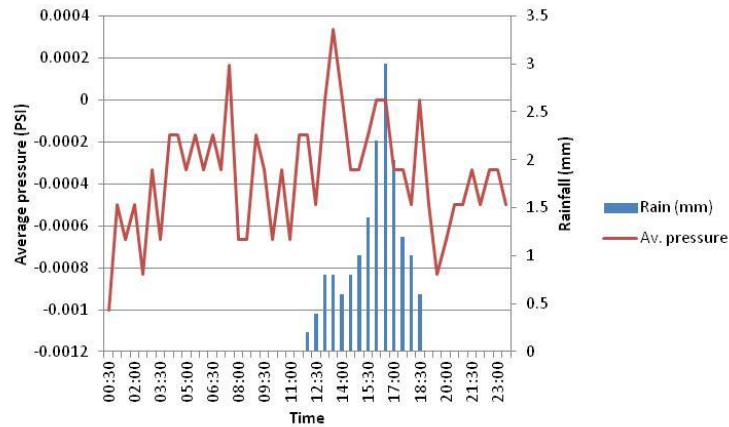
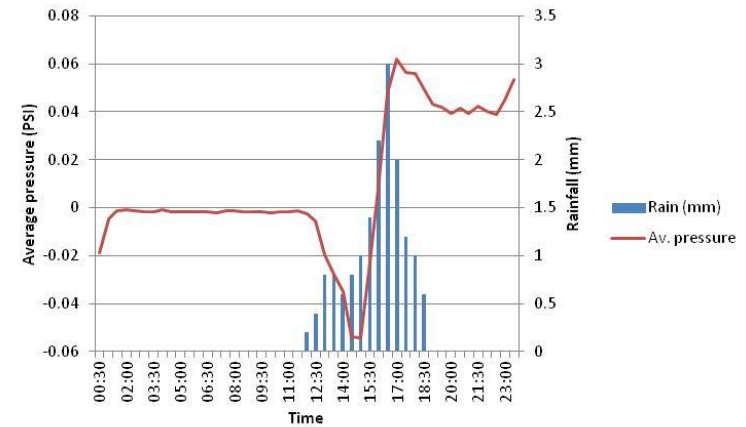
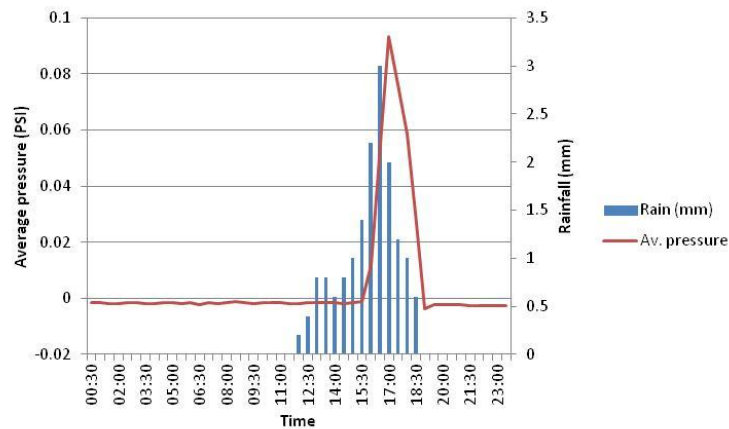
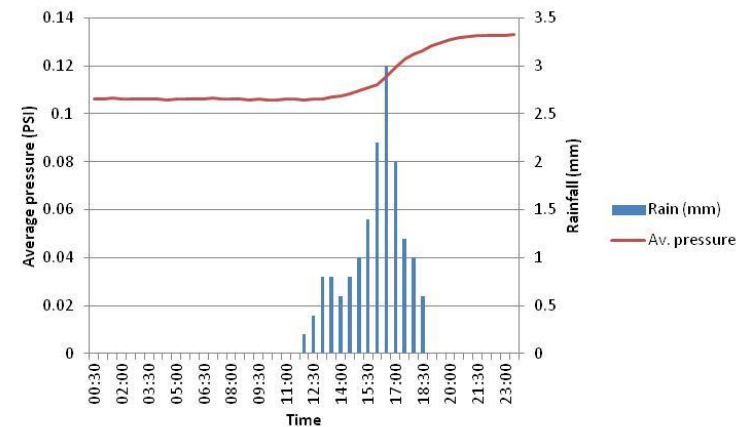
**Figure 34. Cheeseman Terrace rain gardens monitoring 12th January 2017.** Graphs show the records of pressure sensors positioned in i) first rain garden (PS2), ii) middle rain garden (PS3), iii) last rain garden (PS4) and iv) controlled release overflow chamber (PS5). Blue bars represent the pattern of rainfall, the red line indicates the pressure measured by the pressure sensor. Increase in pressure therefore corresponds with an increase in water level within chambers (PS 2, 4 and 5) or water saturation within the soil (PS3).

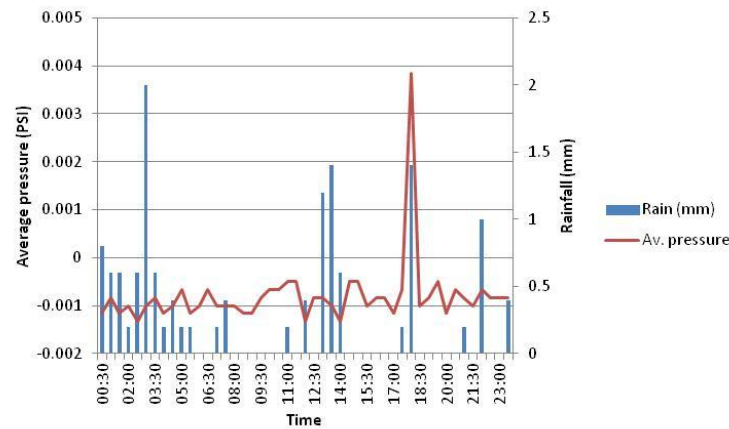
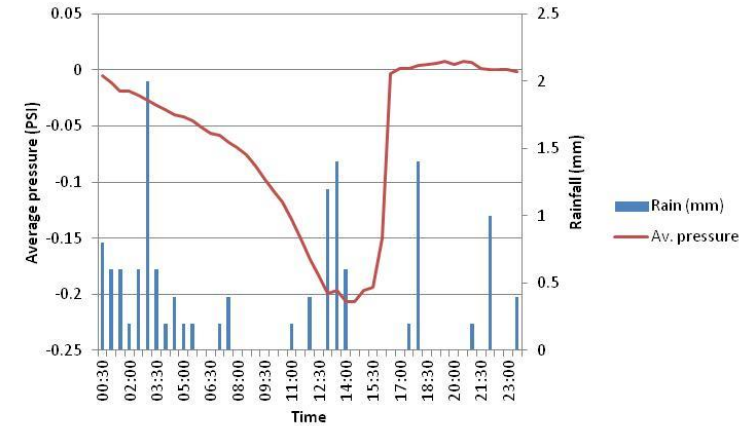
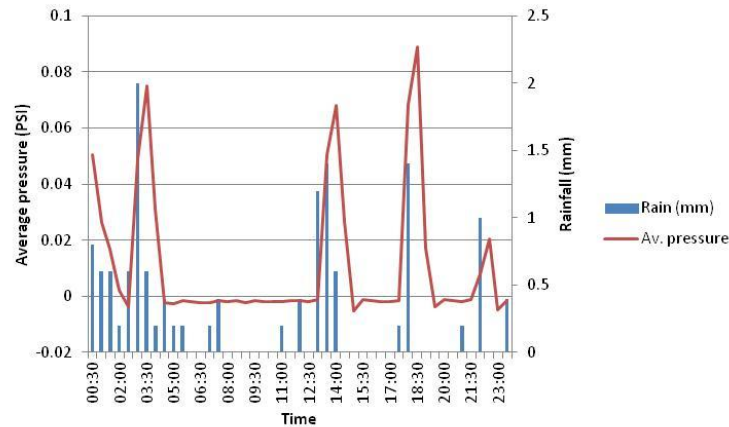
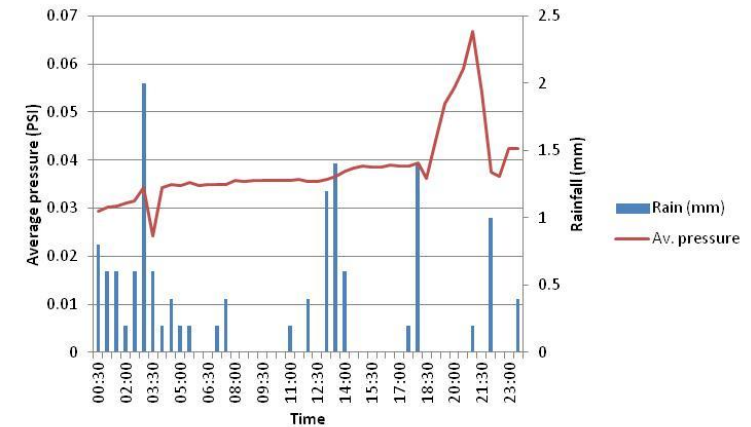
**Figure 35. Cheeseman Terrace rain gardens monitoring 21st November 2016.** Graphs show the records of pressure sensors positioned in i) first rain garden (PS2), ii) middle rain garden (PS3), iii) last rain garden (PS4) and iv) controlled release overflow chamber (PS5). Blue bars represent the pattern of rainfall, the red line indicates the pressure measured by the pressure sensor. Increase in pressure therefore corresponds with an increase in water level within chambers (PS 2, 4 and 5) or water saturation within the soil (PS3).

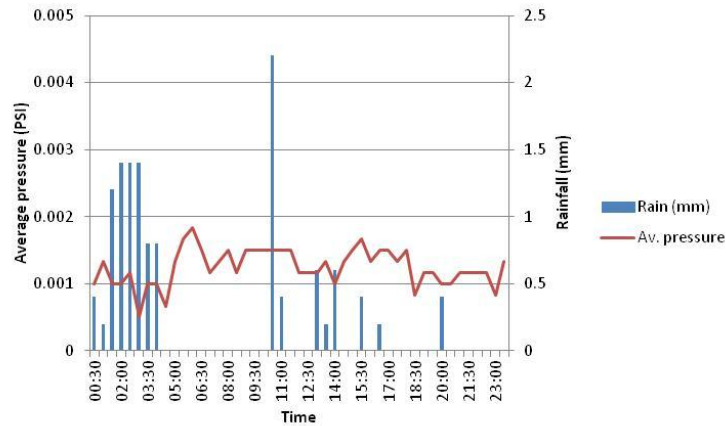
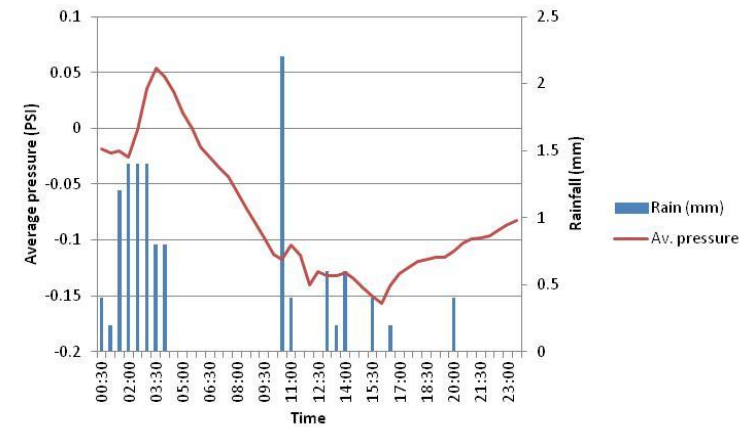
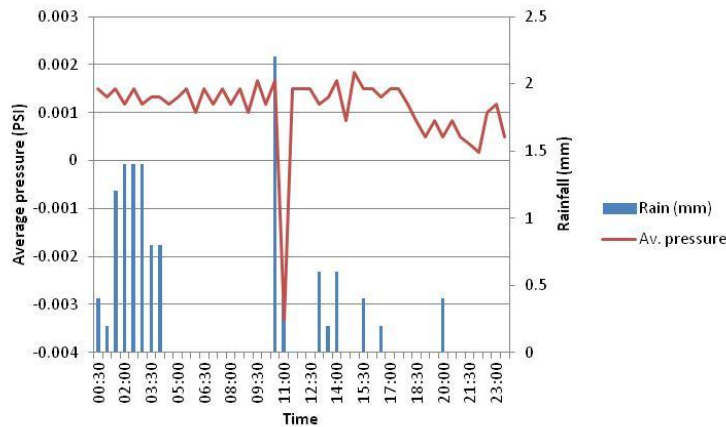
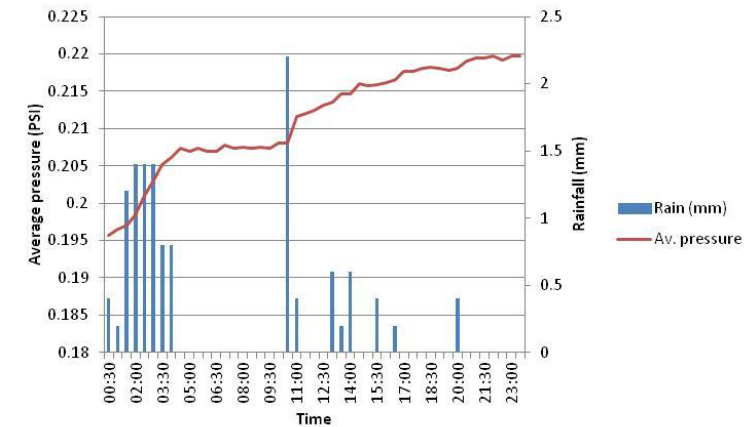
**Figure 36. Cheeseman Terrace rain gardens monitoring 27th February 2017.** Graphs show the records of pressure sensors positioned in i) first rain garden (PS2), ii) middle rain garden (PS3), iii) last rain garden (PS4) and iv) controlled release overflow chamber (PS5). Blue bars represent the pattern of rainfall, the red line indicates the pressure measured by the pressure sensor. Increase in pressure therefore corresponds with an increase in water level within chambers (PS 2, 4 and 5) or water saturation within the soil (PS3).

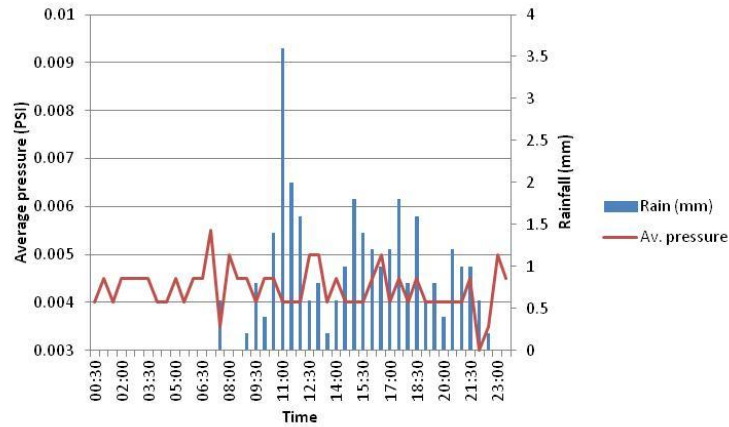
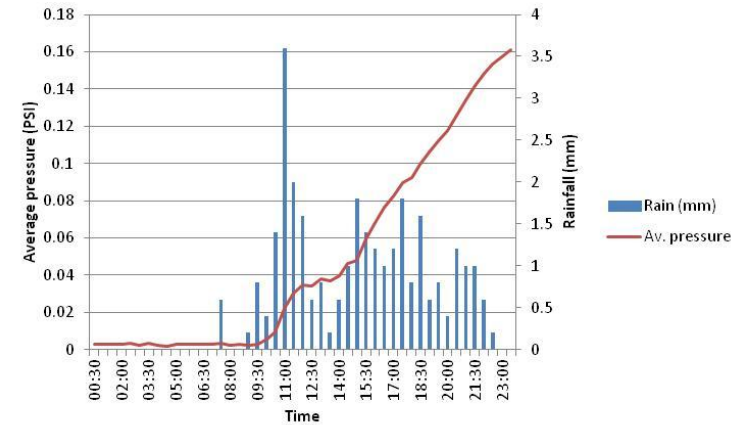
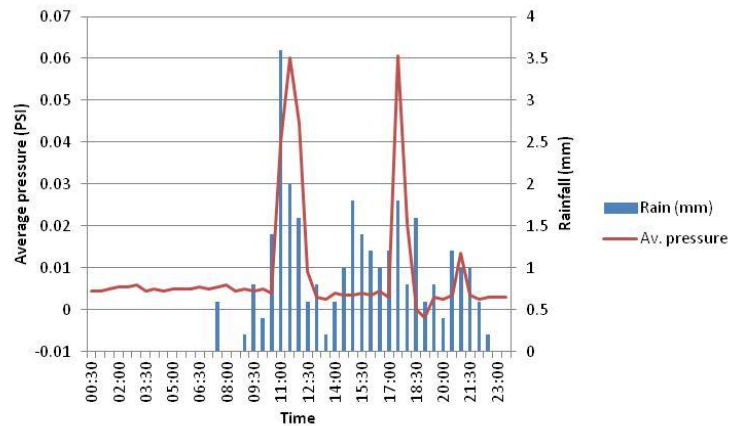
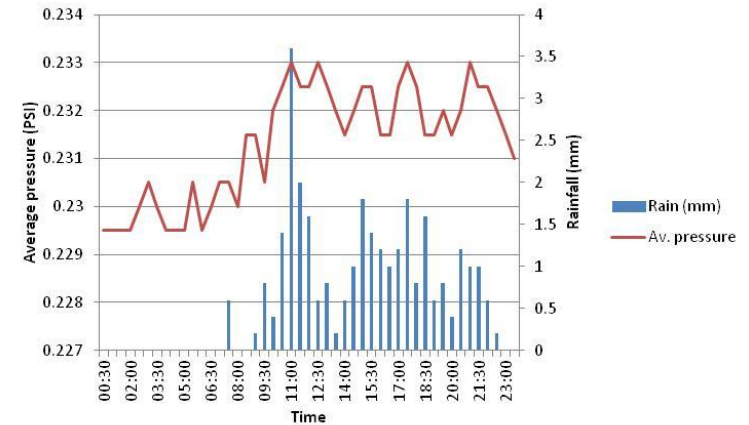
**Figure 37. Cheeseman Terrace rain gardens monitoring 9th August 2017.** Graphs show the records of pressure sensors positioned in i) first rain garden (PS2), ii) middle rain garden (PS3), iii) last rain garden (PS4) and iv) controlled release overflow chamber (PS5). Blue bars represent the pattern of rainfall, the red line indicates the pressure measured by the pressure sensor. Increase in pressure therefore corresponds with an increase in water level within chambers (PS 2, 4 and 5) or water saturation within the soil (PS3).
