**Climate Proofing Housing Landscapes:  
Monitoring Report 3**

**October 2016 to September 2017**

**Authors: Connop, S., Clough, J., Alam, R. and Nash, C.**

H&F Council and Groundwork London worked with local residents to design and implement climate change adaptation measures on three housing estates in the borough, making them more resilient and adapted for the future.

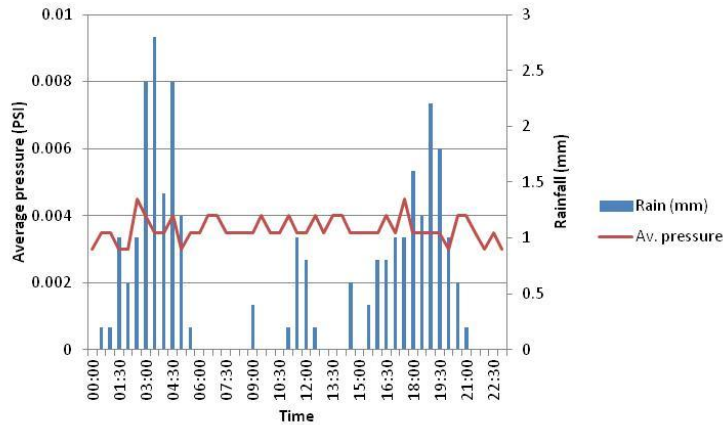
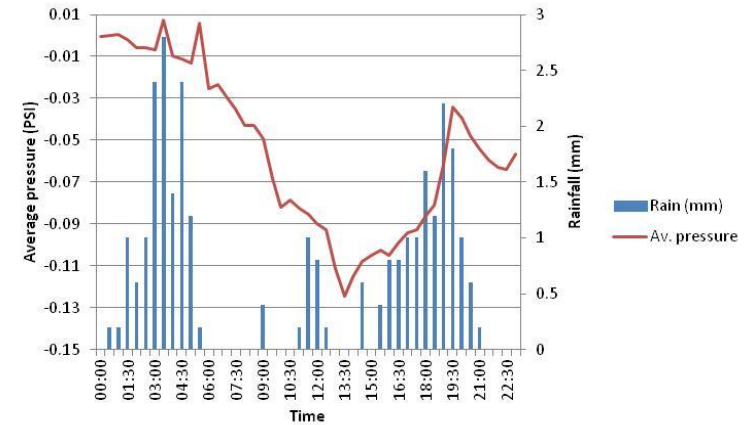
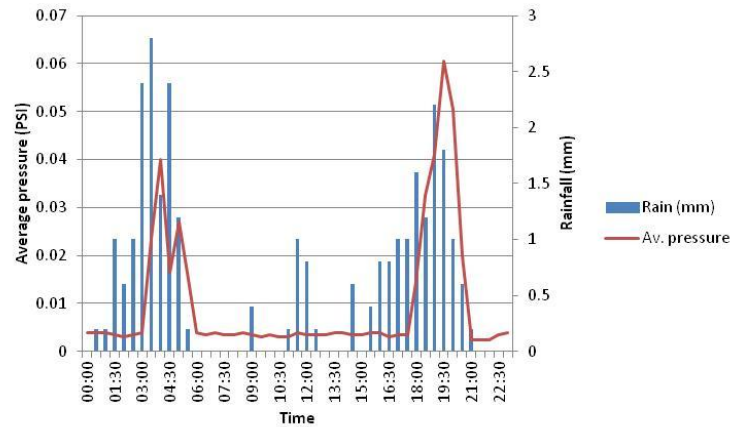
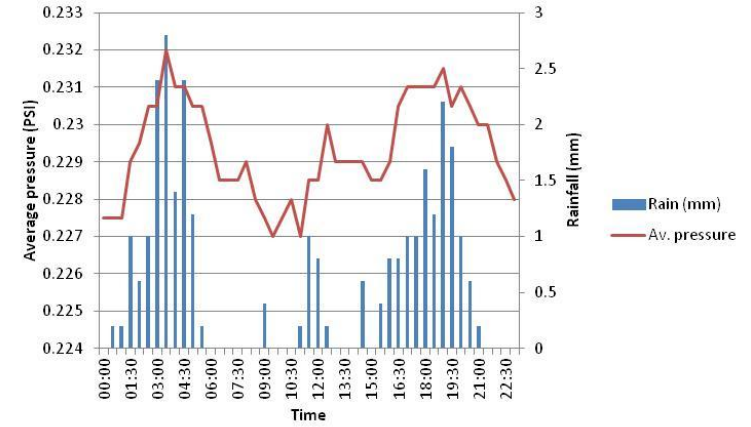
**Figure 38. Cheeseman Terrace rain gardens monitoring 17th May 2017.** Graphs show the records of pressure sensors positioned in i) first rain garden (PS2), ii) middle rain garden (PS3), iii) last rain garden (PS4) and iv) controlled release overflow chamber (PS5). Blue bars represent the pattern of rainfall, the red line indicates the pressure measured by the pressure sensor. Increase in pressure therefore corresponds with an increase in water level within chambers (PS 2, 4 and 5) or water saturation within the soil (PS3).

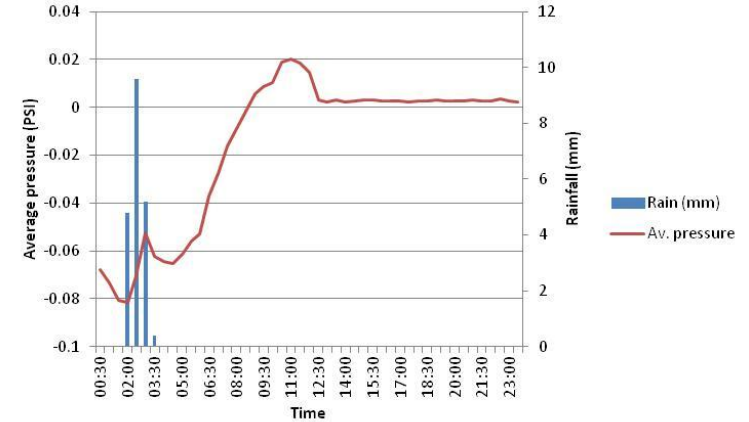
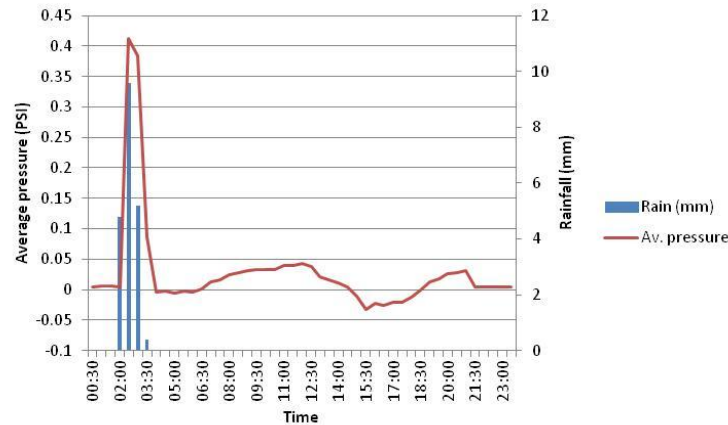
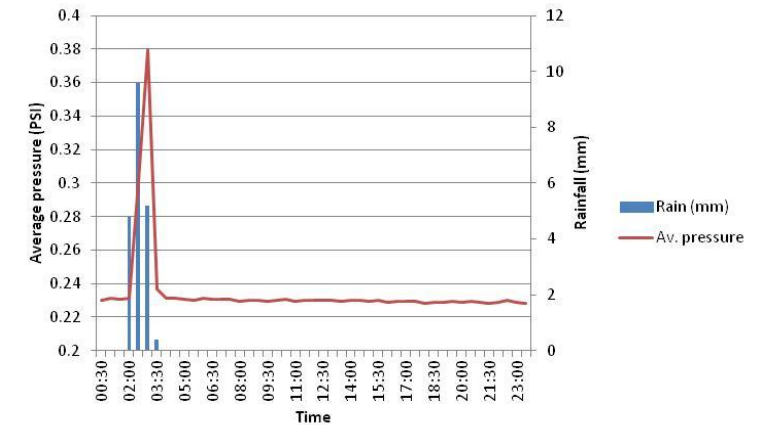
**Figure 39. Cheeseman Terrace rain gardens monitoring 30th July 2017.** Graphs show the records of pressure sensors positioned in i) first rain garden (PS2), ii) middle rain garden (PS3), iii) last rain garden (PS4) and iv) Controlled release overflow chamber (PS5). Blue bars represent the pattern of rainfall, the red line indicates the pressure measured by the pressure sensor. Increase in pressure therefore corresponds with an increase in water level within chambers (PS 2, 4 and 5) or water saturation within the soil (PS3).

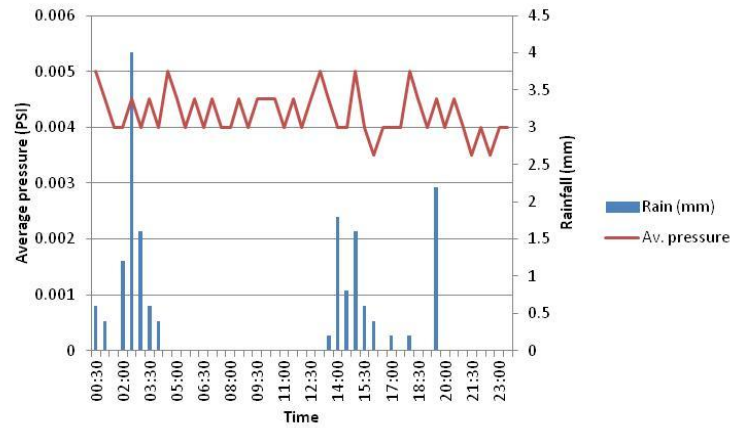
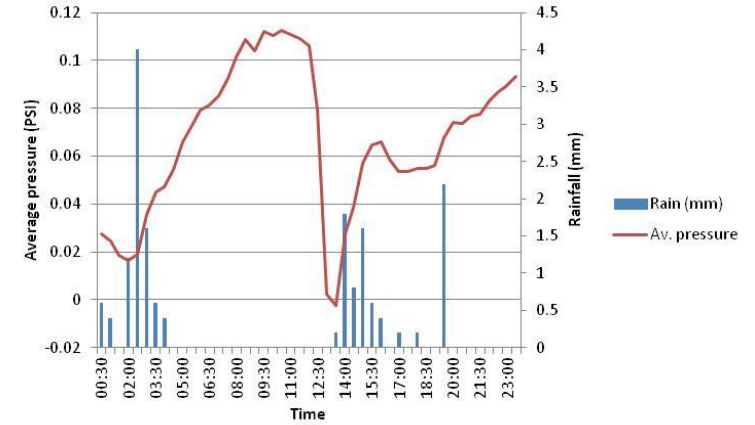
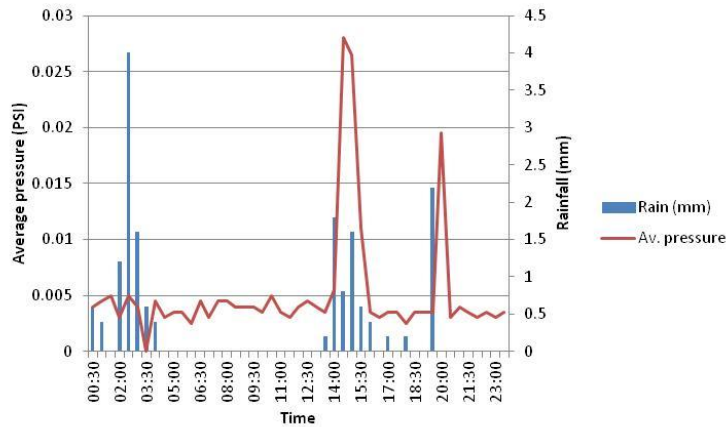
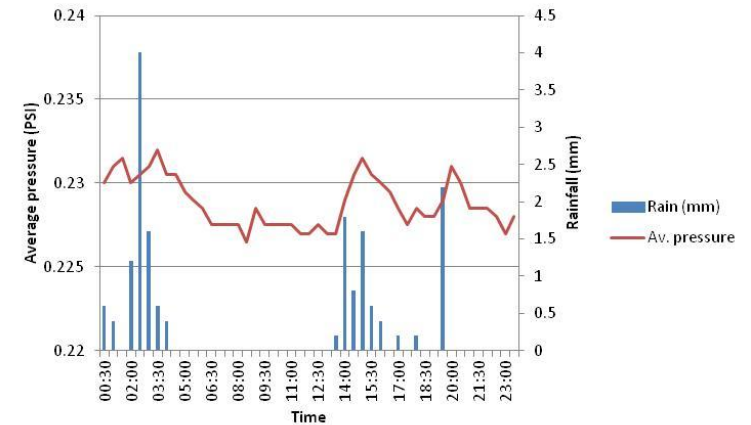
**Figure 40. Cheeseman Terrace rain gardens monitoring 22nd July 2017.** Graphs show the records of pressure sensors positioned in i) first rain garden (PS2), ii) middle rain garden (PS3), iii) last rain garden (PS4) and iv) controlled release overflow chamber (PS5). Blue bars represent the pattern of rainfall, the red line indicates the pressure measured by the pressure sensor. Increase in pressure therefore corresponds with an increase in water level within chambers (PS 2, 4 and 5) or water saturation within the soil (PS3).

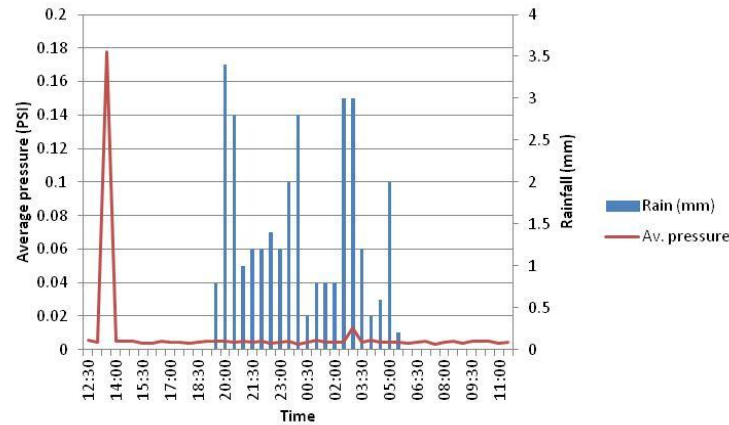
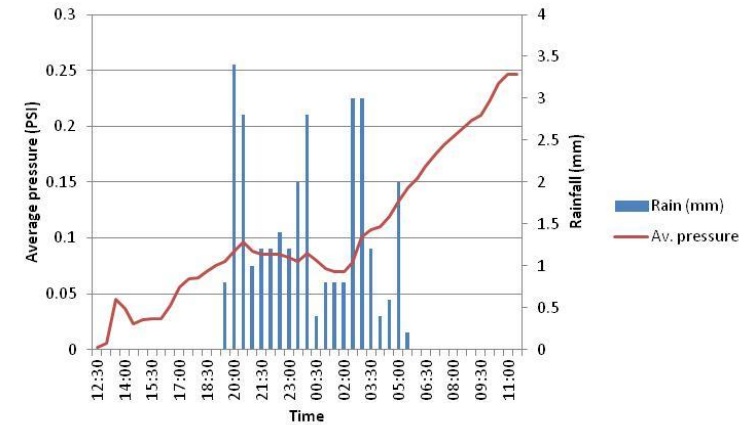
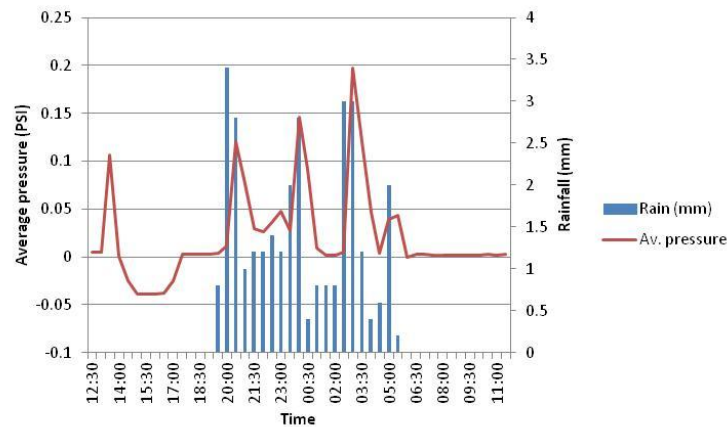
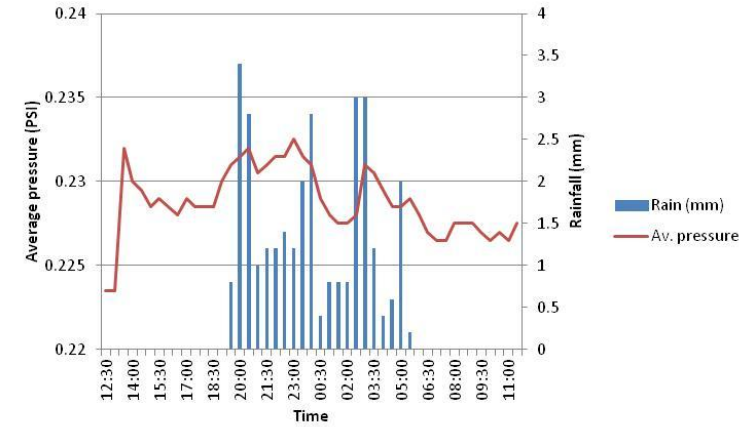
**Figure 41. Cheeseman Terrace rain gardens monitoring 11th/12th July 2017.** Graphs show the records of pressure sensors positioned in i) first rain garden (PS2), ii) middle rain garden (PS3), iii) last rain garden (PS4) and iv) controlled release overflow chamber (PS5). Blue bars represent the pattern of rainfall, the red line indicates the pressure measured by the pressure sensor. Increase in pressure therefore corresponds with an increase in water level within chambers (PS 2, 4 and 5) or water saturation within the soil (PS3).

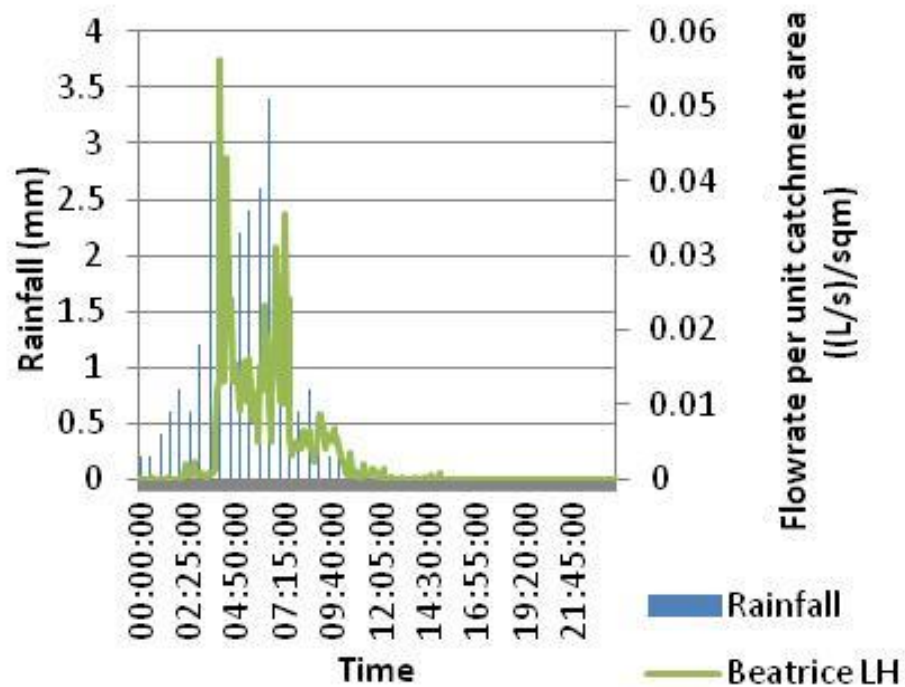
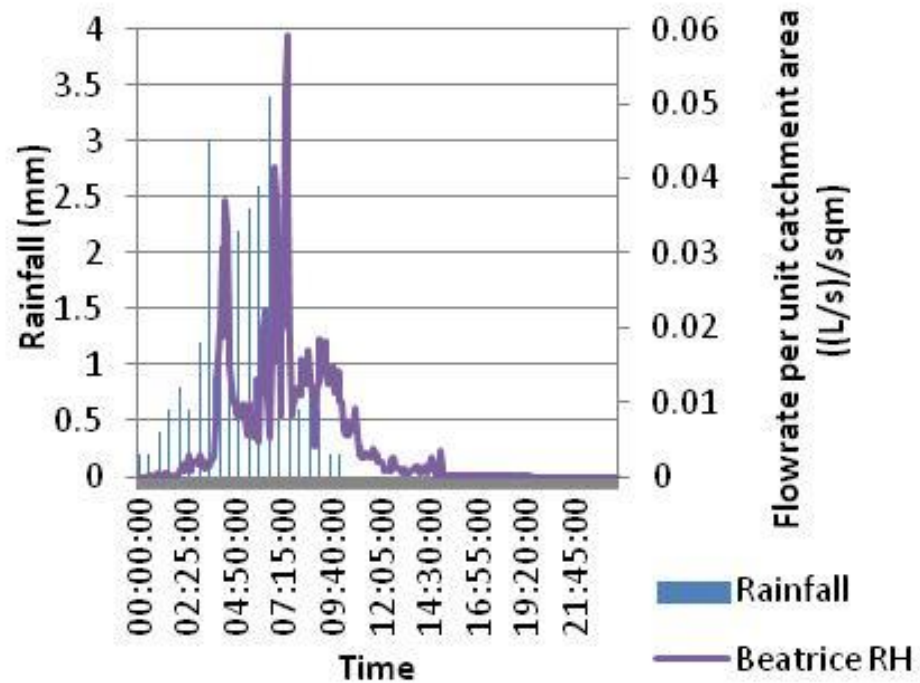
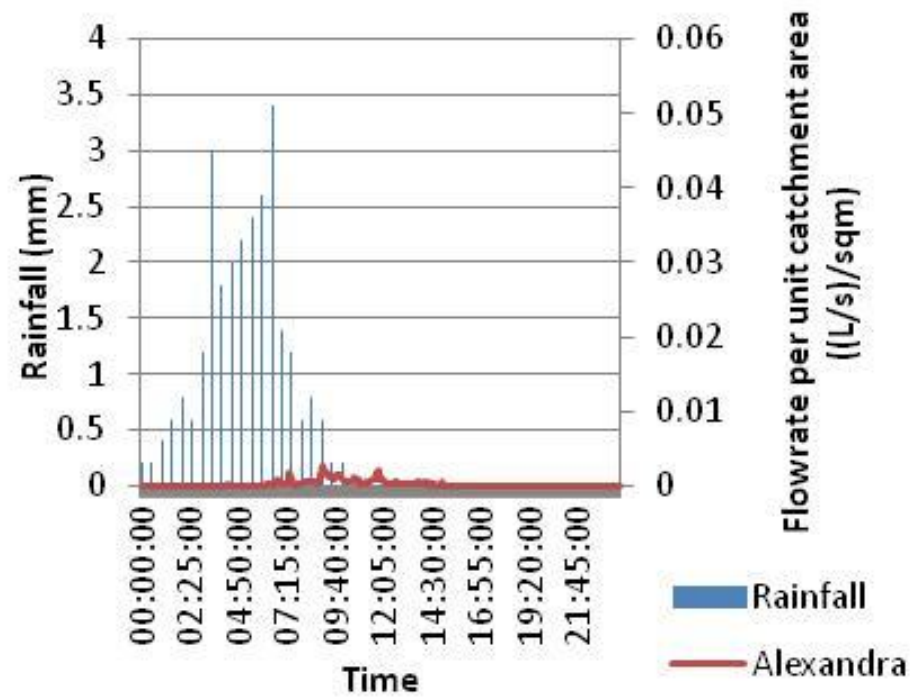
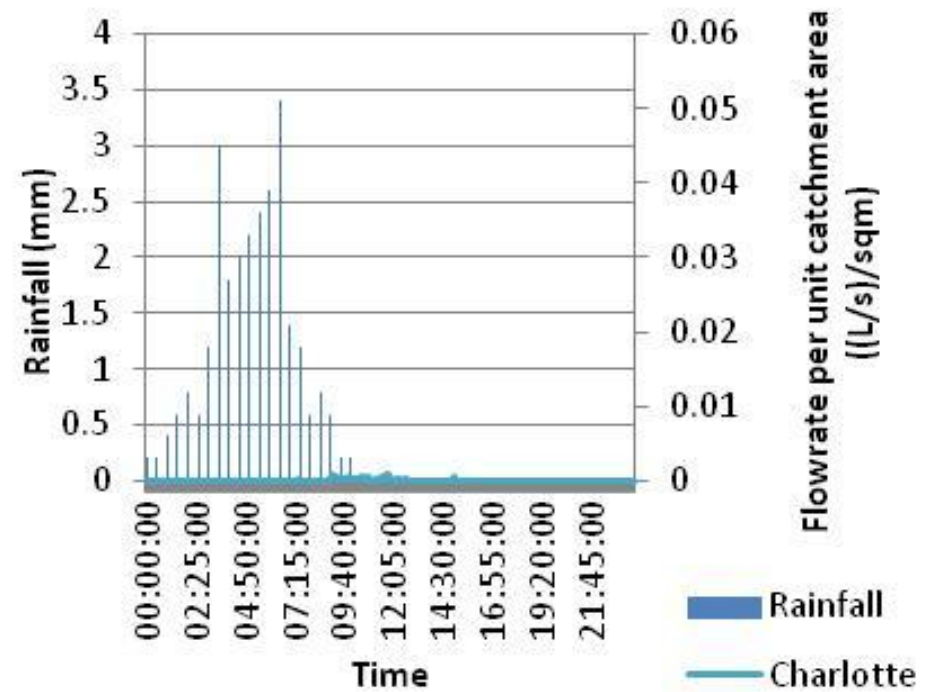
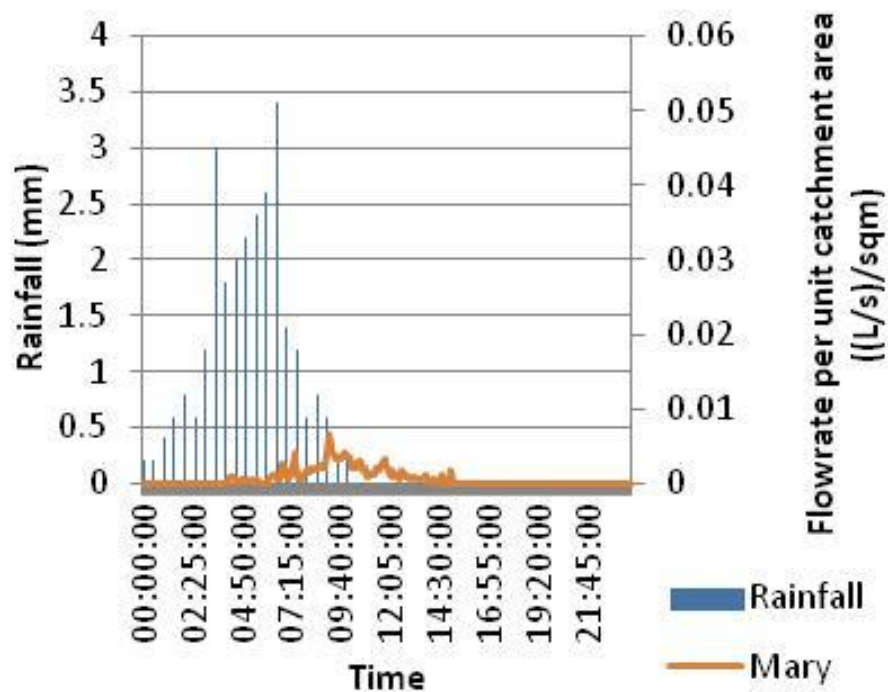
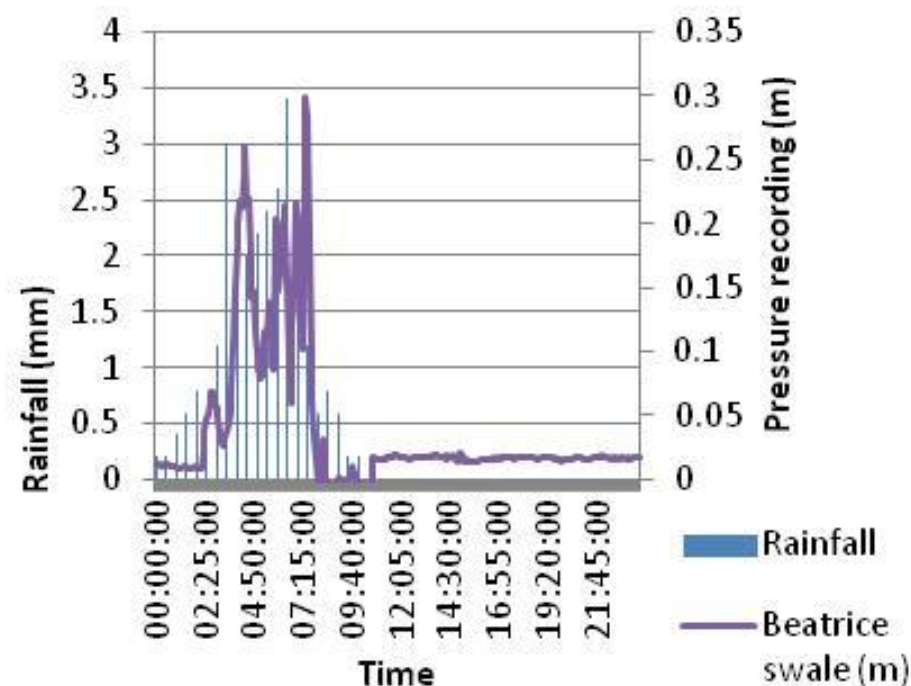
**Figure 43. Water attenuation patterns from Queen Caroline Estate, Hammersmith, 9th November 2016.** Graphs represent individual storm management infrastructure components: (i) and (ii) represent the two control roof areas on Beatrice House (with no green roof), (iii), (iv) and (v) represent the three pramshed green roofs at Queen Caroline Estate, and (vi) the pressure sensor beneath Beatrice swale compared to rainfall patterns for the same rain event. Roof flow rates were measured using a pressure sensor combined with a v-notch weir. The swale was measured using a pressure sensor beneath the swale. All run off flow rates have been adjusted to a rate per metre squared to compensate for difference in catchment area. *N.B. It must be noted that the control roofs were pitched roofs and the catchment areas were based on the aerial view of the roof (i.e. a 2D 'vertical footprint'). Due to the pitch, the direction of rain for the rain event may have affected the volume of water recorded on the control roofs (i.e. the SE-facing pitched roofs would be expected to catch more rain from a SE wind direction rain event than a NE wind rain event). As such, the peak flows from the control roofs were likely to be a conservative estimate for all rain events other than those with wind from a SE direction.*

Data from the pressure sensor in the Beatrice swale (Figure 43.vi) supported the evidence captured by the time-lapse cameras for this event. The pressure sensor captured the swale reacting quickly to rainfall by recording an increase in pressure very quickly following rain (caused by water pooling above the sensor). This increase in pressure was short-lived however, with a reduction in pressure in a relatively short period of time following the cessation of the rain. This indicated that the swale was effectively conveying and infiltrating the stormwater, rather than the basin holding pooled water over long periods. This is important as it means that stormwater storage volumes are available for the next rain event.

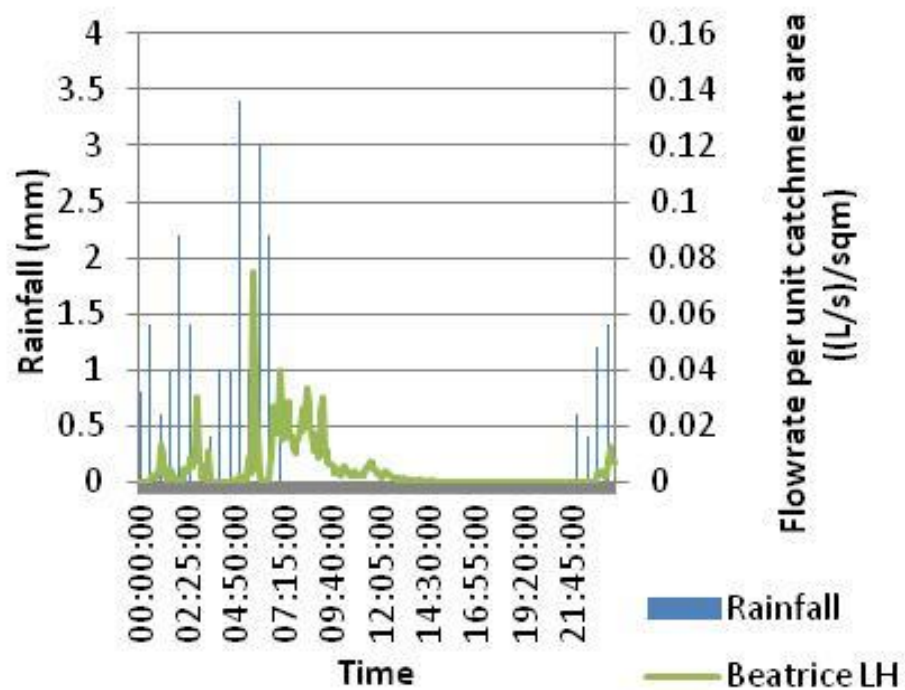
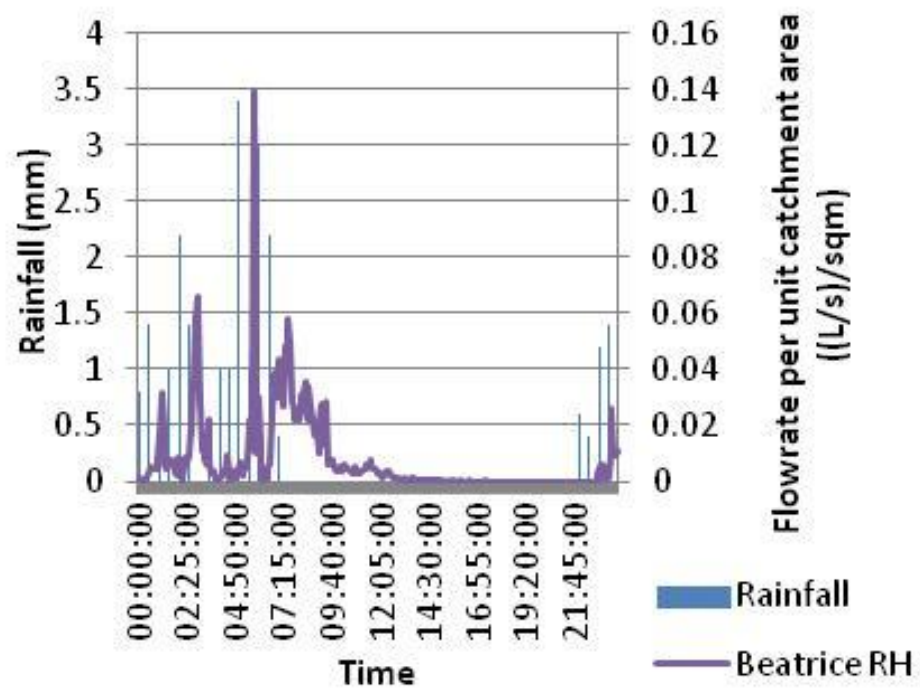
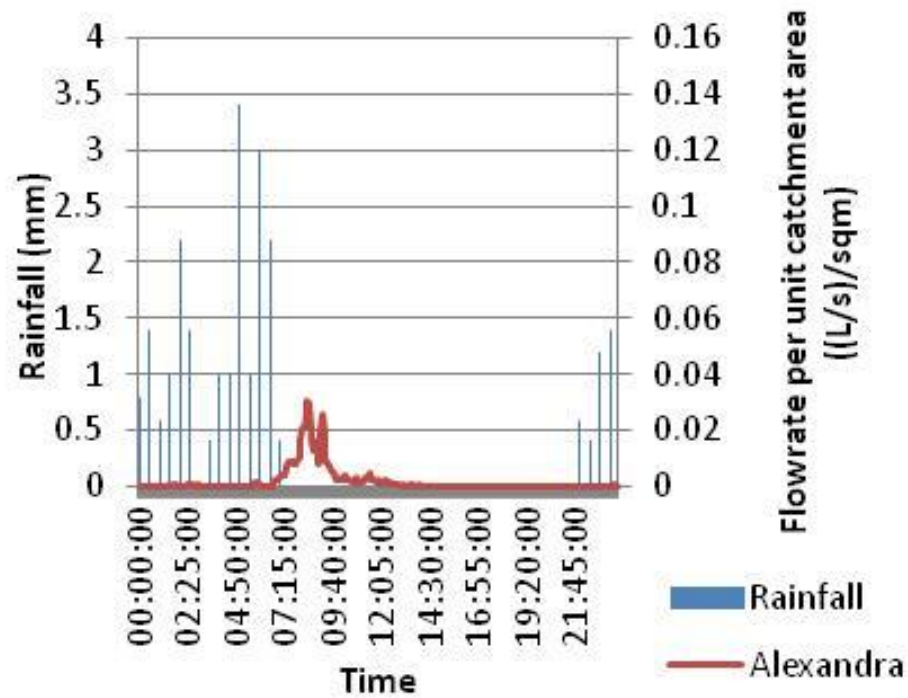
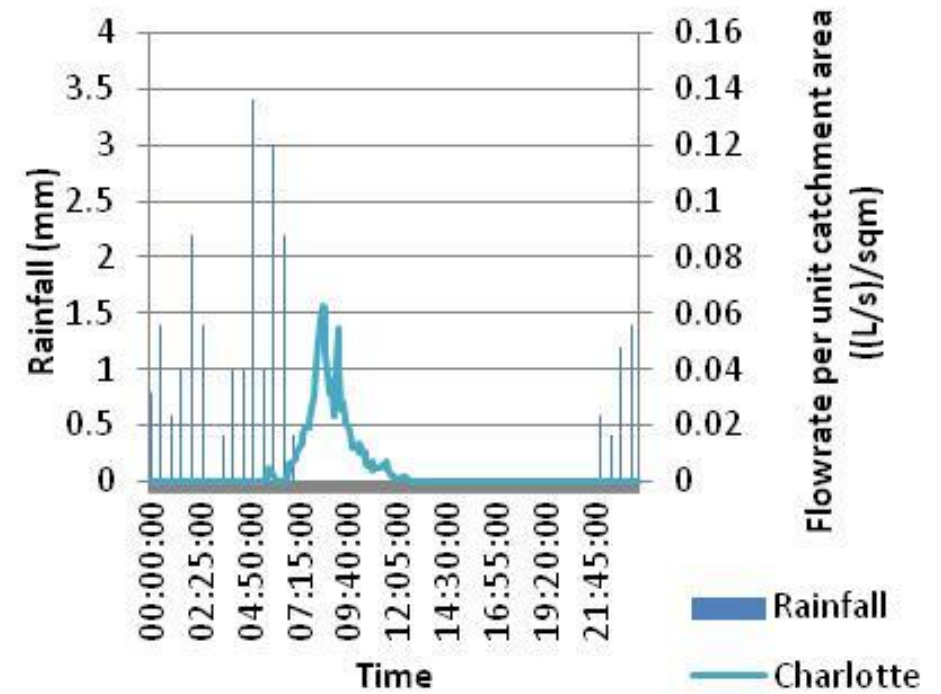
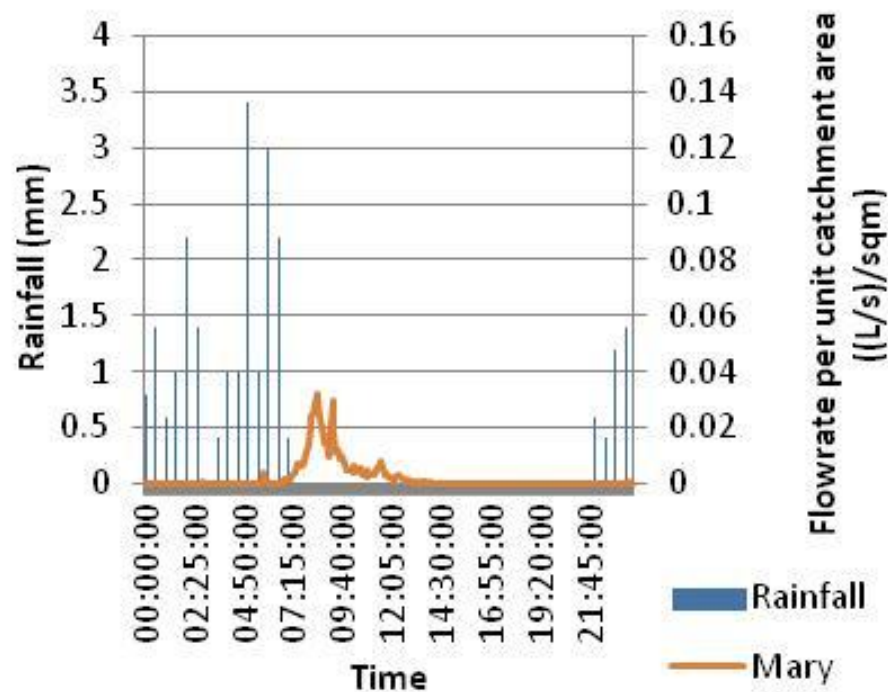
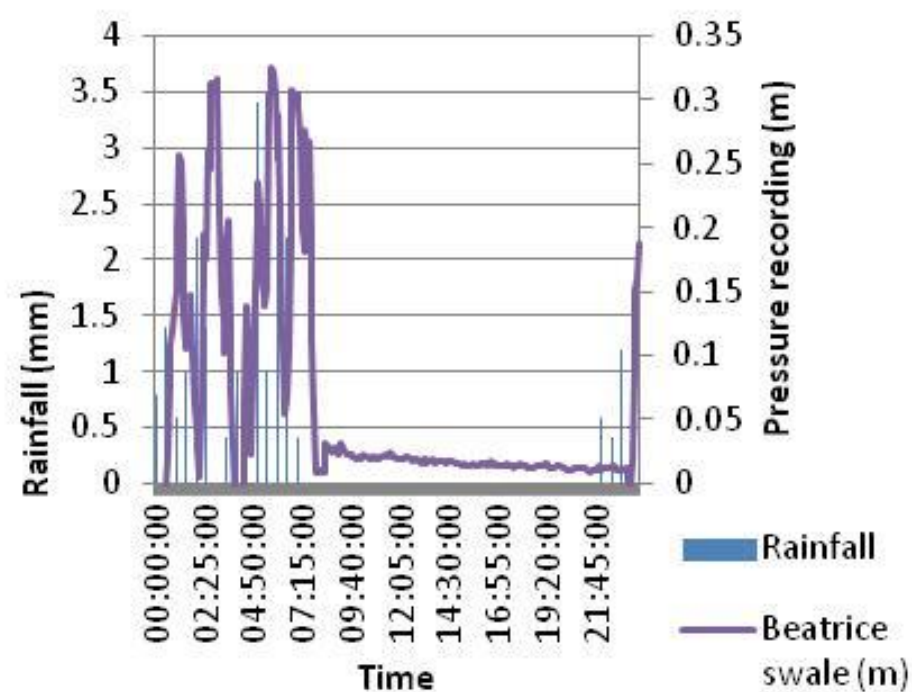
**Figure 45. Water attenuation patterns from Queen Caroline Estate, Hammersmith, 20th November 2016.** Graphs represent individual storm management infrastructure components: (i) and (ii) represent the two control roof areas on Beatrice House (with no green roof), (iii), (iv) and (v) represent the three pram shed green roofs at Queen Caroline Estate, and (vi) the pressure sensor beneath Beatrice swale compared to rainfall patterns for the same rain event. Roof flow rates were measured using a pressure sensor combined with a v-notch weir. The swale was measured using a pressure sensor beneath the swale. All run off flow rates have been adjusted to a rate per metre squared to compensate for difference in catchment area. ***N.B. It must be noted that the control roofs were pitched roofs and the catchment areas were based on the aerial view of the roof (i.e. a 2D 'vertical footprint'). Due to the pitch, the direction of rain for the rain event may have affected the volume of water recorded on the control roofs (i.e. the SE-facing pitched roofs would be expected to catch more rain from a SE wind direction rain event than a NE wind rain event). As such, the peak flows from the control roofs were likely to be a conservative estimate for all rain events other than those with wind from a SE direction.***

Data from the pressure sensor in the Beatrice swale (Figure 45.vi) supported the evidence captured by the time-lapse cameras for this event. The pressure sensor captured the swale reacting quickly to rainfall by recording an increase in pressure very quickly following rain (caused by water pooling above the sensor). This increase in pressure was short-lived however, with a reduction in pressure in a relatively short period following the cessation of the rain. This indicated that the swale was effectively conveying and infiltrating the stormwater, rather than the basin holding pooled water over long periods. This is important as it means that stormwater storage volumes are available for the next rain event.

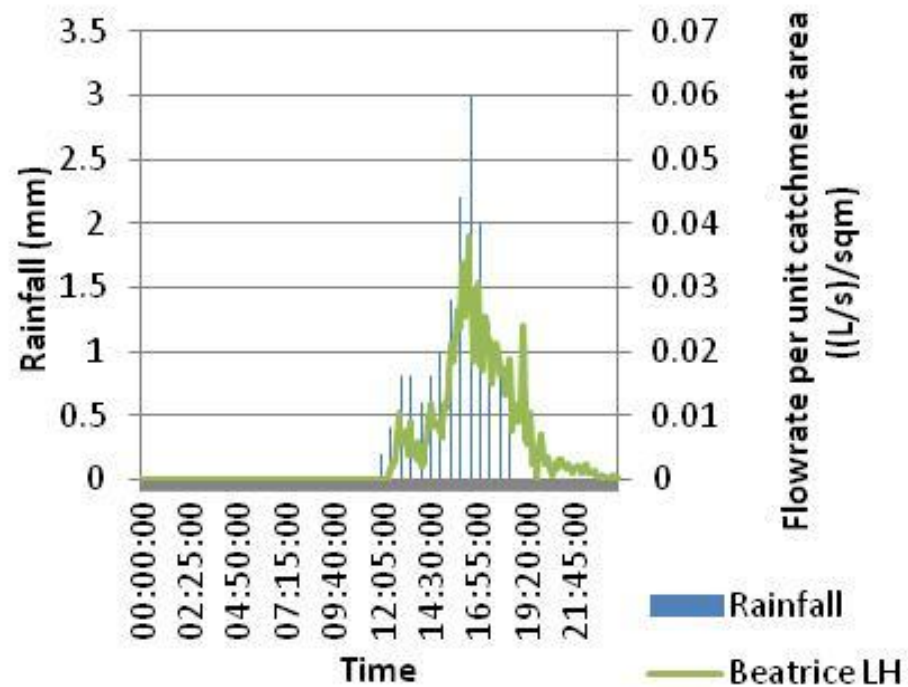
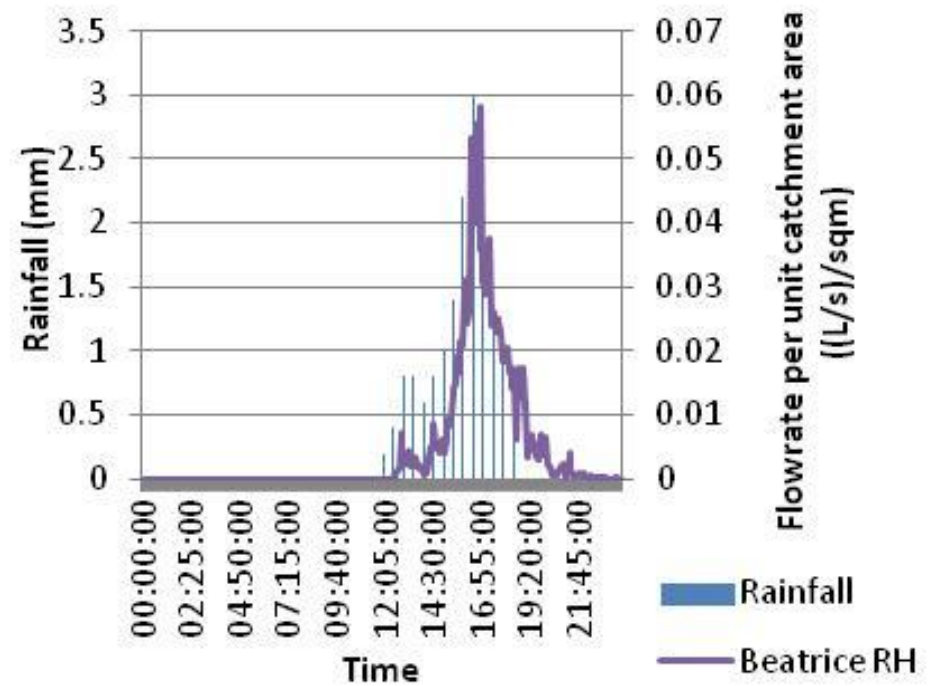
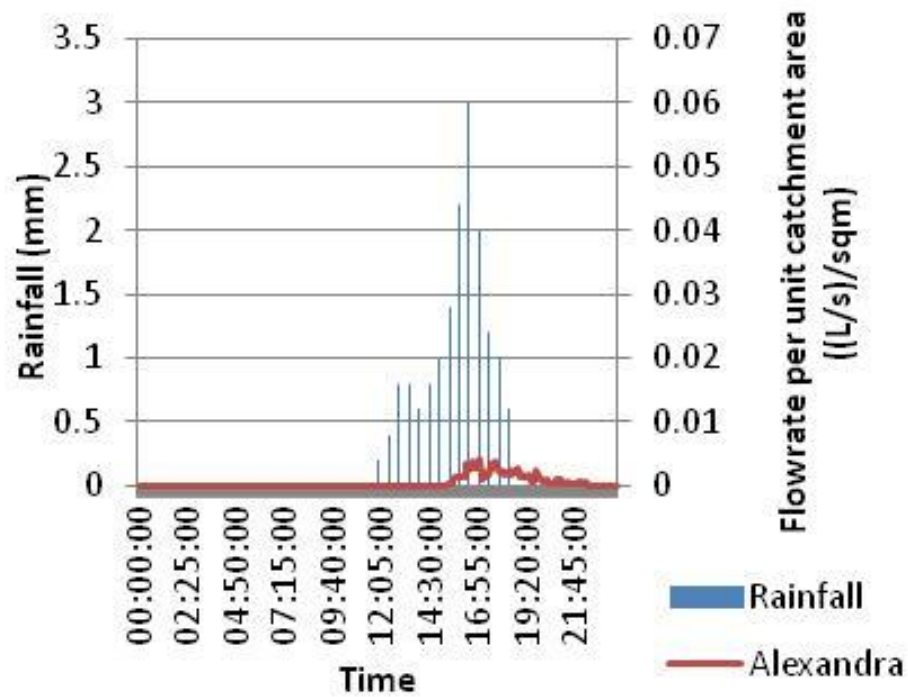
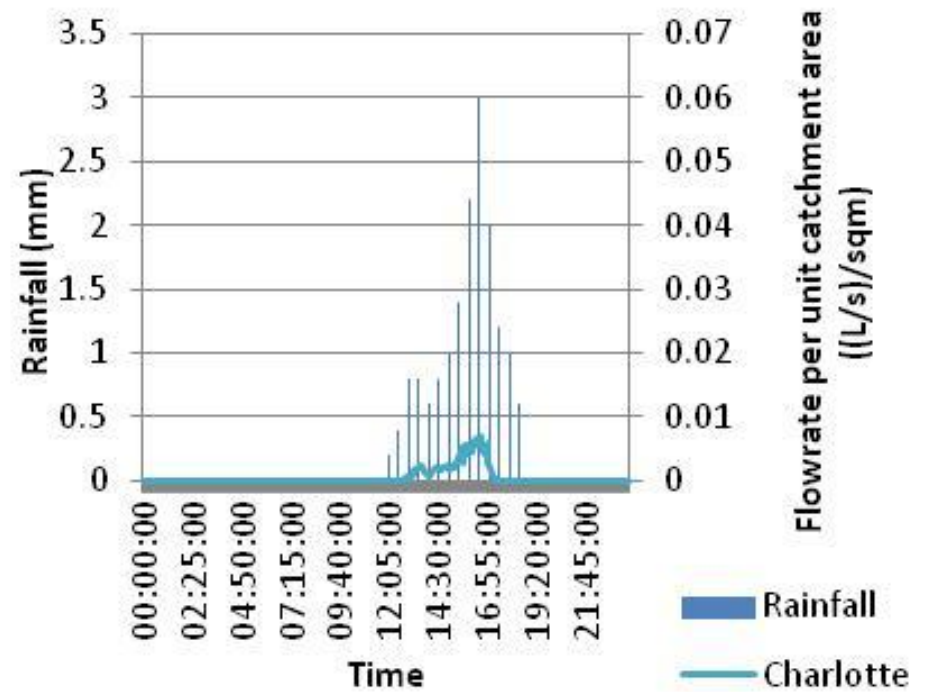
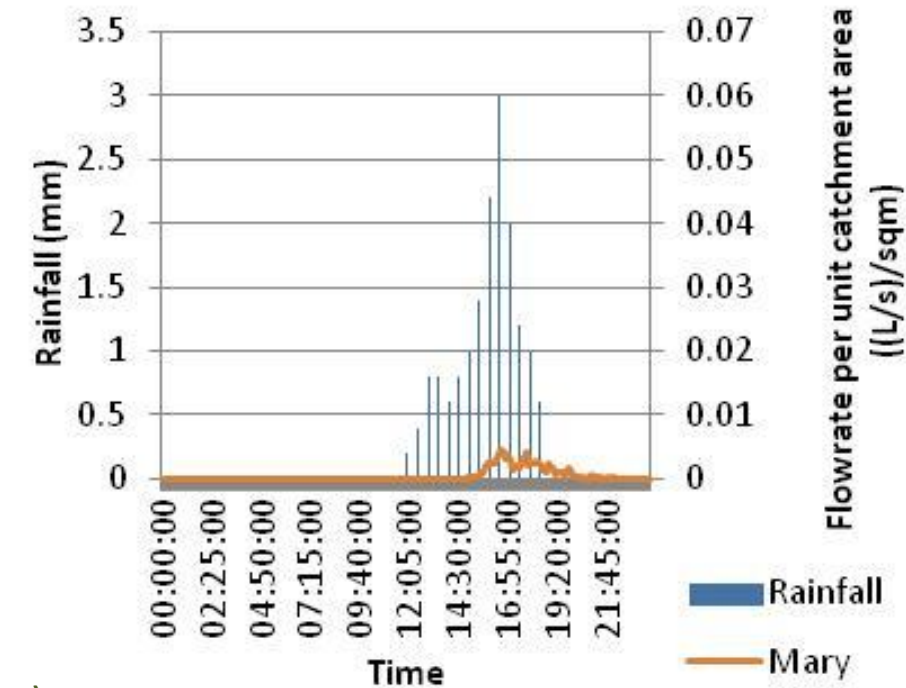
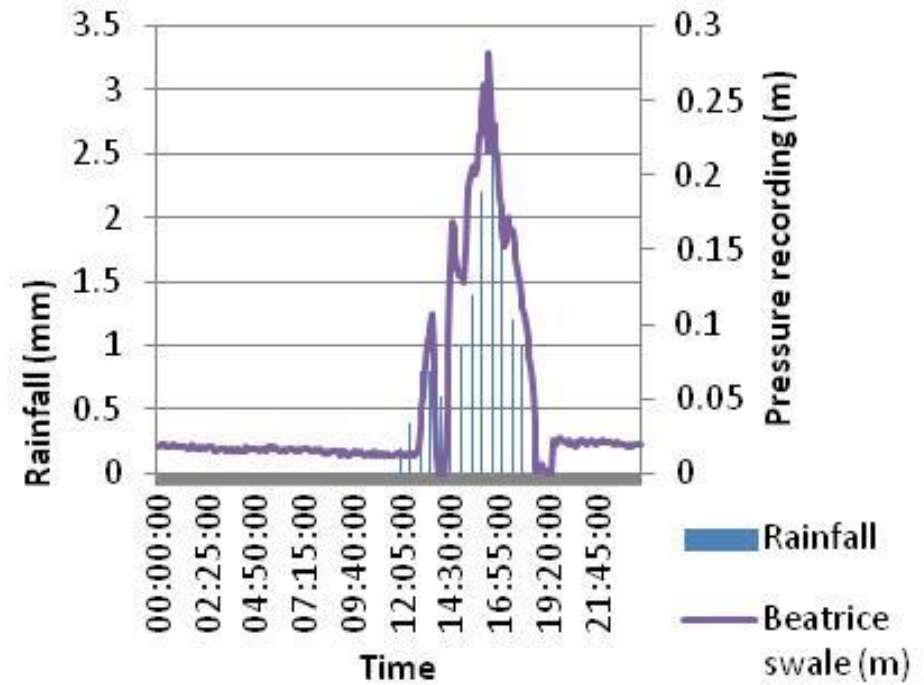
**Figure 47. Water attenuation patterns from Queen Caroline Estate, Hammersmith, 12th January 2017.** Graphs represent individual storm management infrastructure components: (i) and (ii) represent the two control roof areas on Beatrice House (with no green roof), (iii), (iv) and (v) represent the three pram shed green roofs at Queen Caroline Estate, and (vi) the pressure sensor beneath Beatrice swale compared to rainfall patterns for the same rain event. Roof flow rates were measured using a pressure sensor combined with a v-notch weir. The swale was measured using a pressure sensor beneath the swale. All run off flow rates have been adjusted to a rate per metre squared to compensate for difference in catchment area. *N.B. It must be noted that the control roofs were pitched roofs and the catchment areas were based on the aerial view of the roof (i.e. a 2D 'vertical footprint'). Due to the pitch, the direction of rain for the rain event may have affected the volume of water recorded on the control roofs (i.e. the SE-facing pitched roofs would be expected to catch more rain from a SE wind direction rain event than a NE wind rain event). As such, the peak flows from the control roofs were likely to be a conservative estimate for all rain events other than those with wind from a SE direction.*

Data from the pressure sensor in the Beatrice swale (Figure 47.vi) supported the evidence captured by the time-lapse cameras for this event. The pressure sensor captured the swale reacting quickly to rainfall by recording an increase in pressure very quickly following rain (caused by water pooling above the sensor). This increase in pressure was short-lived however, with a reduction in pressure in a relatively short period following the cessation of the rain. This indicated that the swale was effectively conveying and infiltrating the stormwater, rather than the basin holding pooled water over long periods. This is important as it means that stormwater storage volumes are available for the next rain event.

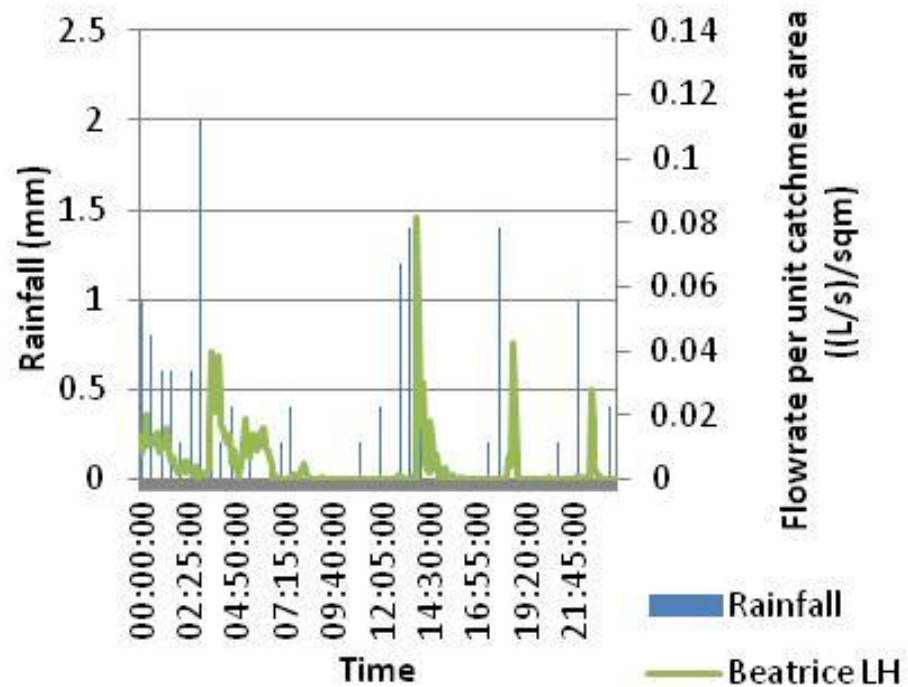
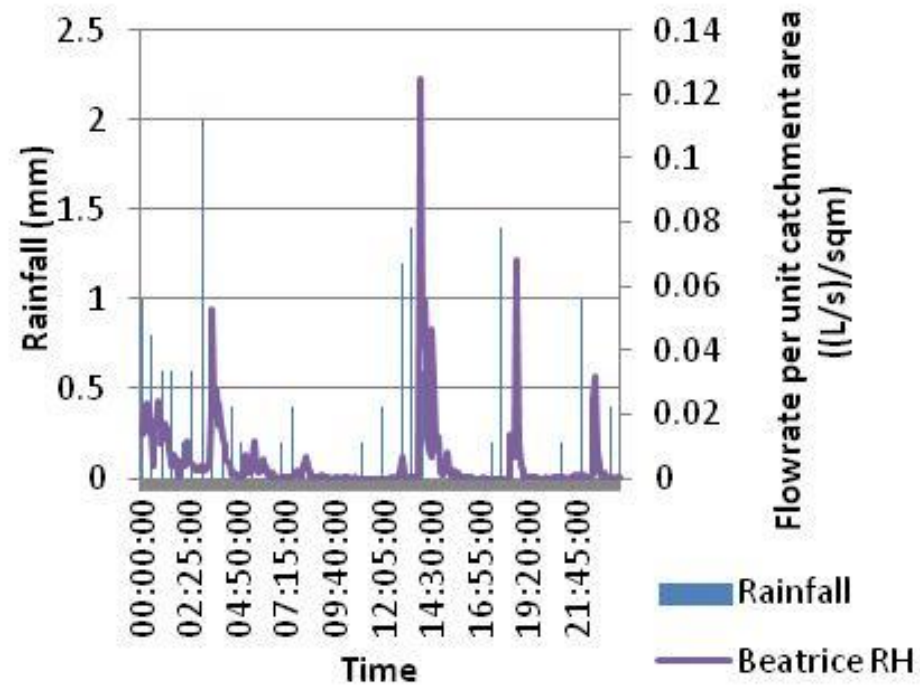
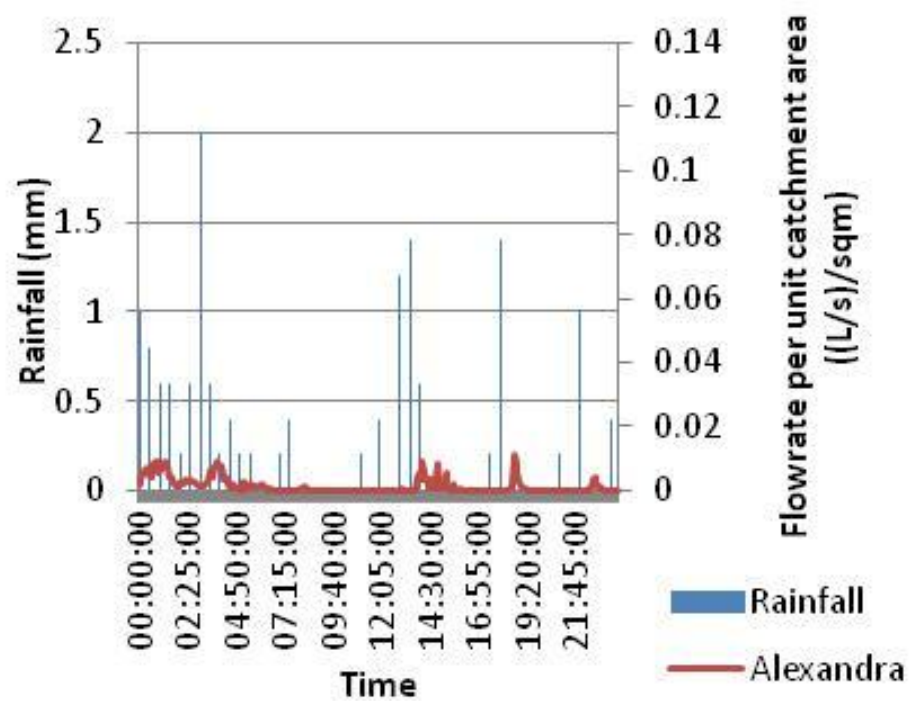
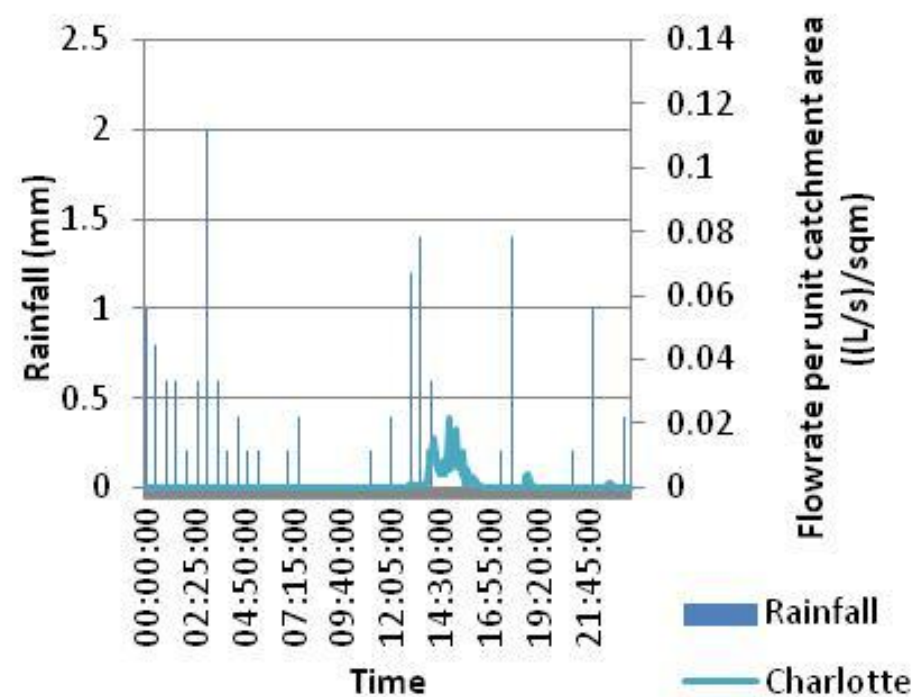
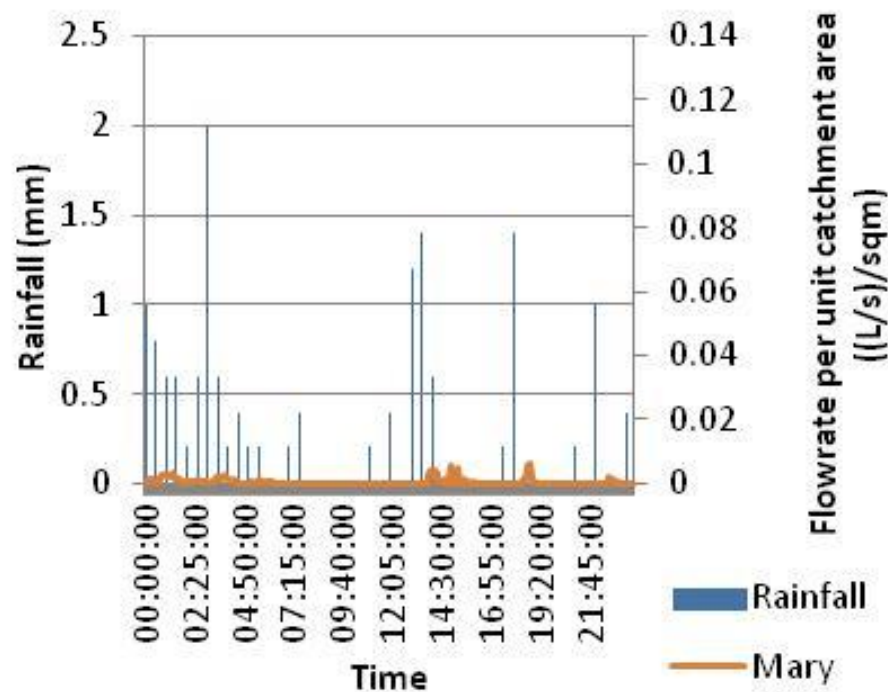
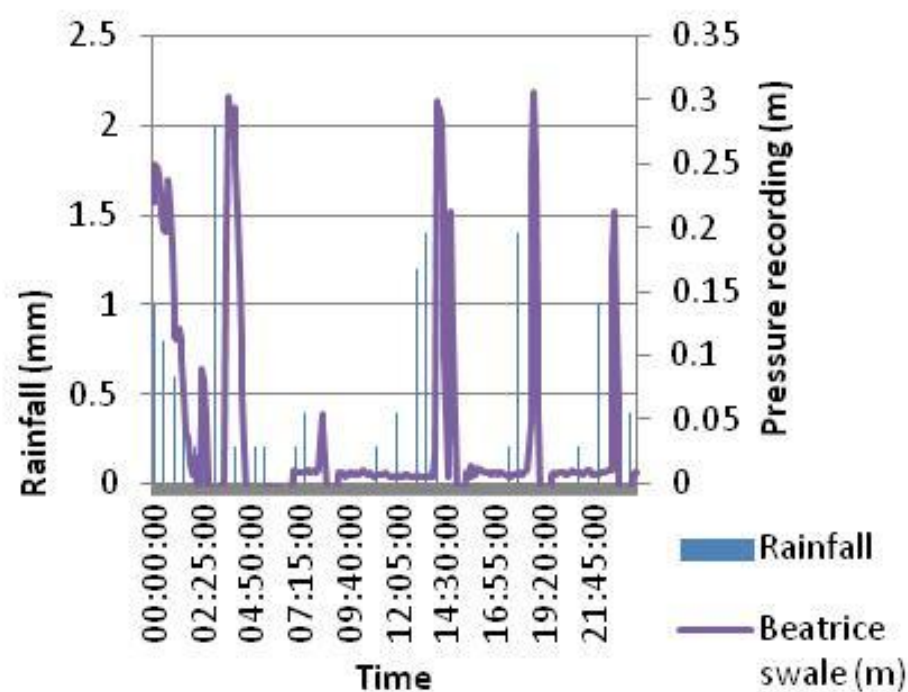
**Figure 49. Water attenuation patterns from Queen Caroline Estate, Hammersmith, 21st November 2016.** Graphs represent individual storm management infrastructure components: (i) and (ii) represent the two control roof areas on Beatrice House (with no green roof), (iii), (iv) and (v) represent the three pram shed green roofs at Queen Caroline Estate, and (vi) the pressure sensor beneath Beatrice swale compared to rainfall patterns for the same rain event. Roof flow rates were measured using a pressure sensor combined with a v-notch weir. The swale was measured using a pressure sensor beneath the swale. All run off flow rates have been adjusted to a rate per metre squared to compensate for difference in catchment area. *N.B. It must be noted that the control roofs were pitched roofs and the catchment areas were based on the aerial view of the roof (i.e. a 2D 'vertical footprint'). Due to the pitch, the direction of rain for the rain event may have affected the volume of water recorded on the control roofs (i.e. the SE-facing pitched roofs would be expected to catch more rain from a SE wind direction rain event than a NE wind rain event). As such, the peak flows from the control roofs were likely to be a conservative estimate for all rain events other than those with wind from a SE direction.*

Data from the pressure sensor in the Beatrice swale (Figure 49.vi) supported the evidence captured by the time-lapse cameras for this event. The pressure sensor captured the swale reacting quickly to rainfall by recording an increase in pressure very quickly following rain (caused by water pooling above the sensor). This increase in pressure was short-lived however, with a reduction in pressure in a relatively short period following the cessation of the rain. This indicated that the swale was effectively conveying and infiltrating the stormwater, rather than the basin holding pooled water over long periods. This is important as it means that stormwater storage volumes are available for the next rain event.
