**Climate Proofing Housing Landscapes:  
Monitoring Report 3**

**October 2016 to September 2017**

**Authors: Connop, S., Clough, J., Alam, R. and Nash, C.**

H&F Council and Groundwork London worked with local residents to design and implement climate change adaptation measures on three housing estates in the borough, making them more resilient and adapted for the future.

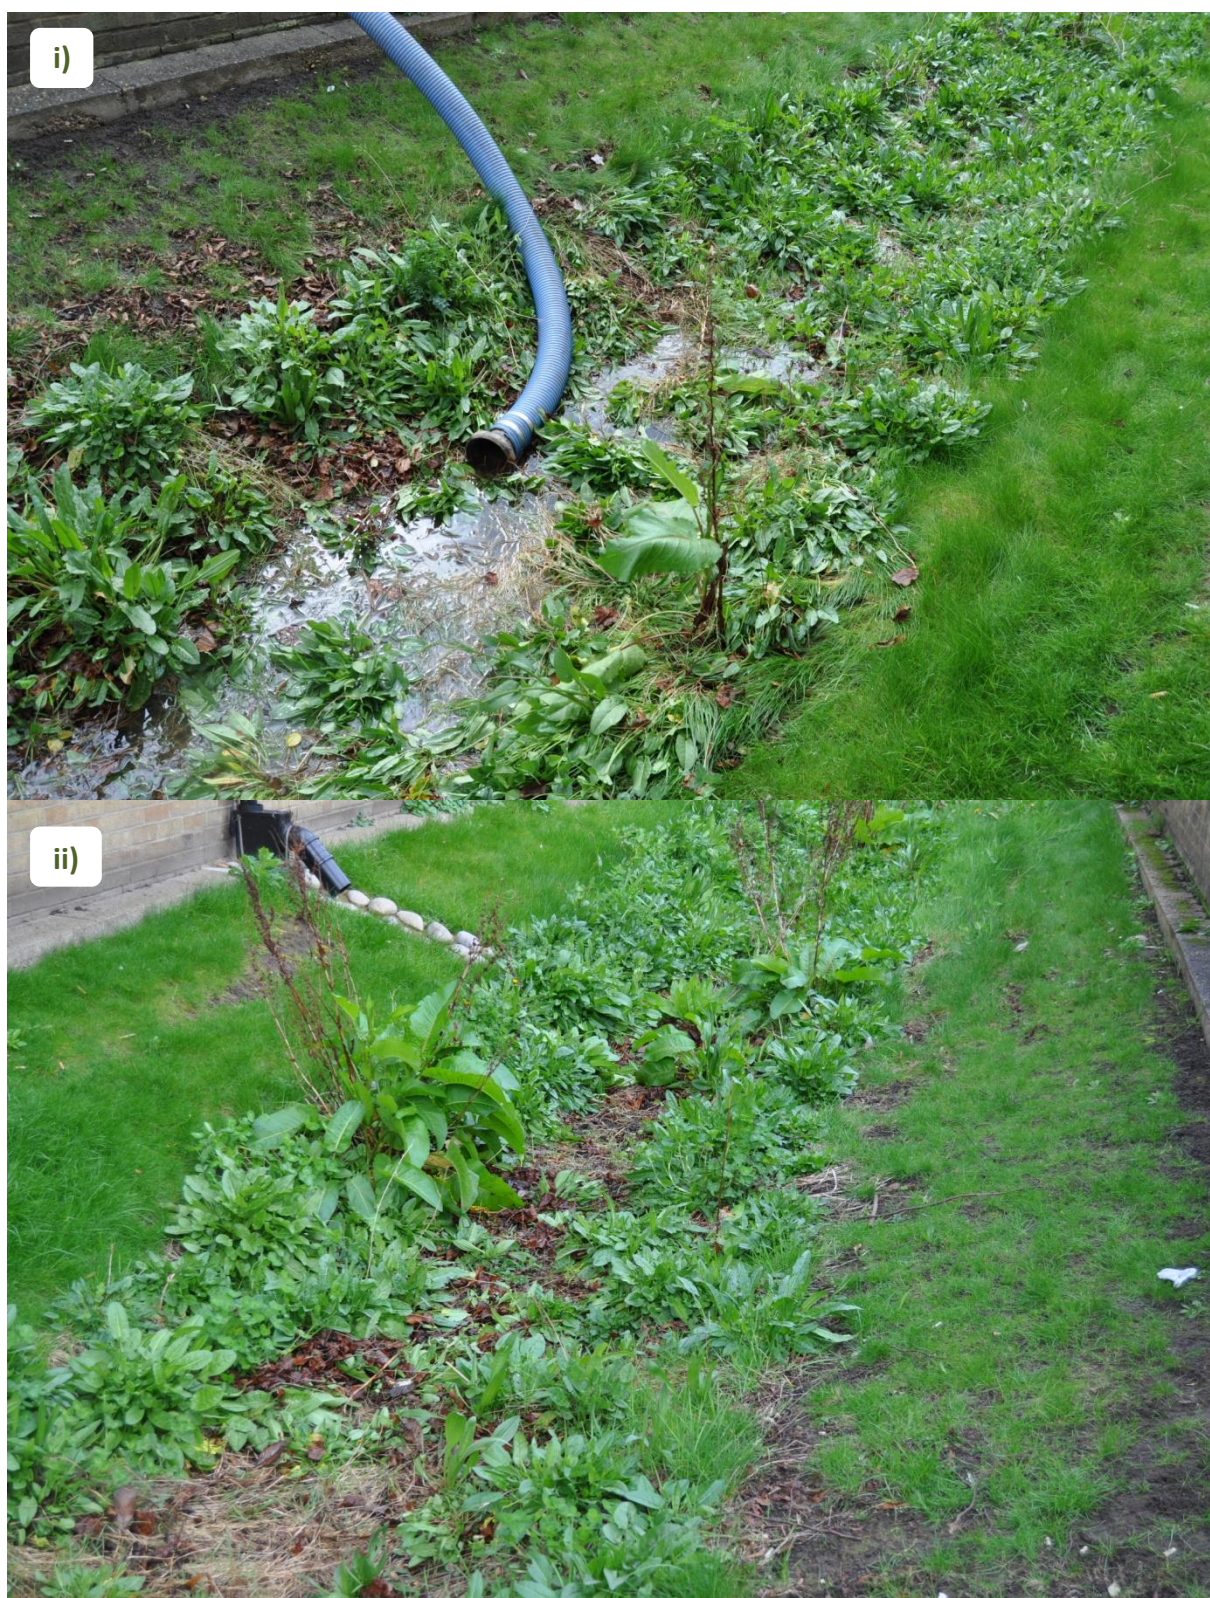
**Figure 66. Images from the storm simulation event at Beatrice House swale, Queen Caroline Estate, 23rd March 2017. Images show i) the Beatrice House swale immediately after the last of the 10,000 Litres of water was released and ii) the centre of the swale where the water was pumped in 10 minutes after the last of the water was released.**

Using visual monitoring of the swale during the storm simulation event, it was possible to confirm that the Beatrice House swale was able to retain all of the 10,000 Litres of stormwater that was pumped into the basin. Moreover, at no point during the storm simulation did water pooling in the swale reach the swale's stormwater overflow. This was evidenced with the photographs taken during the simulation. From observation, however, it was apparent that water pooled to a much greater extent than during the summer rain simulation event. This difference was also apparent from the photographs (Connop et al. 2106) This result indicated that, during wet winter periods, infiltration was slower than during the summer simulation. Nevertheless, the swale had additional storage capacity that could be used. That could include additional capacity so that a storm greater than a 1 in 100 year event could be retained, or that additional catchment area could be diverted into the existing swale for retention of a 1 in 100 year 1 hour rain event.

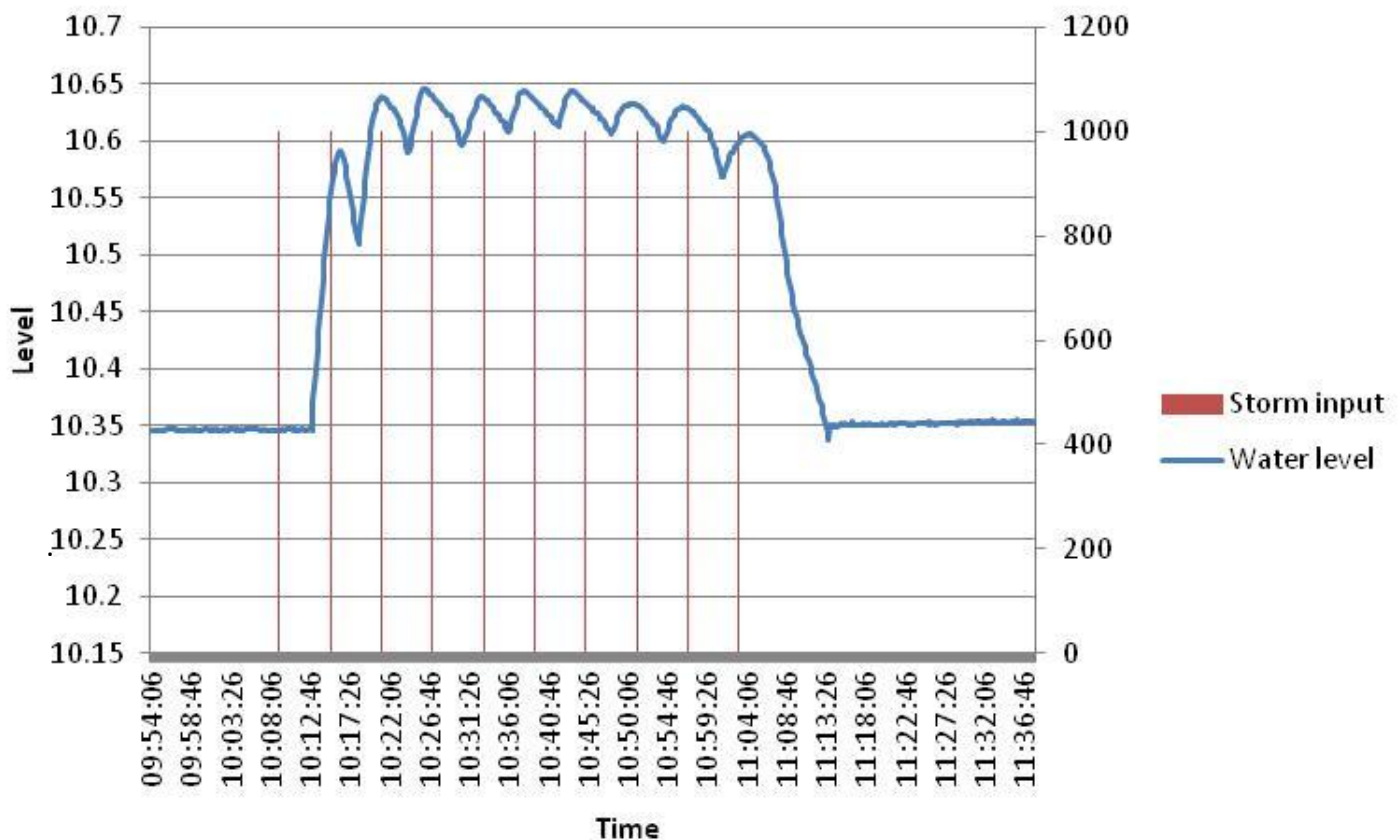
Following the initiation of the first 1000 L of the storm event, the levellogger recorded no additional pressure above the baseline level. This may have been indicative of a delay between the infilling of the swale and the water infiltrating to the levellogger, or may have indicated that all of the initial storm simulation water infiltrated very quickly before saturation resulted in pooling. This pattern was the same as was recorded during the summer rain simulation. By the time that the second 1000 L of water had been pumped into the swale, the water level had increased indicating that pooling/soil saturation was occurring. Following the cessation of the storm simulation (i.e. after all 10,000 L had been pumped into the swale), the levellogger indicated that pooling disappeared very rapidly - within 10 minutes of the end of pumping the pressure readings had returned to the pre-testing baseline level. This data supported observations made on site and indicated that infiltration rates were fast. This provided evidence that recharge volumes would be available very quickly following a 1 in 100 year storm event during winter conditions. This mimicked the results recorded during the summer simulation. Whilst there was greater pooling during this winter event and the time for the levellogger pressure to return to the baseline level following the cessation of the storm event was slightly longer, this was still very rapid and

indicated that the swale was easily able to cope with 1 in 100 year storm events for the current catchment area.

**Figure 67. Pressure sensor data from 1 in 100 year storm simulation event at Beatrice House swale, Queen Caroline Estate, London Borough of Hammersmith and Fulham.** Blue bars represent the times when stormwater was pumped into the swale, the red line represents the readings of a pressure sensor buried beneath the swale to monitor pooling water.

- i) Input of the first 1,000 L of storm water was not detected by the pressure sensor. This was presumably because the pressure sensor is offset to the side of centre of the swale (next to the westernmost downpipe) and it took till the second 1000 L input for the water to reach the pressure sensor.
- ii) Despite the weather preceding the stimulation being wet (including the morning of the simulation) and temperatures being cool and thus evaporation rates being low, evidence of infiltration was recorded between each 1000 L stormwater input.
- iii) Water pooling observed during the test was more obvious than during the previous summer testing.

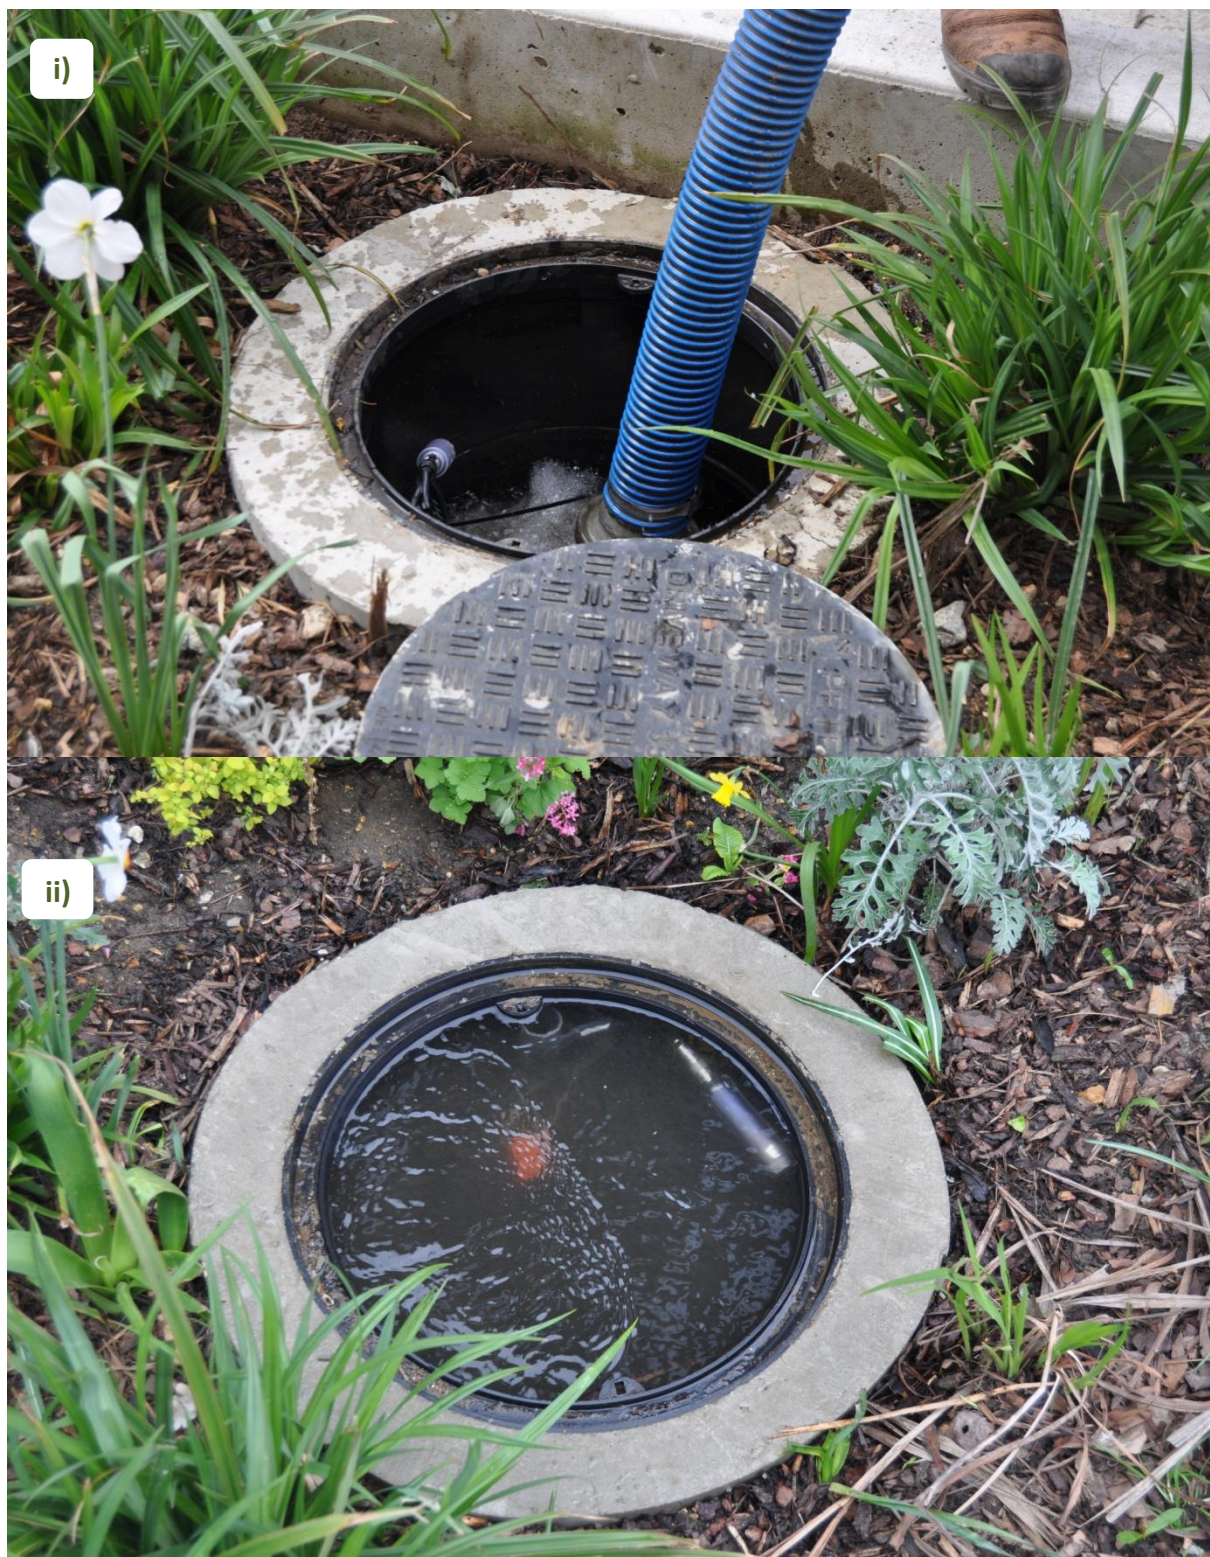
**Figure 71. Images from the storm simulation event at the Sun Road rain gardens, Cheeseman Terrace Estate, 24th March 2017. Images show i) water being pumped into the inspection chamber of the rain garden; ii) inlet chamber full after the stormwater was pumped in.**

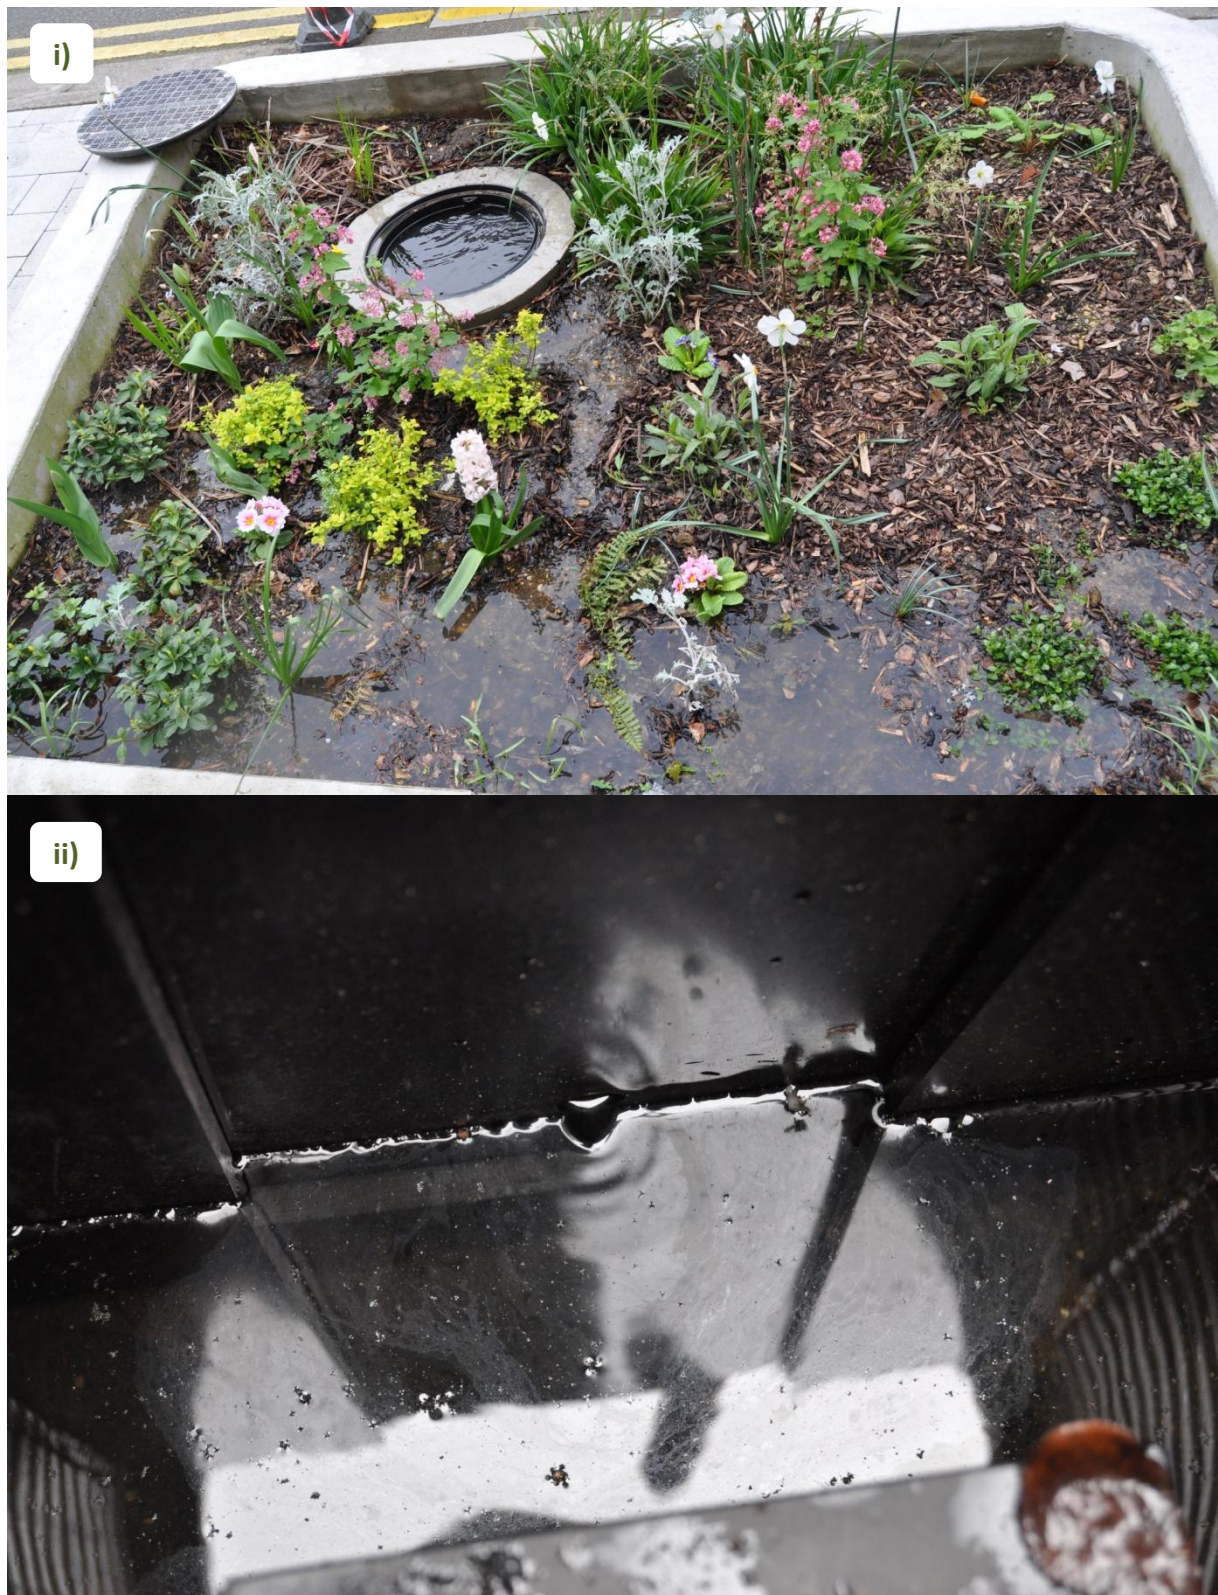
**Figure 72. Images from the storm simulation event at the Sun Road rain gardens, Cheeseman Terrace Estate, 24th March 2017. Images show i) the rain garden inspection chamber overflowing onto the rain garden during the rain simulation and ii) the control flow chamber releasing water from the rain gardens following the 1 in 5 year storm event simulation.**

- After approximately 5000 L of stormwater input, the control flow chamber began to fill and a controlled flow rate was released into the combined sewer system. The water level in the control flow chamber did not rise to a level whereby it came close to over-topping the weir. However stormwater was observed backing up through the road-under drains.

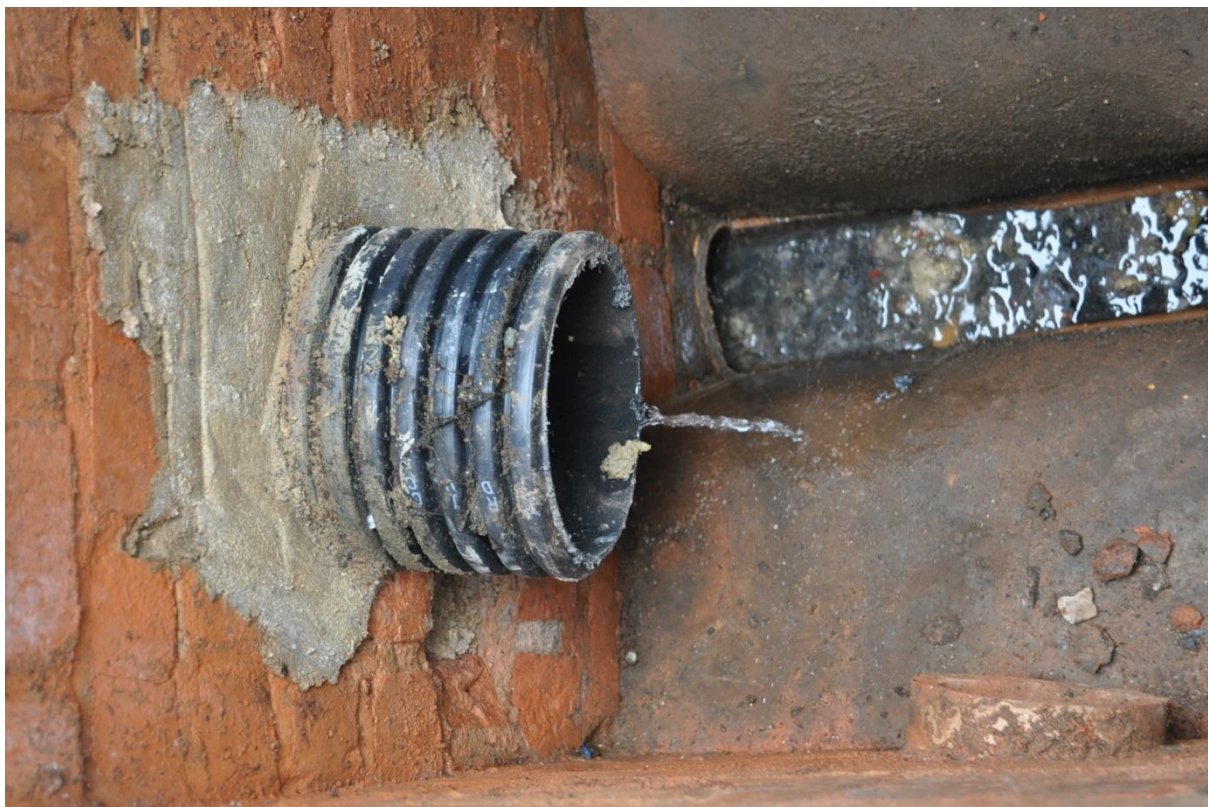
**Figure 73. Image from the storm simulation event at the Sun Road rain gardens, Cheeseman Terrace Estate, 27th March 2017.** Image shows the stormwater that was released from the rain garden overflow being released to the combined sewer system during the final 1000 L release of the stormwater simulation test.

Using visual monitoring of the rain gardens during the storm simulation event, it was possible to confirm that the Cheeseman Terrace rain gardens were not able to retain all of the 6,000 Litres of stormwater that was pumped into the inspection chambers. Whilst this was not necessarily a surprise, as the rain garden was designed to cope with a 1 in 2 event, it did not mirror the results from summer test where all of the storm event was retained. This indicated a difference in performance between the summer and winter periods, presumably linked to the substrate within and beneath the rain gardens being more saturated during the winter rain event. This exceedance of capacity was evidenced with the photographs taken during the simulation. This included a filling and overflowing of water within the inspection chambers, water being released through the overflow chamber and water entering the storm sewer system. Water was also observed backing up through the under-road drainage channels and overflowing from the roadside storm drains. This indicated that the rate stormwater was introduced exceeded the ability of the rain garden system to convey water to the overflow chamber. This may, however, have been the result of the method of introducing the water to the rain garden through rapid bursts, rather than evenly throughout the hour period. Nevertheless, the water level in the inspection chambers

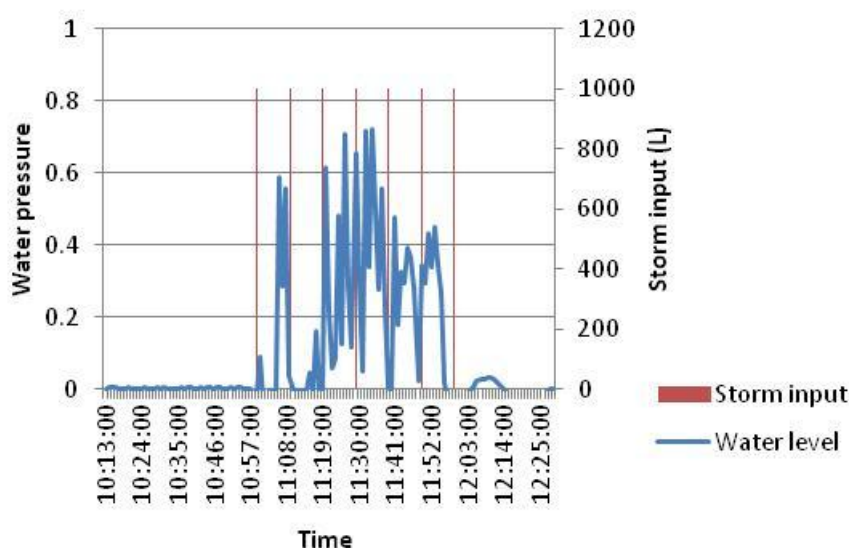
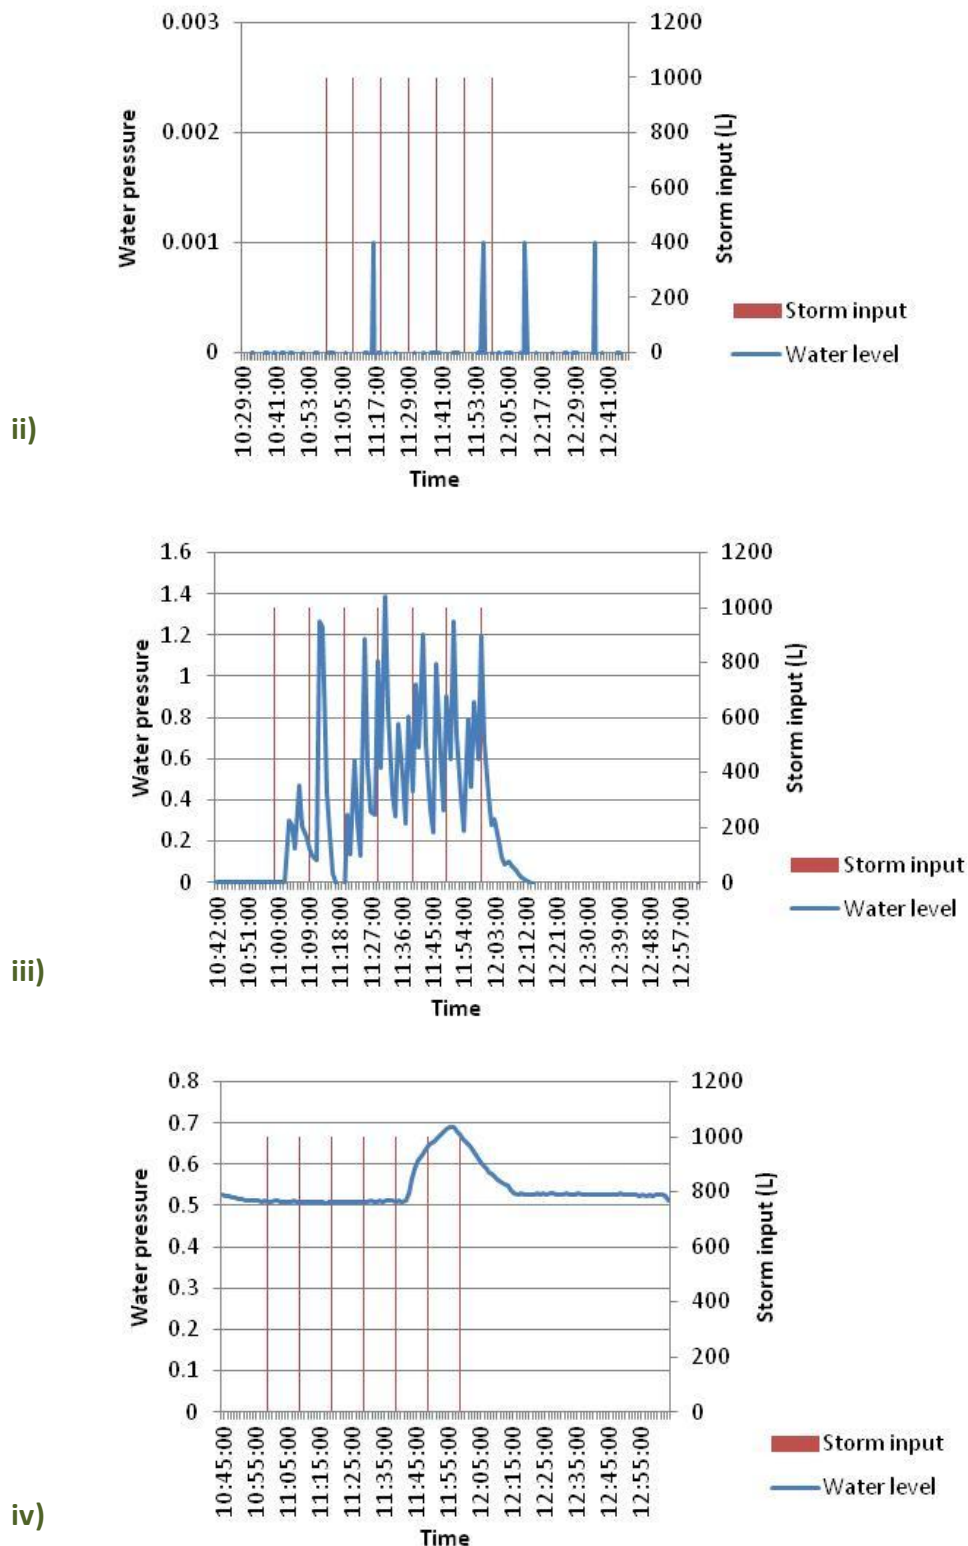
Figure 74 represents the pressure sensor data from the series of pressure loggers situated throughout the rain garden complex at Sun Road, Cheeseman Terrace. The southernmost (PS2) and northern most gauges (PS4) were situated in the drainage pipes at the bottom of the inspection chambers immediately within the rain gardens where the road runoff gullies enter the base of the rain gardens. The middle gauge (PS3) was buried in the substrate of the rain garden between the other two rain gardens. The outlet gauge (PS5) was situated before the weir in the controlled outflow chamber that links the rain garden drainage pipes to the combined sewer system. The data provides a comprehensive representation of the performance of the rain gardens during the 1 in 5 year 1 hour summer storm event on the swale.

**Figure 74. Pressure sensor data from the storm event at Sun Road Rain Gardens, 24th March 2017.** A 1 in 5 year 1 hour storm event simulated to assess rain garden performance. The graphs represent i) a pressure sensor in the drainage channel at the base of the southernmost rain garden (FS2); ii) a pressure sensor in the substrate of the middle rain garden (FS3); iii) a pressure sensor in the drainage channel at the base of the northernmost rain garden (FS4); iv) a pressure sensor in the weir in the controlled outflow chamber that links the rain garden drainage pipes to the combined sewer system (FS5).

- Despite the significant volumes of stormwater introduced via the inspection chamber, there was evidence of infiltration from the rain garden between each stormwater release with levels recorded by pressure sensors PS2, PS3 and PS4 dropping between inputs of stormwater.

- Fifteen minutes after the final 1000 L (of the total 6000 L) was released into the rain garden, infiltration had occurred to such an extent that no further release was recorded at the control flow chamber. This observed result was supported by data from pressure sensor PS5 in the control flow chamber which returned to the pre-testing baseline level within 20 minutes of reaching the peak pressure value (Figure 74).

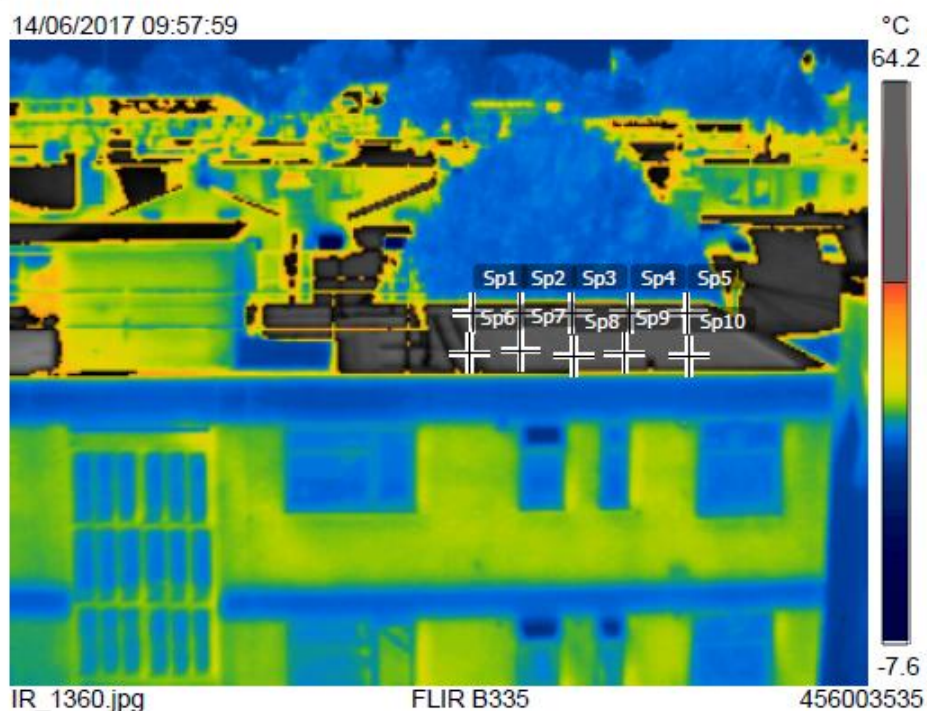
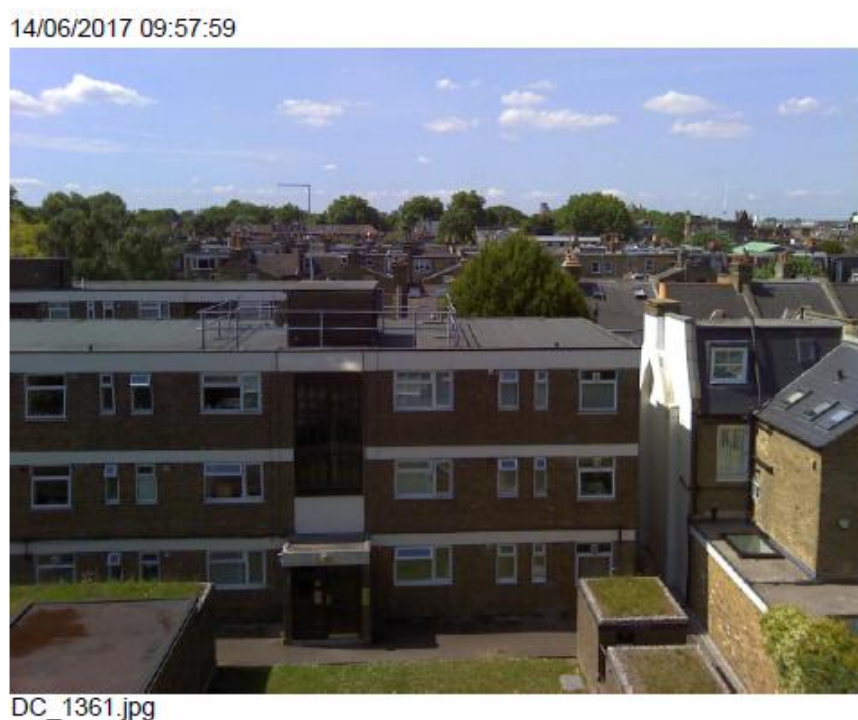
**Figure 75. Photo and infrared image of the control roof and surrounding grey infrastructure at Richard Knight House on the 14th June 2017.** FLIR tools software was used to identify temperatures at selected points within the field of view. The hottest temperatures (>45 °C) were associated with the control roof and other surrounding roofs. These areas were recorded as being substantially hotter than the maximum daily temperature recorded by the nearby weather station (26.3 °C).

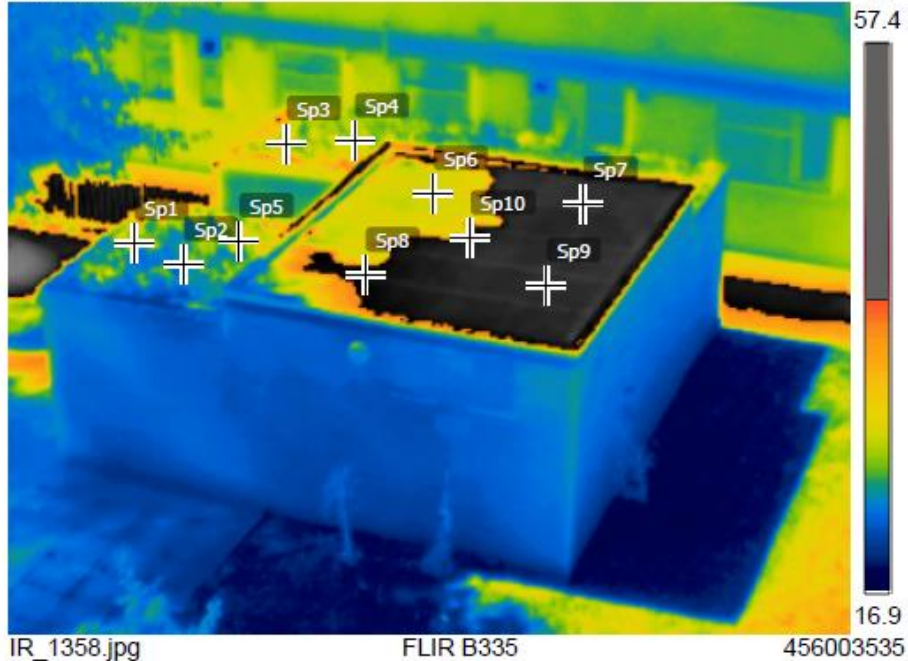
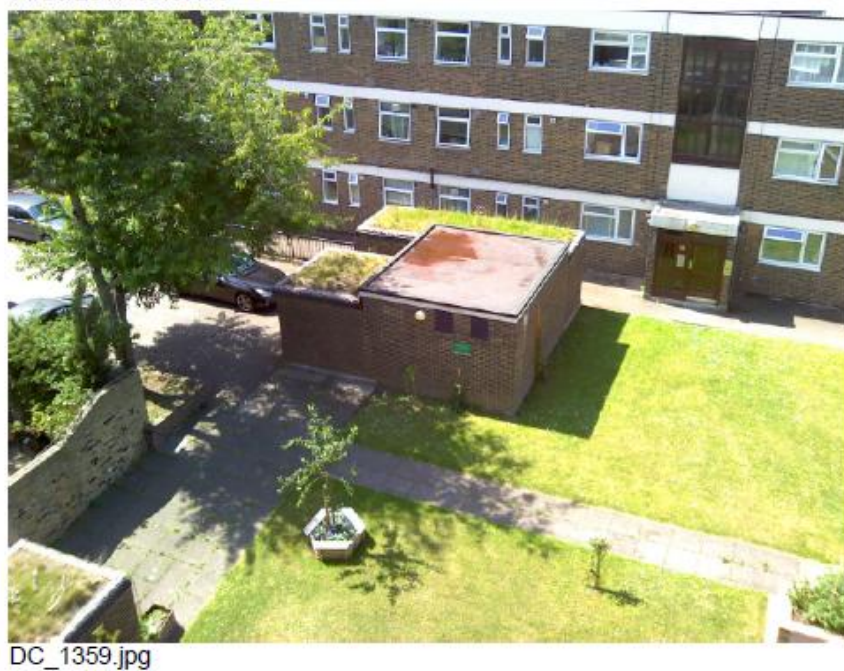
**Figure 76. Photo and infrared image of standard pramshed and green roofs at Richard Knight House on the 14th June 2017.** FLIR tools software was used to identify temperatures at selected points within the field of view. The hottest temperatures ( $>40\text{ }^{\circ}\text{C}$ ) were associated with the pramshed roof. These areas were recorded as being substantially hotter than the maximum daily temperature recorded by the nearby weather station ( $26.3\text{ }^{\circ}\text{C}$ ). Temperatures on the pramshed green roofs were substantially lower at  $<30\text{ }^{\circ}\text{C}$ . These temperatures were either lower or similar to the temperature of pooled water on the standard pramshed roof ( $29.8\text{ }^{\circ}\text{C}$ ).

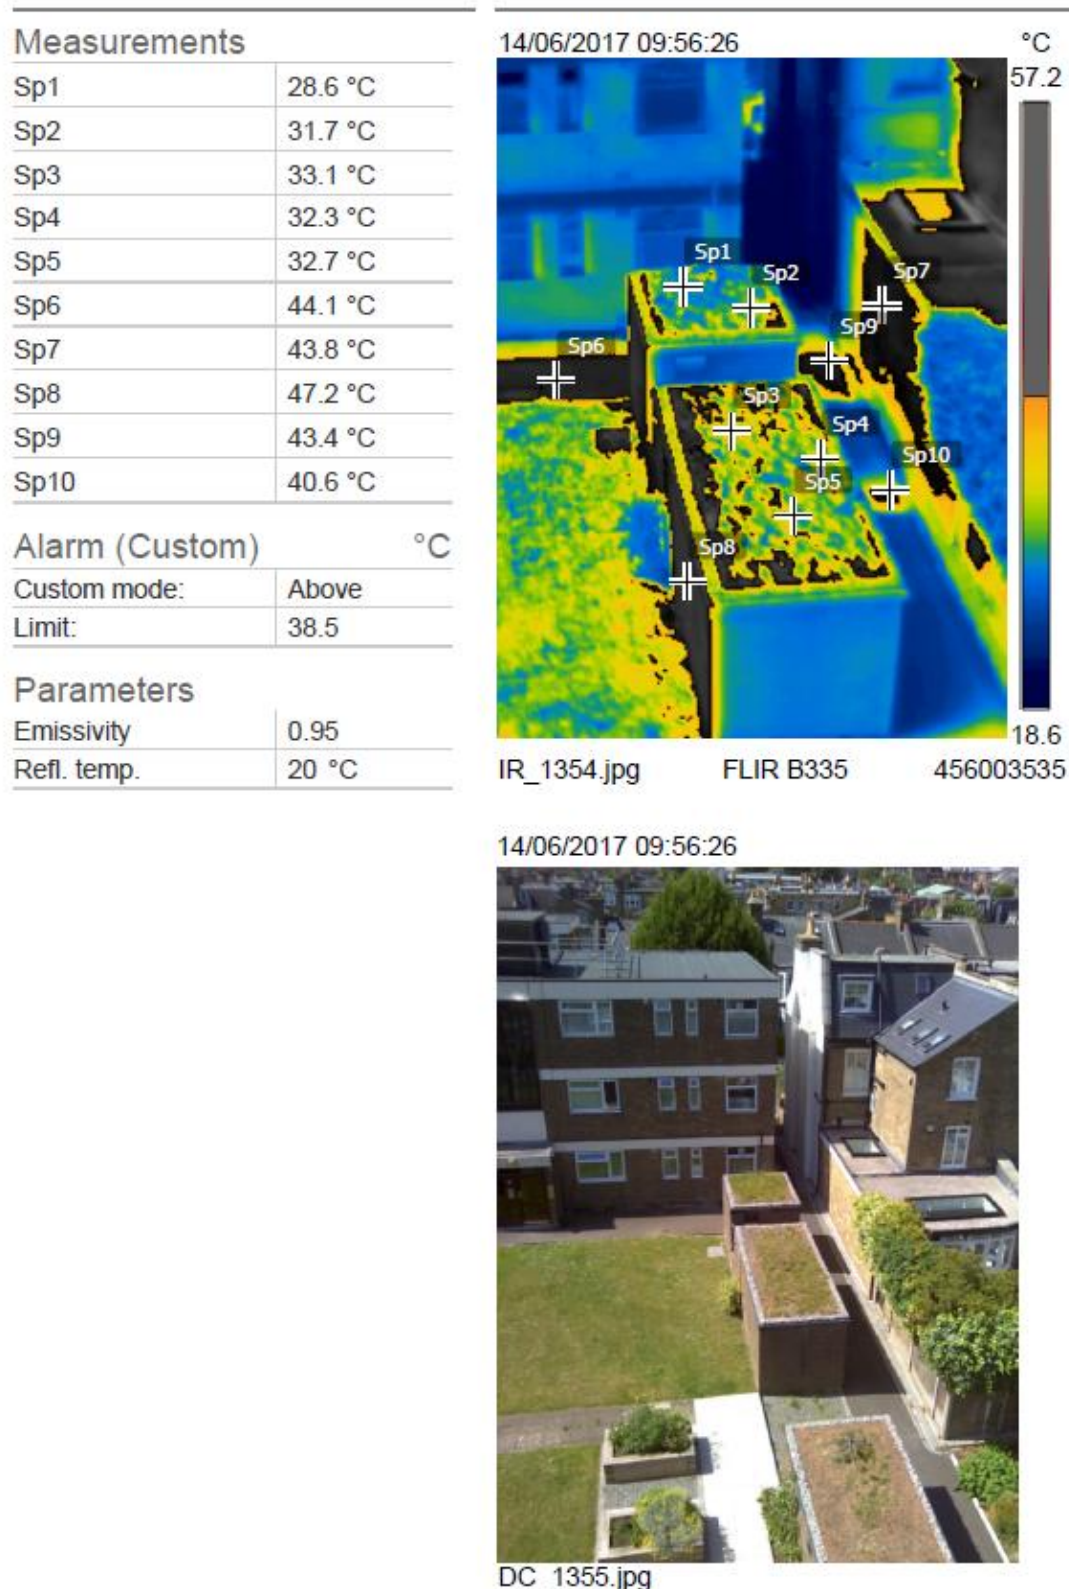
**Figure 77. Photo and infrared image of pramshed green roofs at Richard Knight House on the 14th June 2017.** FLIR tools software was used to identify temperatures at selected points within the field of view. The hottest temperatures (>40 °C) were associated with the surrounding grey infrastructure. These areas were recorded as being substantially hotter than the maximum daily temperature recorded by the nearby weather station (26.3 °C). Temperatures on the pramshed green roofs were lower at <35°C.

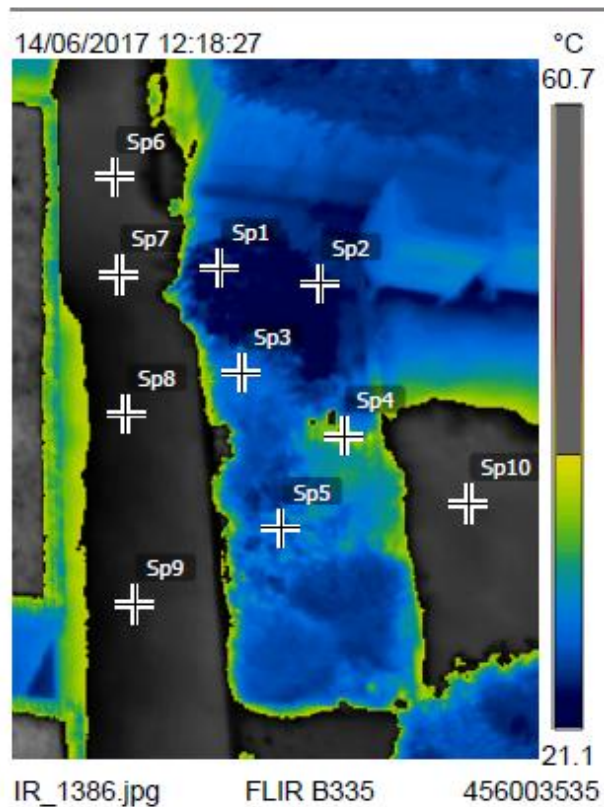
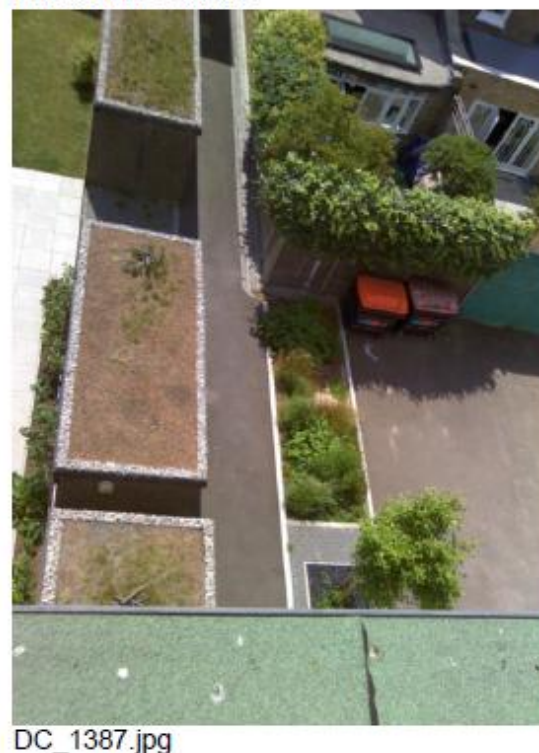
**Figure 78. Photo and infrared image of Richard Knight House rain garden and surrounding grey infrastructure on the 14th June 2017.** FLIR tools software was used to identify temperatures at selected points within the field of view. The hottest temperatures ( $>45^{\circ}\text{C}$ ) were associated with the surrounding grey infrastructure. These areas were recorded as being substantially hotter than the maximum daily temperature recorded by the nearby weather station ( $26.3^{\circ}\text{C}$ ). Temperatures on the green roofs were lower by at least 6 degrees with all temperatures  $<36^{\circ}\text{C}$ .

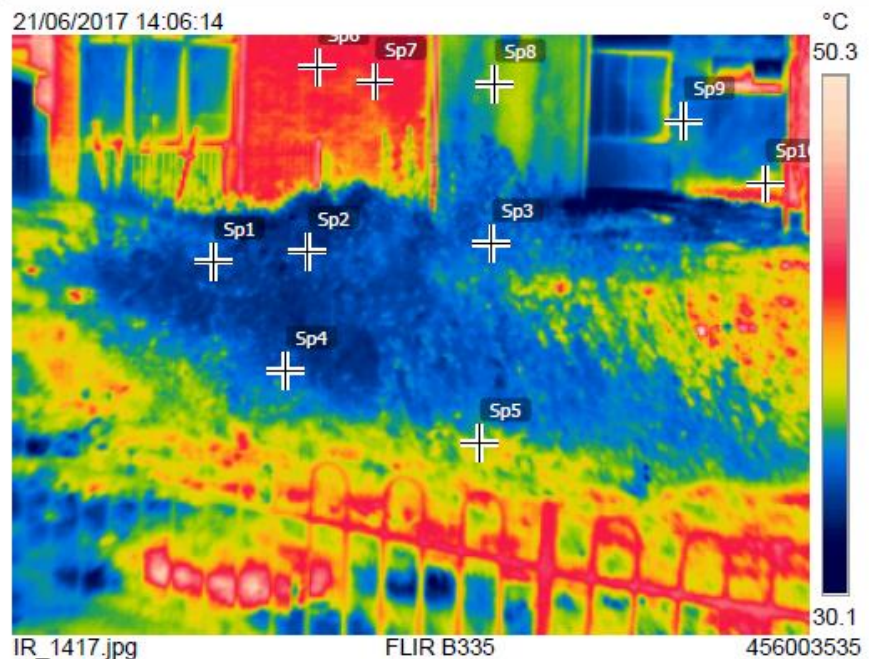
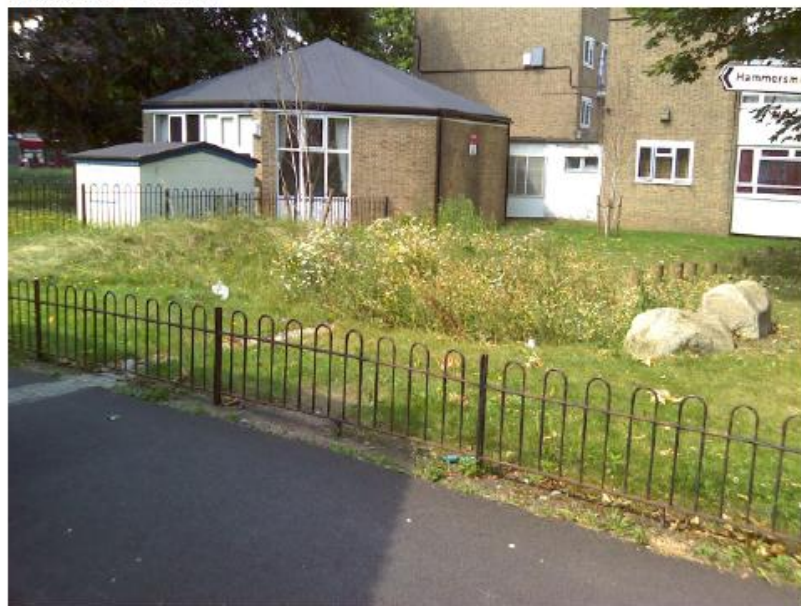
**Figure 82. Photo and infrared image of a well-established detention basin at Queen Caroline Estate and surrounding grey infrastructure on the 21st June 2017.** FLIR tools software was used to identify temperatures at selected points within the field of view. The hottest temperatures were associated with the surrounding walls and hard surfaces. All areas were recorded as being substantially hotter than the maximum daily temperature recorded by the nearby weather station (34.1 °C). However temperatures observed in the vegetated areas were cooler with all temperatures around 37°C or less. The coolest areas were observed in the well-established vegetation (sp 2 at 34.4°C).

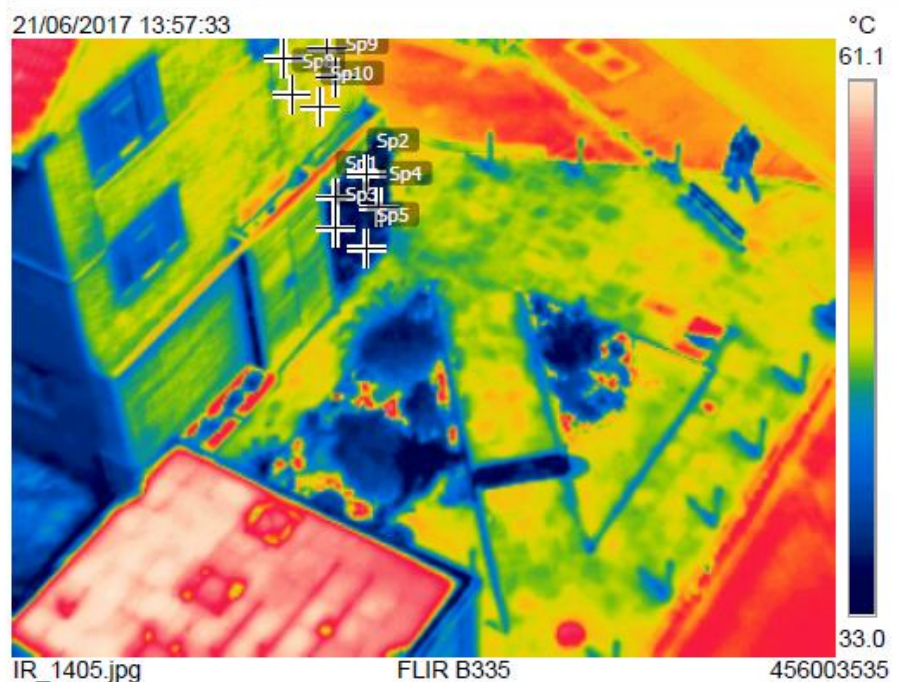
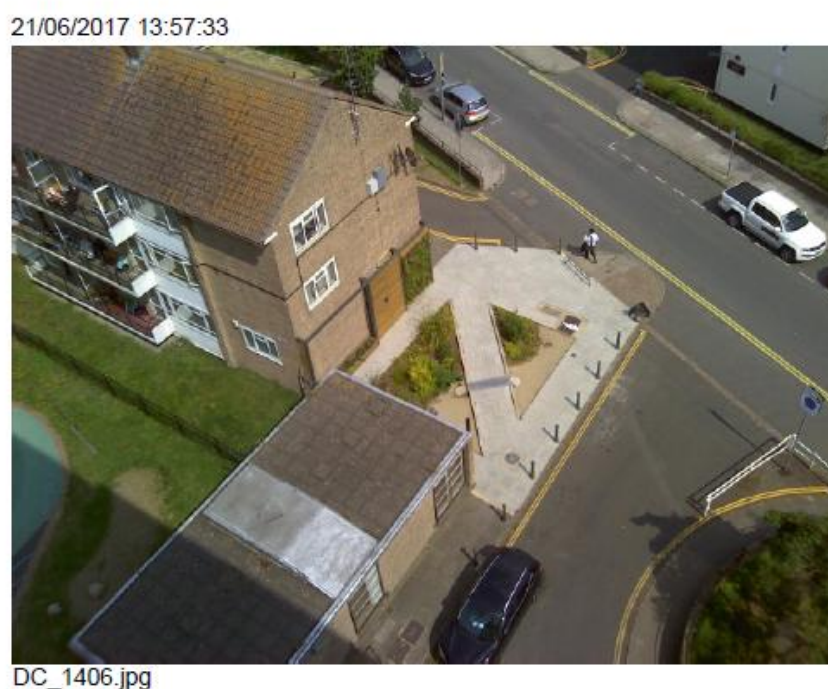
**Figure 84. Photo and infrared image of the vertical rain garden at Queen Caroline Estate and surrounding grey infrastructure on the 21st June 2017.** FLIR tools software was used to identify temperatures at selected points within the field of view. The hottest temperatures ( $>45\text{ }^{\circ}\text{C}$ ) were associated with the surrounding hard surfaces (including walls, roads and paving). These areas were recorded as being substantially hotter than the maximum daily temperature recorded by the nearby weather station ( $34.1\text{ }^{\circ}\text{C}$ ). Temperatures observed in the newly installed vertical rain garden were lower with all temperatures  $<38^{\circ}\text{C}$ . The coolest areas were observed in the planted green wall area (sp 3 at  $34.9^{\circ}\text{C}$ ).

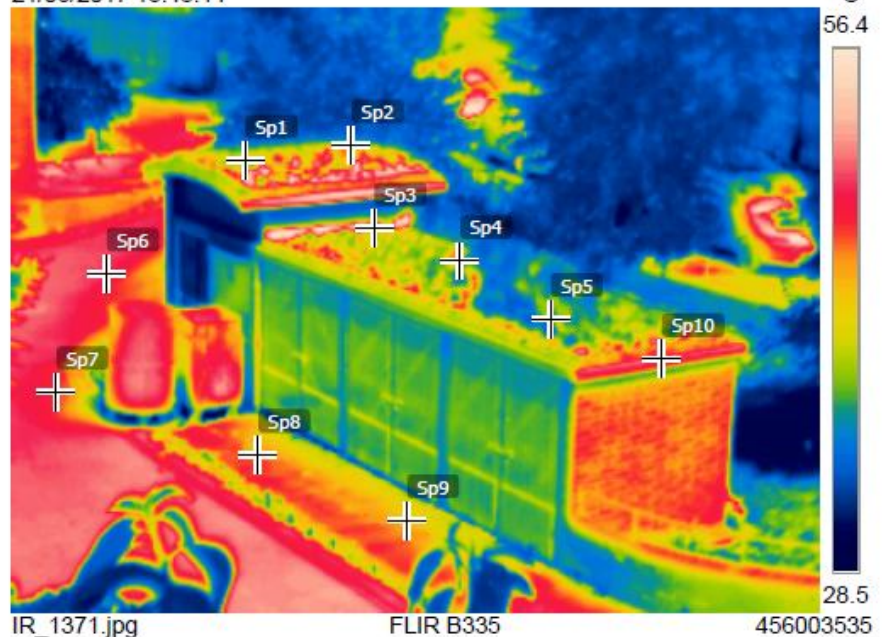
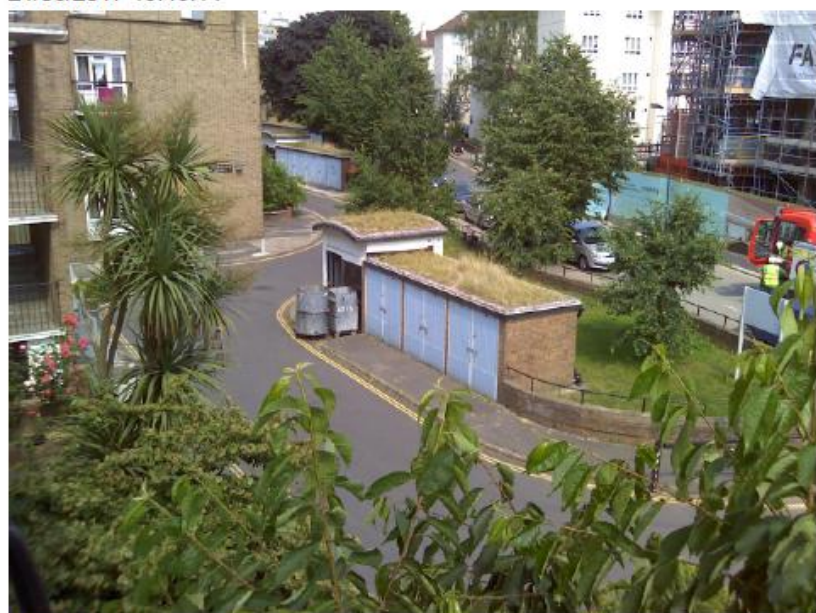
**Figure 85. Photo and infrared image of one of the pram shed green roofs at Queen Caroline Estate (Alexandra house) and surrounding grey infrastructure on the 21st June 2017.** FLIR tools software was used to identify temperatures at selected points within the field of view. The hottest temperatures ( $>45^{\circ}\text{C}$ ) were associated with the surrounding hard surfaces (including walls, roads and paving). These areas were recorded as being substantially hotter than the maximum daily temperature recorded by the nearby weather station ( $34.1^{\circ}\text{C}$ ). Temperatures observed in the newly installed vertical rain garden were lower with all temperatures  $<42^{\circ}\text{C}$ . The coolest areas observed were on the green wall (sp 5 at  $37.6^{\circ}\text{C}$ ).
