**Climate Proofing Housing Landscapes:  
Monitoring Report 3**

**October 2016 to September 2017**

**Authors: Connop, S., Clough, J., Alam, R. and Nash, C.**

H&F Council and Groundwork London worked with local residents to design and implement climate change adaptation measures on three housing estates in the borough, making them more resilient and adapted for the future.

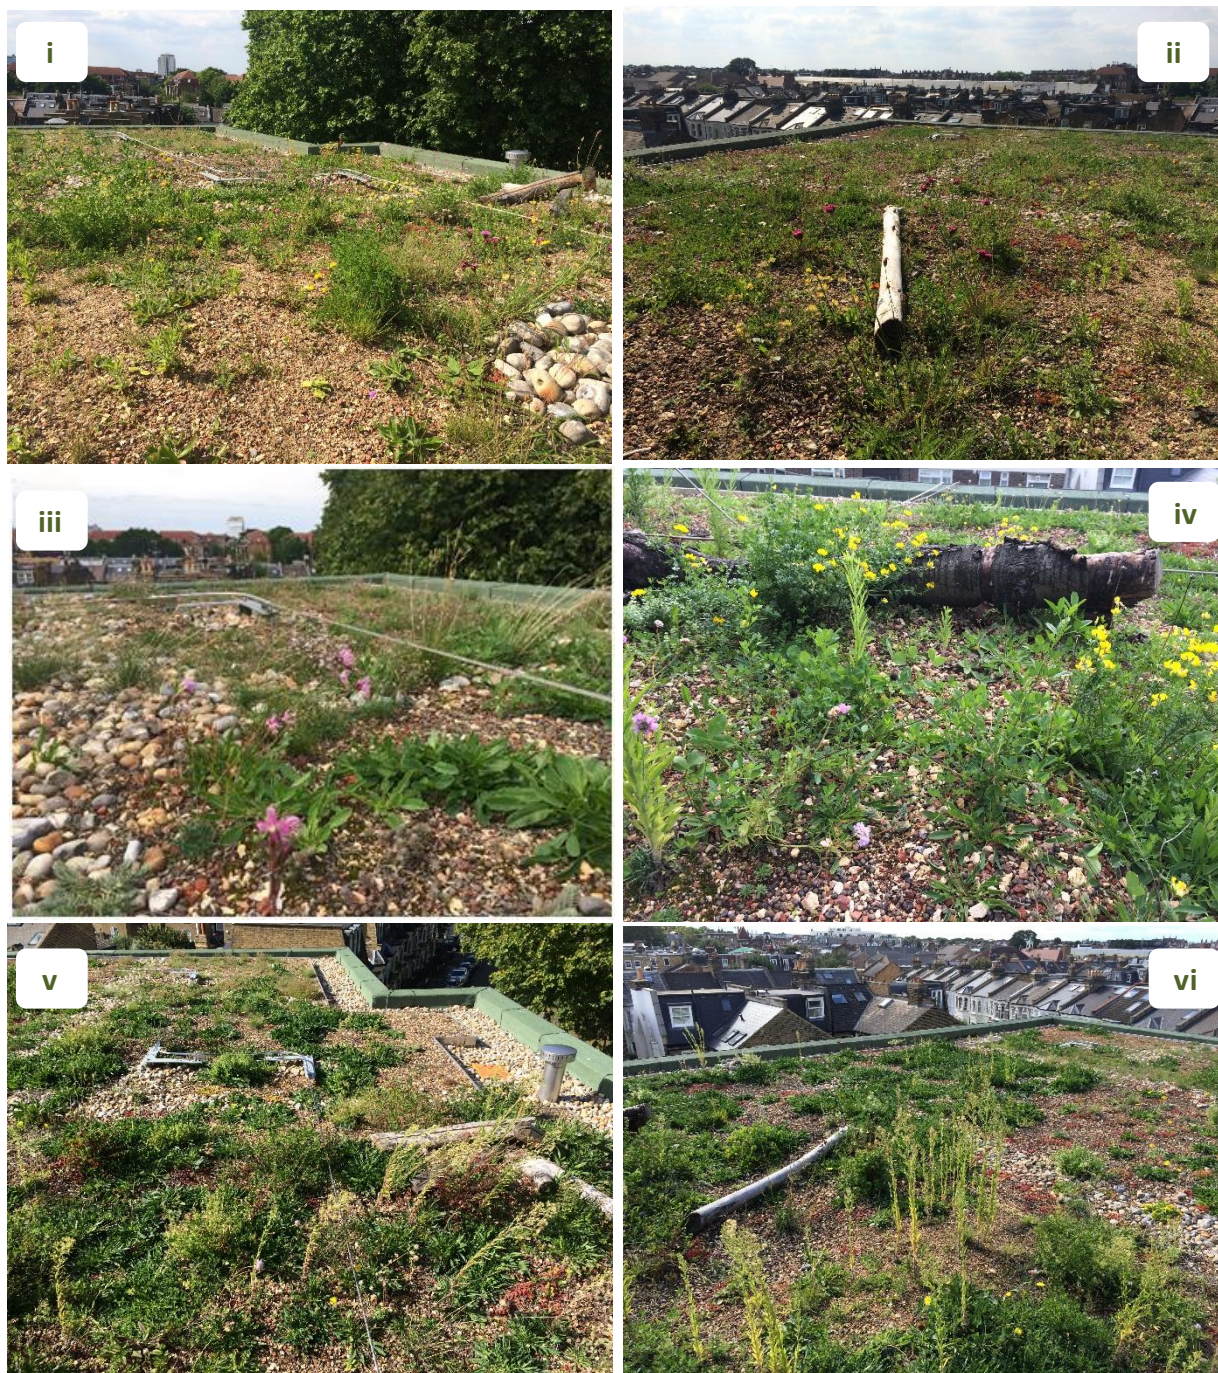
**Figure 110. Images of vegetation development on Richard Knight House green roof, summer 2017.** Images represent: i) 14th June 2017 view of west-facing side of roof looking north; ii) 14th June 2017 view of west-facing side of roof looking south; iii) 11th August 2017 view of west-facing side of roof looking north; iv) 11th August 2017 view of west-facing side of roof looking south; v) 14th September 2017 view of west-facing side of roof looking north; vi) 14th September 2017 view of west-facing side of roof looking south.

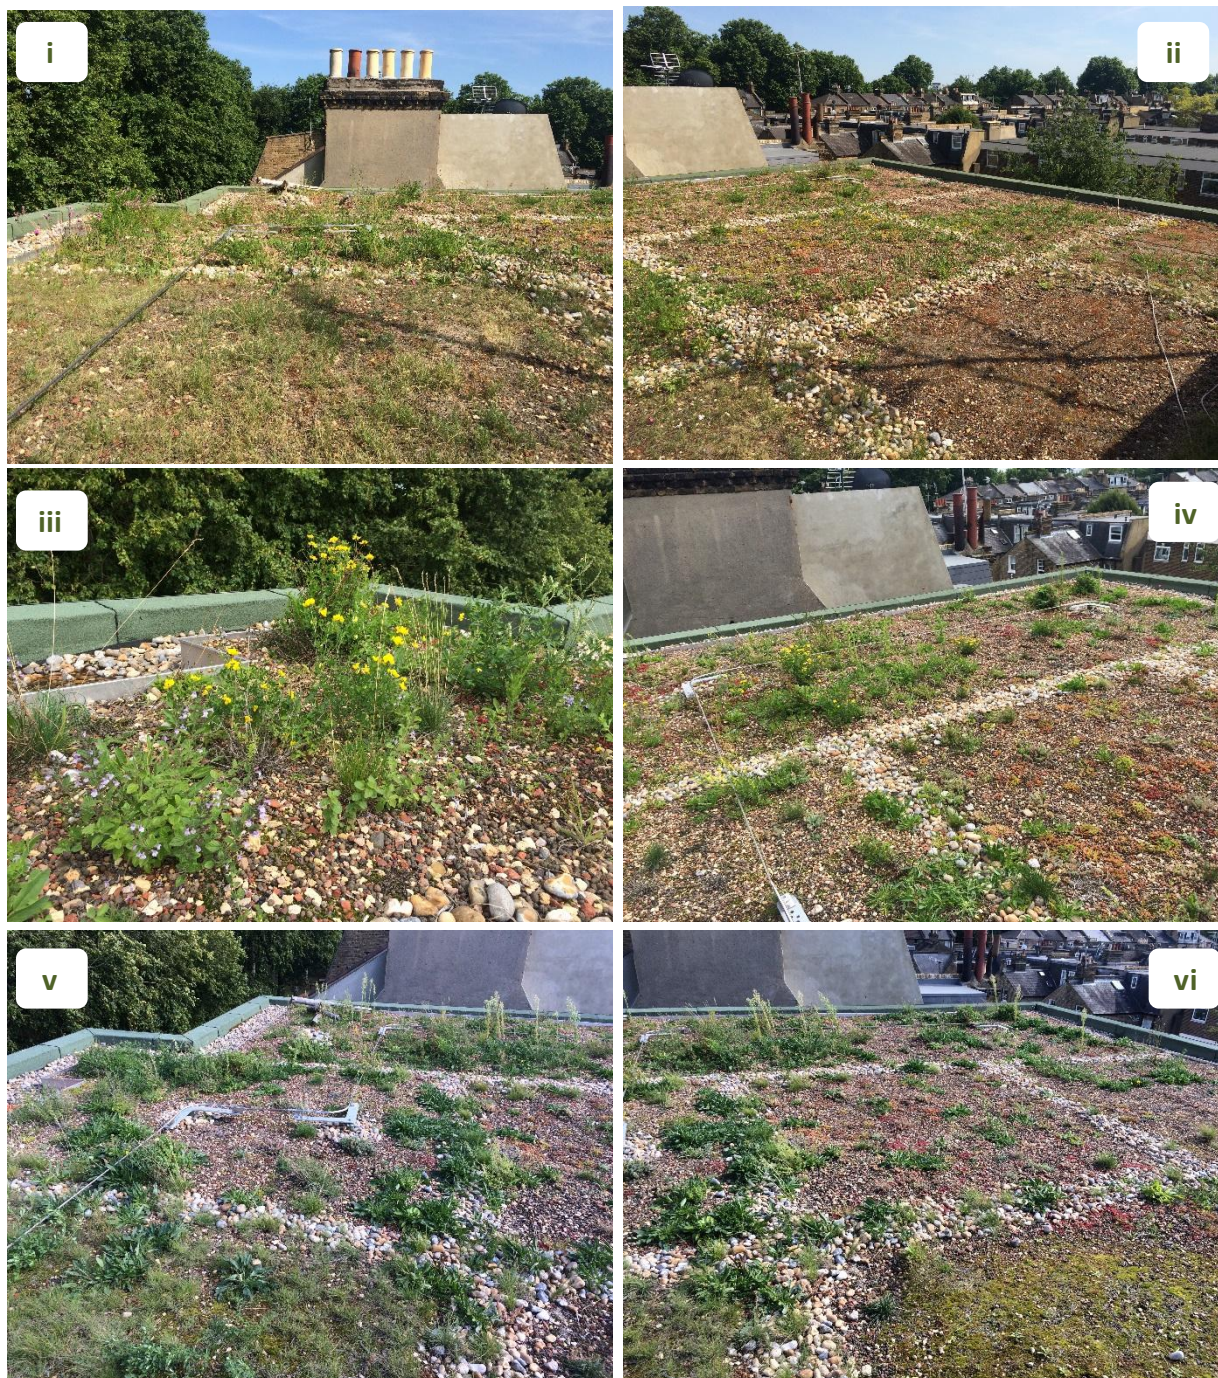
**Figure 111. Images of vegetation development on Richard Knight House green roof, summer 2017.** Images represent: i) 14th June 2017 view of east-facing side of roof looking north; ii) 14th June 2017 view of east-facing side of roof looking south; iii) 11th August 2017 view of east-facing side of roof looking north; iv) 11th August 2017 view of east-facing side of roof looking south; v) 14th September 2017 view of east-facing side of roof looking north; vi) 14th September 2017 view of east-facing side of roof looking south.

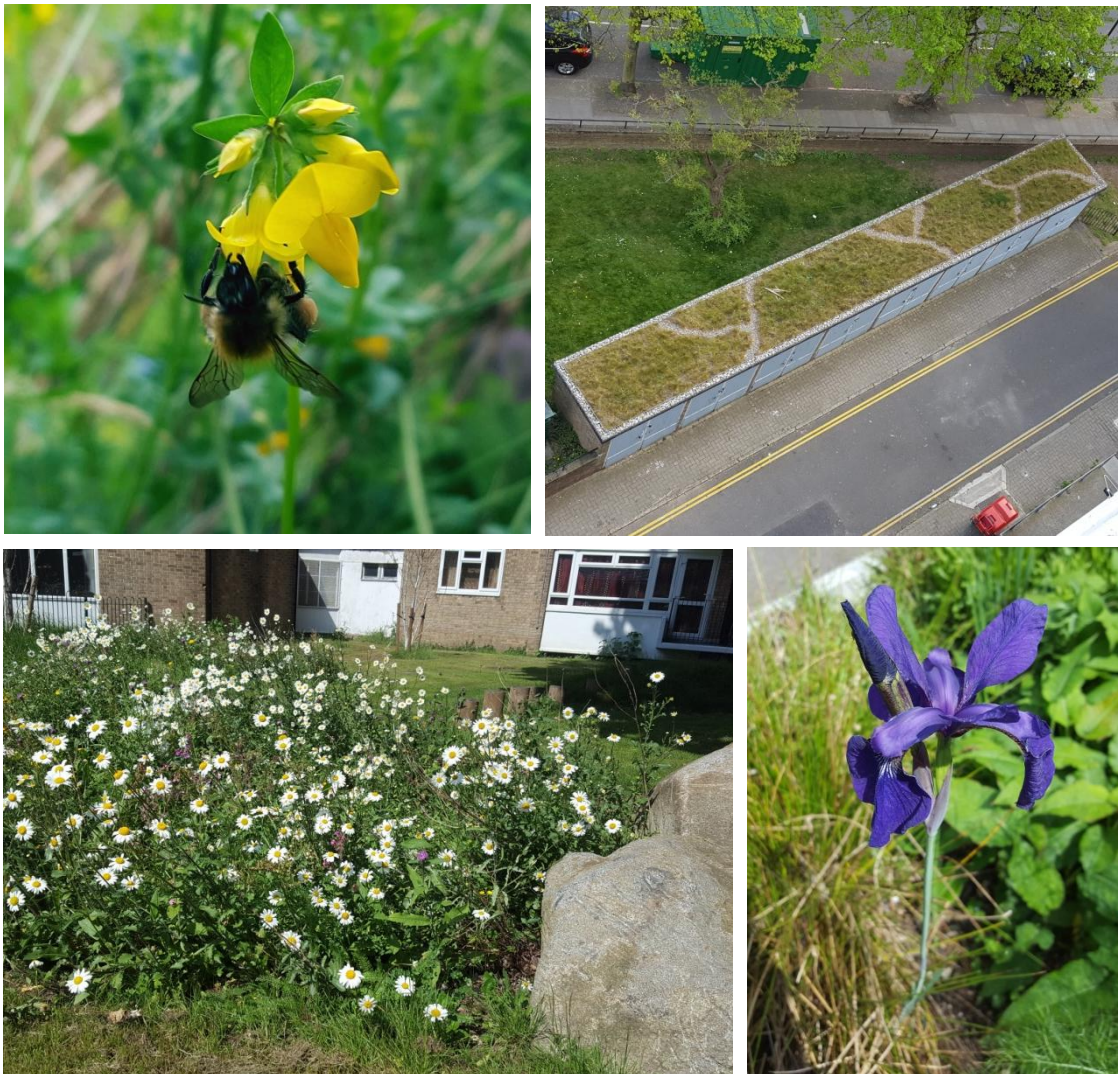
**Figure 112.** Images from green infrastructure retrofit project in Hammersmith. Clockwise from top left: Common carder bee (*Bombus pascuorum*) on birdsfoot trefoil in a swale at Queen Caroline Estate; Pram shed green roof from above showing gravel drainage channels at Queen Caroline Estate; Iris in flower in the Richard Knight House rain garden; and Ox-eye daisies in flower in a SuDS basin at Queen Caroline Estate.

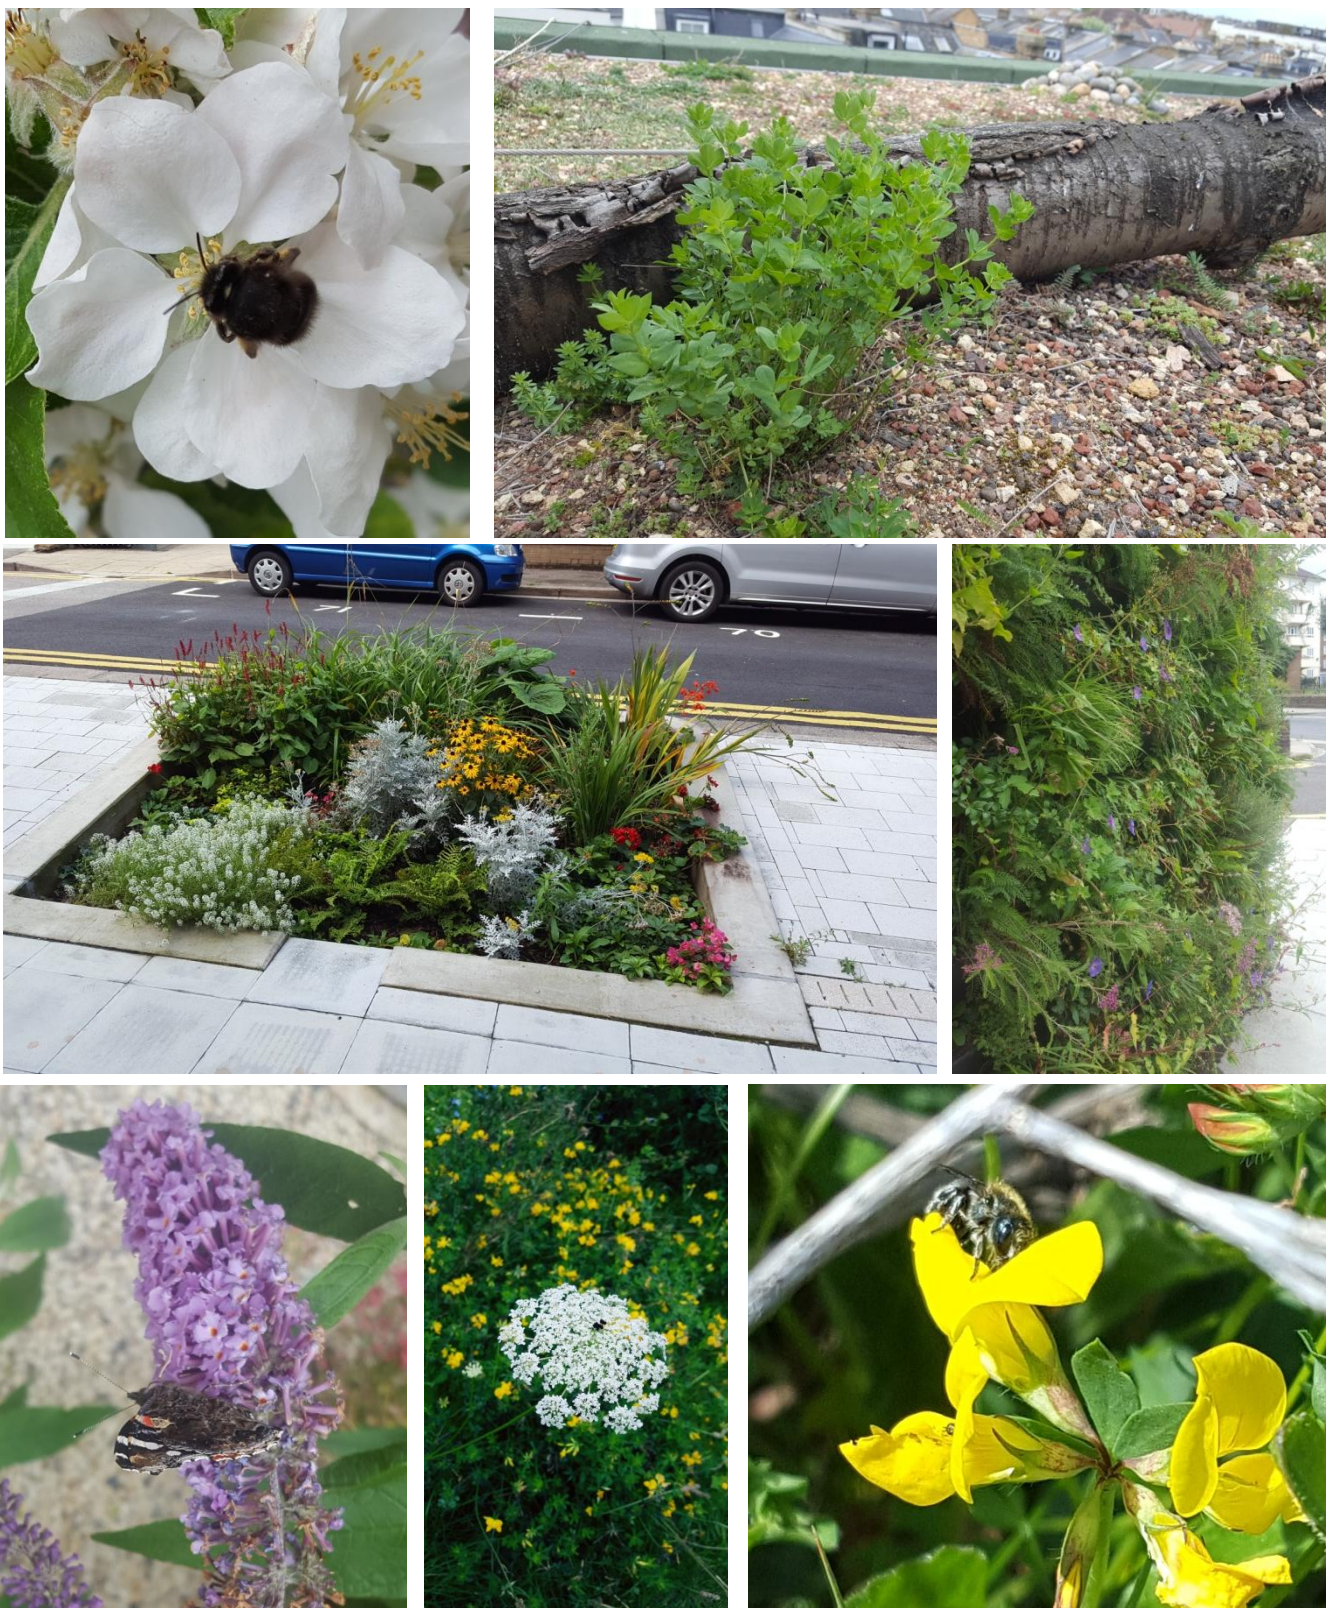
**Figure 113. Images from green infrastructure retrofit project in Hammersmith.** Clockwise from top left: Hairy-footed flower bee (*Anthophora flumipes*) foraging on apple blossom at Richard Knight House; Birdsfoot trefoil growing next to deadwood log on Richard Knight House green roof; Vertical rain garden in full bloom at Queen Caroline Estate; Solitary bee on birdsfoot trefoil at Queen Caroline Estate; Umbellifer in bloom at Queen Caroline Estate; Red admiral butterfly on buddleia in rain garden at Queen Caroline Estate; Rain garden in full bloom at Cheeseman Terrace.

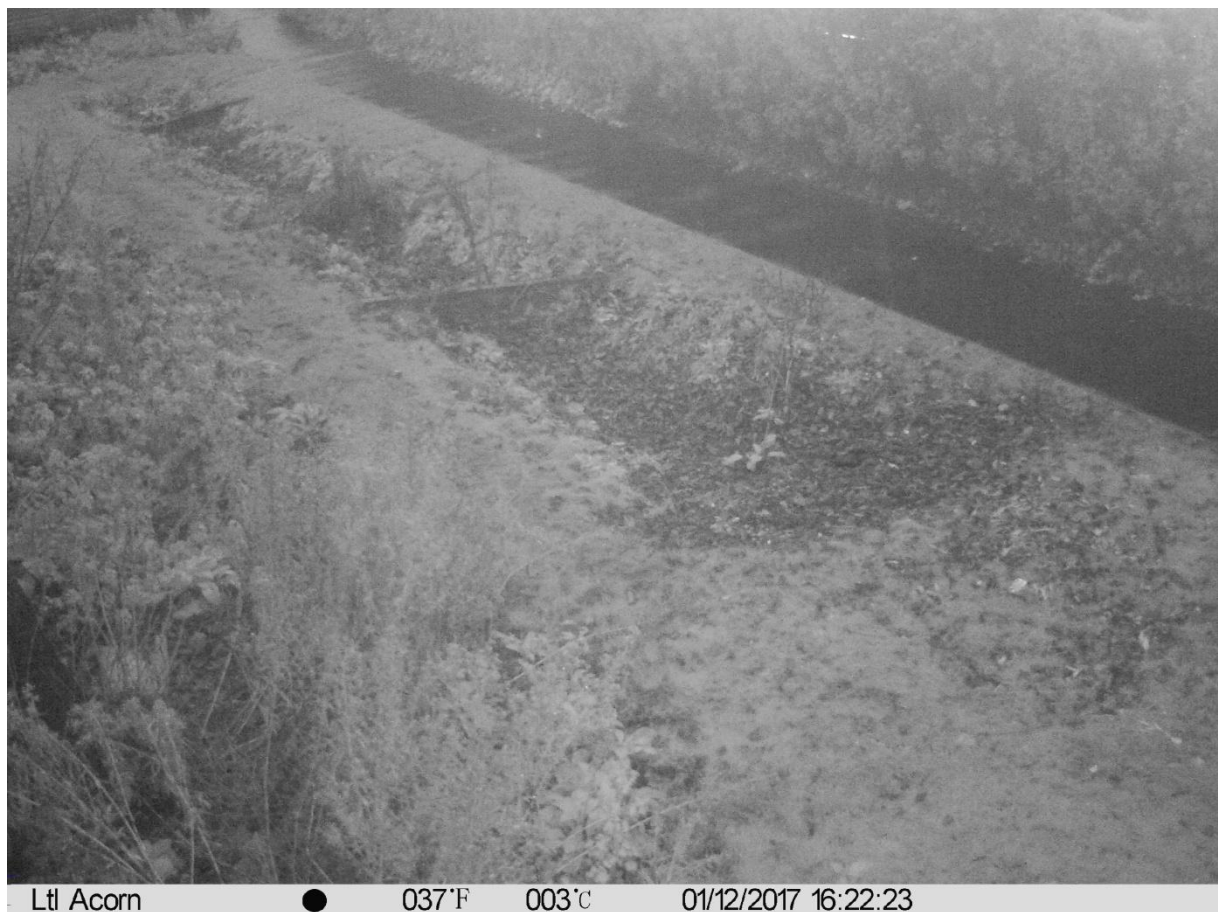
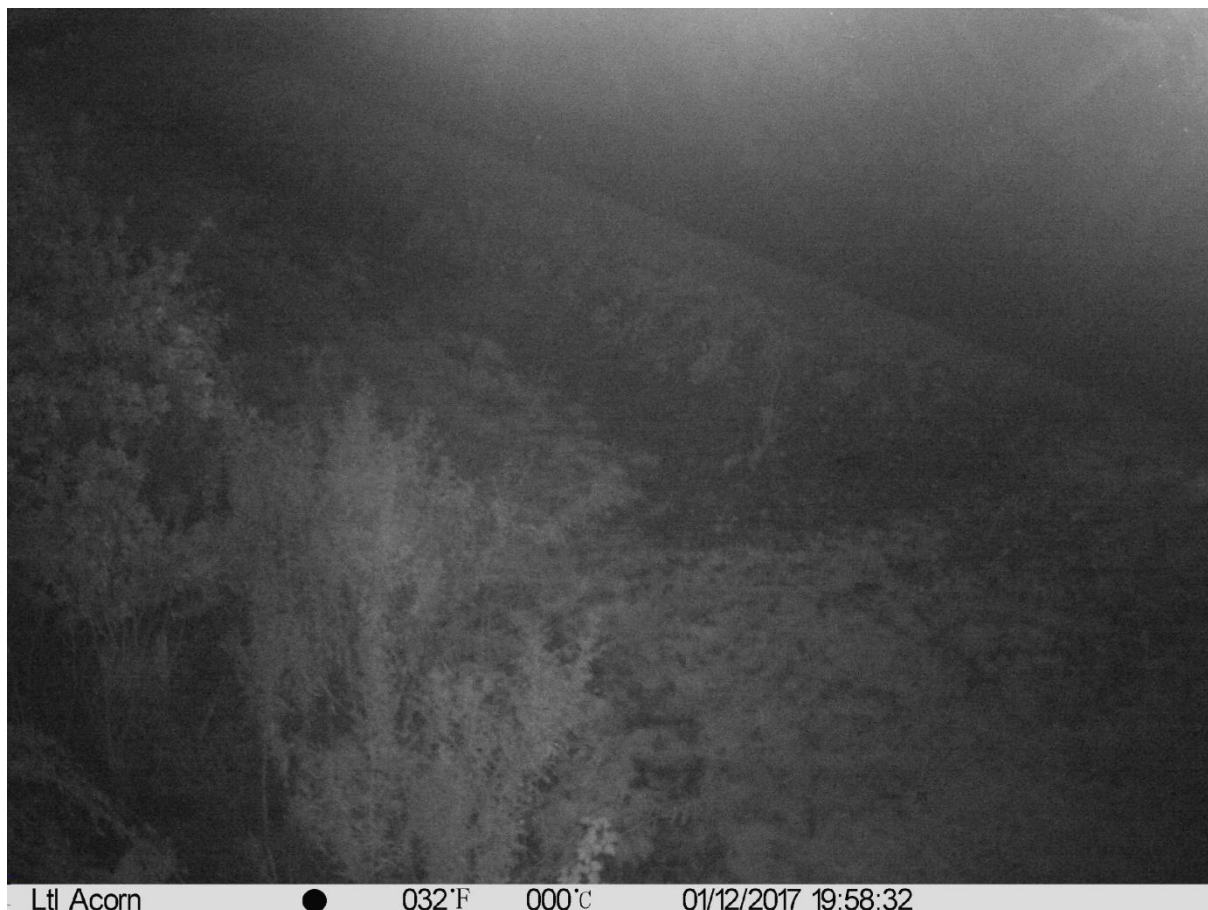
A complete collection of the images from the Alexandra House swale during the rain event from 11:30 to 20:00 on the 12th January 2017 were captured and analysed. They demonstrated that the swale was able to retain and attenuate all of the rainfall that fell directly onto the area and that which was diverted from the neighbouring roof. The images also demonstrated that at around 16:20 during the peak of the rainfall, despite substantial input from the neighbouring roof, there was no obvious standing water within or around the rain garden (Figure 117.i). By the time of the end of the rain event at 20:00, there was also no obvious pooled water (Figure 117.ii) indicating that the swale was infiltrating all of the stormwater.

**Figure 117. Time-lapse camera images from Alexandra House swale (FPC1), 12/01/2017.** Images show i) no evidence of overflowing during a period of high rain intensity at 16:22 and ii) evidence of 100% infiltration/conveyance by the end of the intense rain event at 19:58 on the same day.

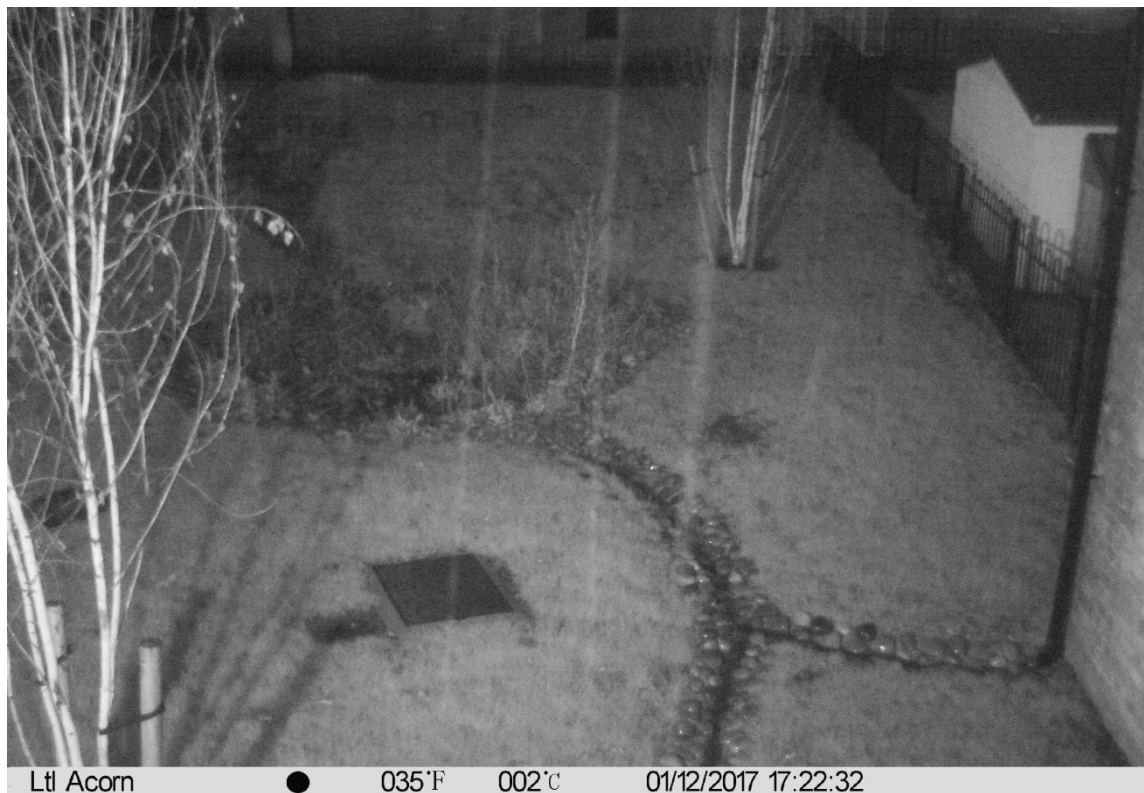
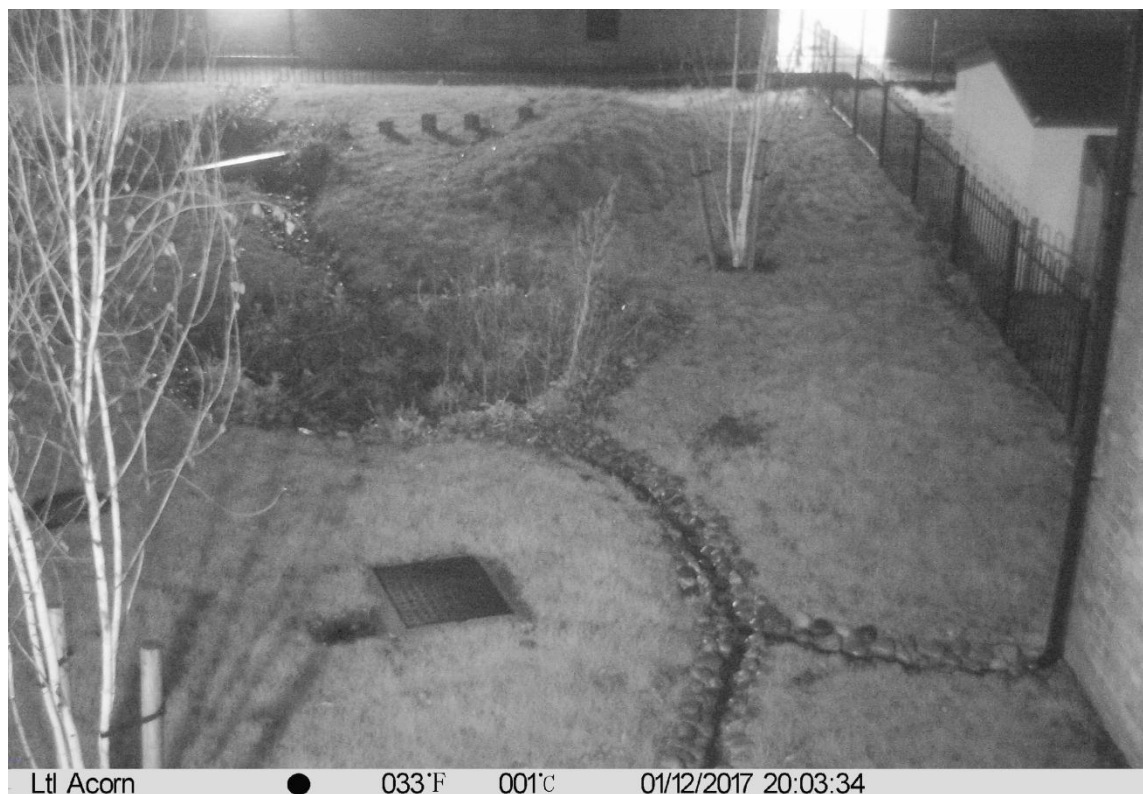
A complete collection of the images from the community hall and Sofia House basins during the rain event from 11:30 to 20:00 on the 12th January 2017 were captured and analysed. They demonstrated that the basins were able to retain and attenuate all of the rainfall that fell directly onto the area and that which was diverted from the neighbouring roofs. The images also demonstrated that at around 17:20 during the peak of the rainfall, despite substantial input from the community hall roof, there was no obvious standing water within or around the basins (Figure 118.i). Following the cessation of the event at 20:00, there was also no obvious pooled water (Figure 118.ii) indicating that the basins were infiltrating all of the stormwater.

**Figure 118. Time-lapse camera images from Community Hall and Sofia House basins (FPC2), 12/01/2017. Images show i) no evidence of overflowing during a period of high rain intensity at 17:22 and ii) evidence of 100% infiltration/conveyance by the end of the intense rain event at 20:03 on the same day.**

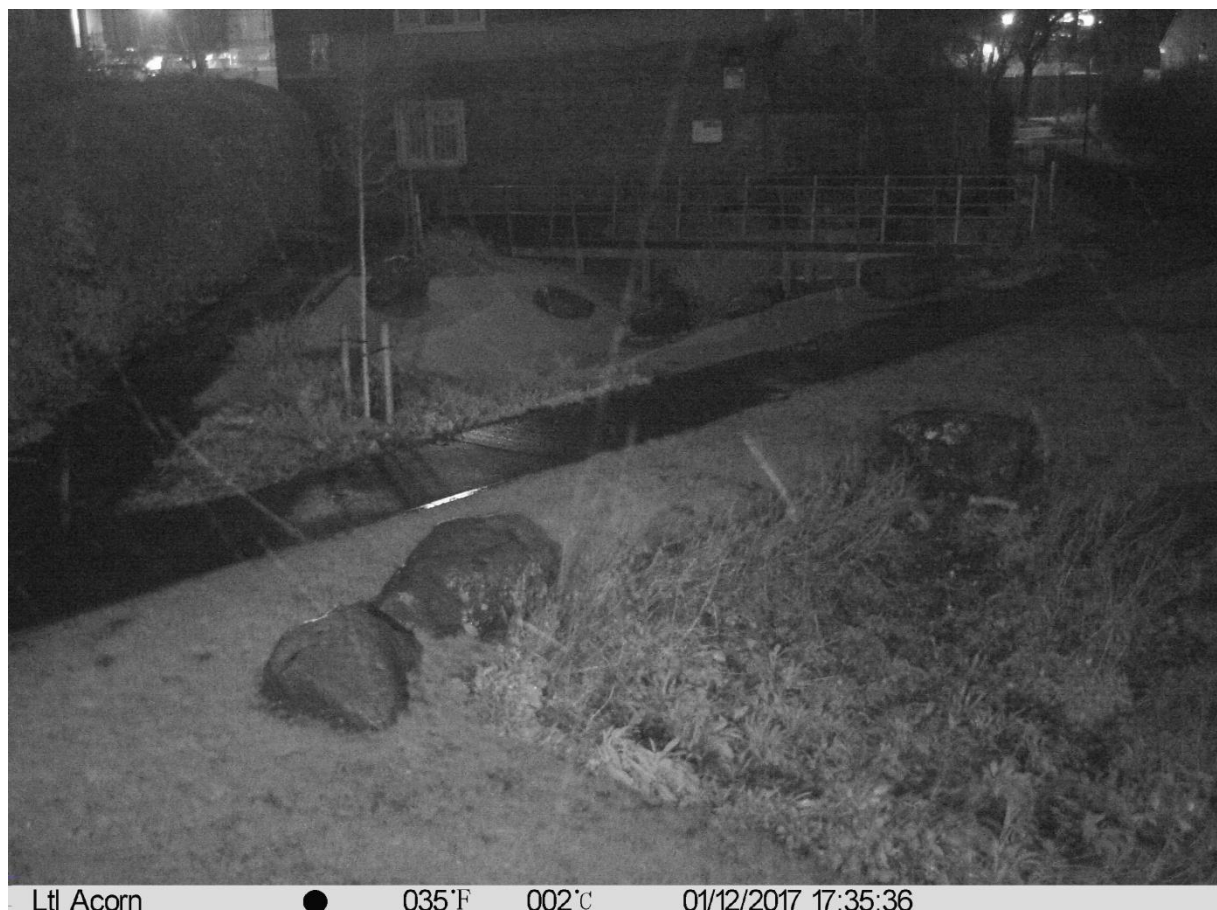
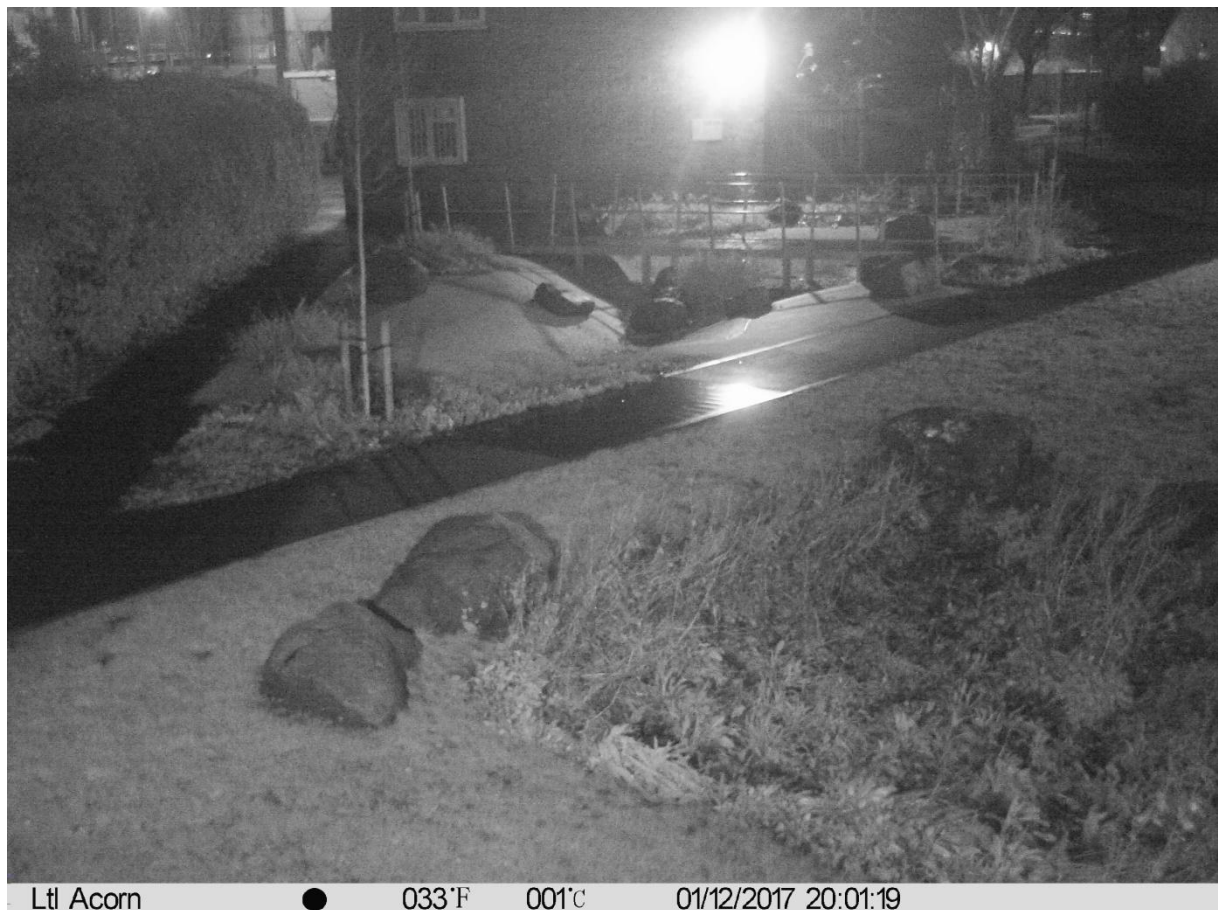
A complete collection of the images from the Adella House basins during the rain event from 11:30 to 20:00 on the 12th January 2017 were captured and analysed. They demonstrated that the basins were able to retain and attenuate all of the rainfall that fell directly onto the area and that which was diverted from the neighbouring roofs. The images also demonstrated that at around 17:35 during the peak of the rainfall, despite substantial input from the Adella House roof, there was no obvious standing water within or around the basins (Figure 119.i). Following the cessation of the event at 20:00, there was also no obvious pooled water (Figure 119.ii) indicating that the basins were infiltrating all of the stormwater.

**Figure 119. Time-lapse camera images from Adella House grass and stoney basins (FPC3), 12/01/2017.** Images show i) no evidence of overflowing during a period of high rain intensity at 17:35 and ii) evidence of 100% infiltration/conveyance by the end of the intense rain event at 20:01 on the same day.

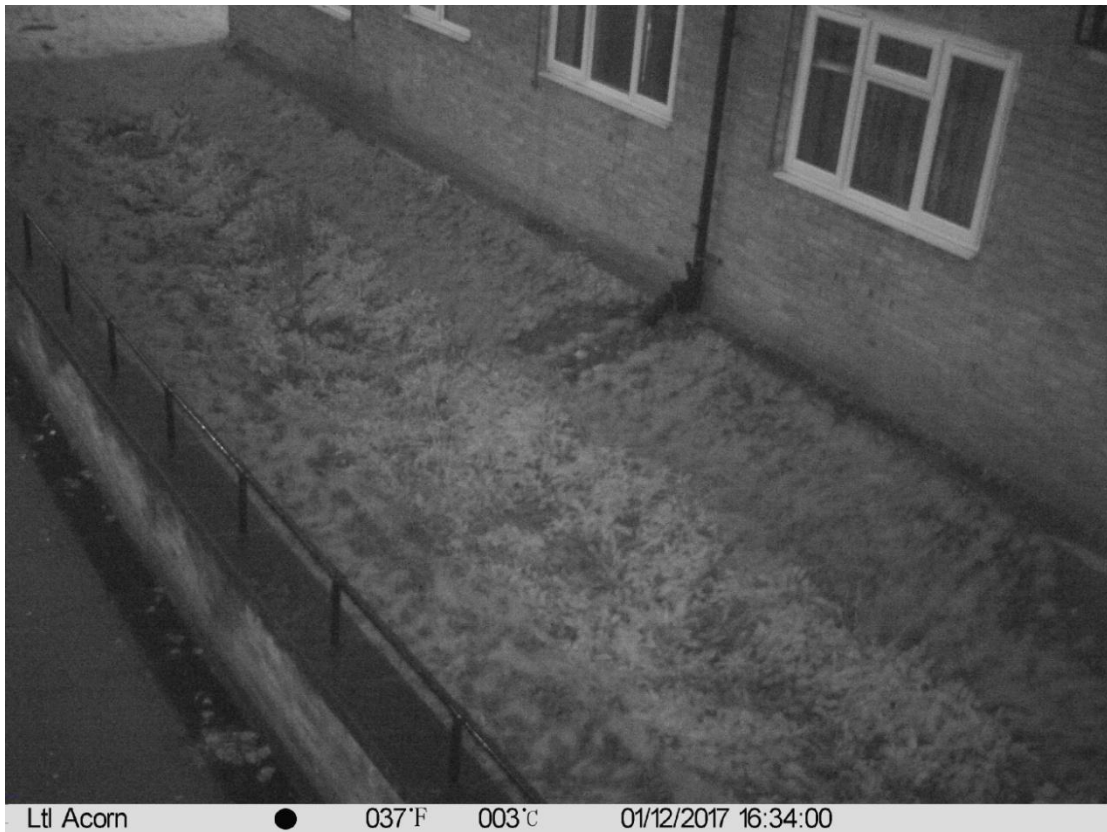
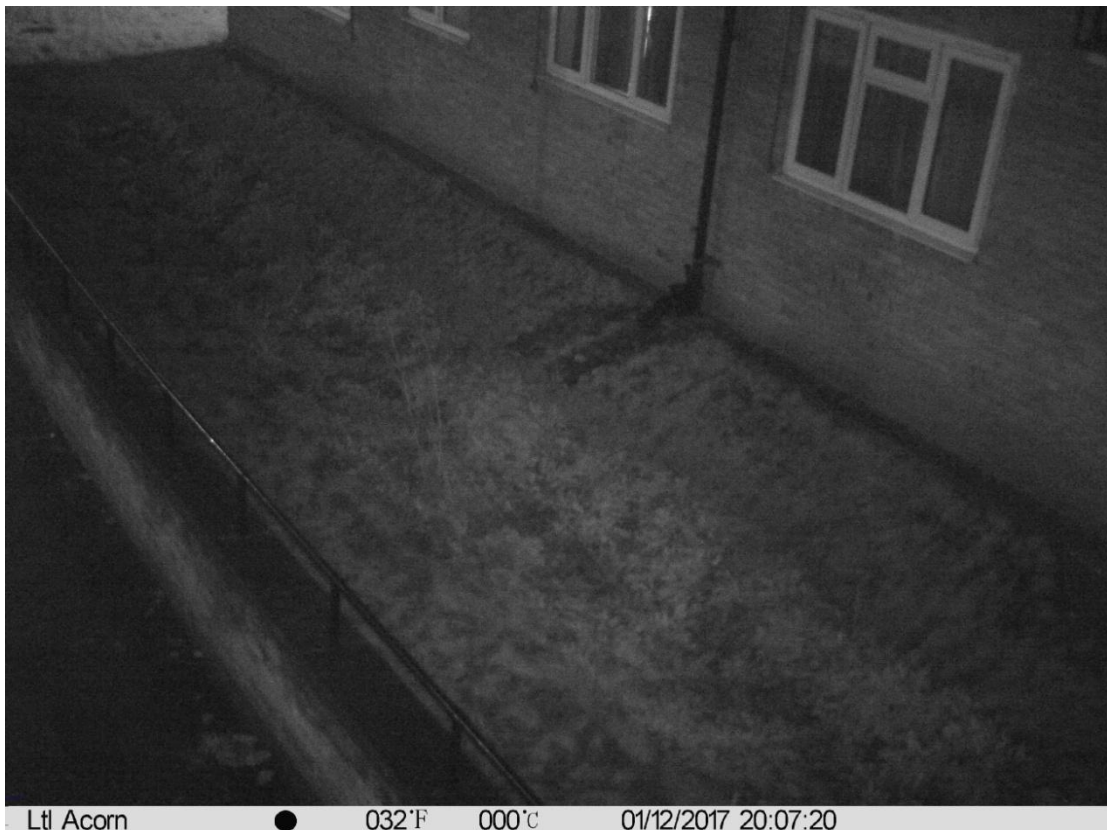
A complete collection of the images from Beatrice House swale during the rain event from 11:30 to 20:00 on the 12th January 2017 were captured and analysed. They demonstrated that the swale was able to retain and attenuate all of the rainfall that fell directly onto the area and that which was diverted from the neighbouring roof. The images also demonstrated that at around 16:35 during the peak of the rainfall, despite substantial input from the Beatrice House roof, there was no obvious standing water within or around the swale (Figure 120.i). Following the cessation of the event at 20:00, there was also no obvious pooled water (Figure 120.ii) indicating that the basins were infiltrating all of the stormwater.

**Figure 120. Time-lapse camera images from Beatrice House swale (FPC4), 12/01/2017.** Images show i) no evidence of overflowing during a period of high rain intensity at 16:34 and ii) evidence of 100% infiltration/conveyance by the end of the intense rain event at 20:07 on the same day.

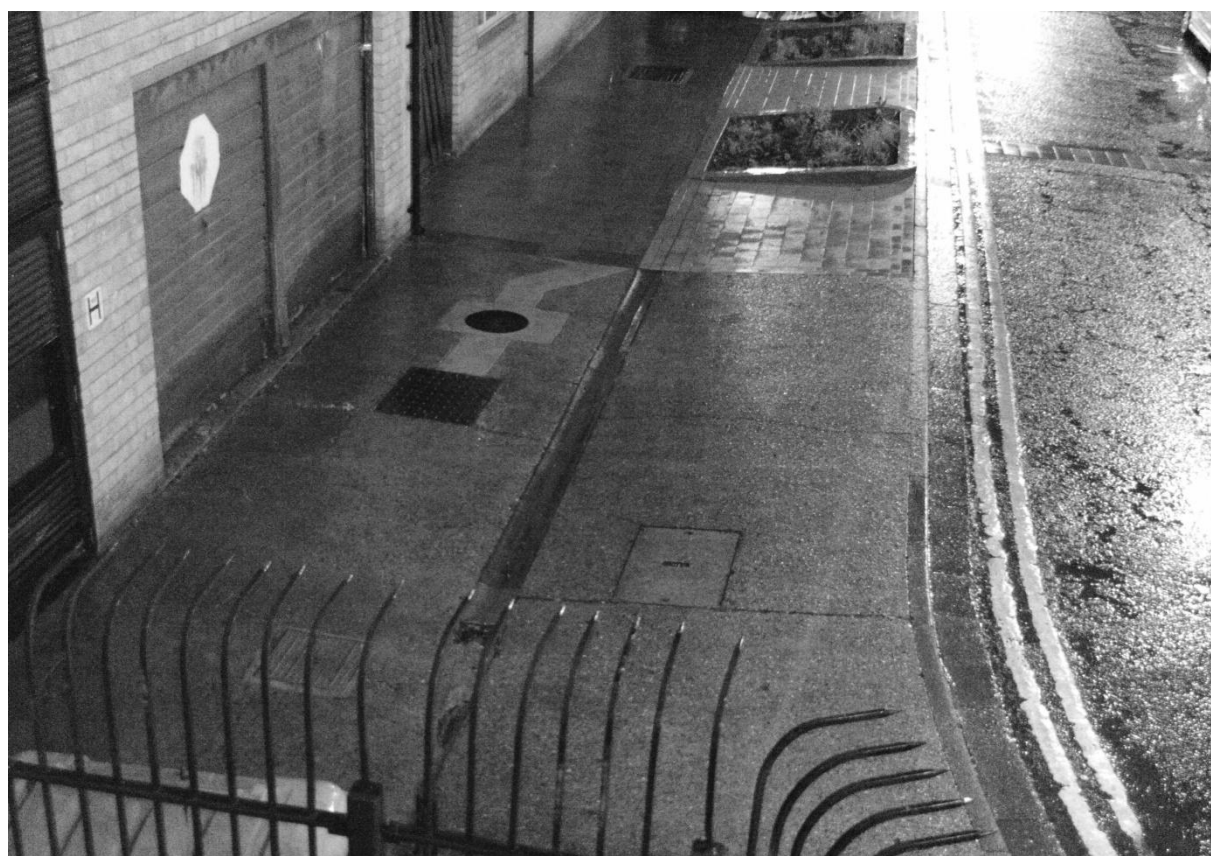
A complete collection of the images from Cheeseman Terrace rain gardens during the rain event from 11:30 to 20:00 on the 12th January 2017 were captured and analysed. They demonstrated that the rain gardens were able to retain and attenuate all of the rainfall that fell directly onto the area. Due to the design of the underdrainage from the road, analysis of pressure sensor data is required in order to establish whether all of the runoff from the road was also managed. Nevertheless, the images also demonstrated that at around 16:35 during the peak of the rainfall, there was no obvious standing water within or around the rain gardens (Figure 121.i). Following the cessation of the event at 20:00, there was also no obvious pooled water (Figure 121.ii) indicating that the rain gardens were not becoming saturated with stormwater.

**Figure 121. Time-lapse camera images from Cheeseman Terrace rain gardens (FPC6), 12/01/2011.** Images show i) no evidence of overflowing during a period of high rain intensity at 16:37 and ii) evidence of 100% infiltration/conveyance by the end of the intense rain event at 20:07 on the same day. N.B. the date displayed on the images does not correspond with the date of the rain event. This was due to a labelling error on the cameras. The actual data of the image was 12/01/2017.

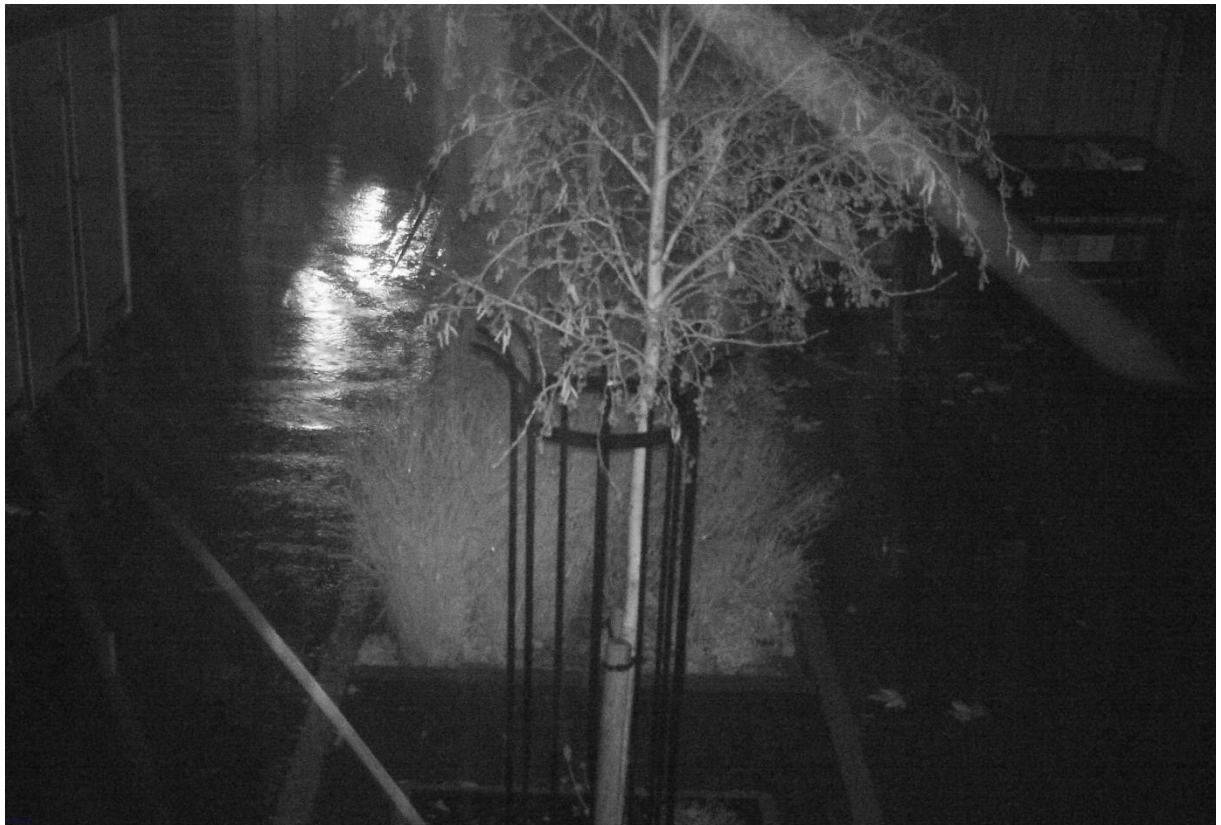
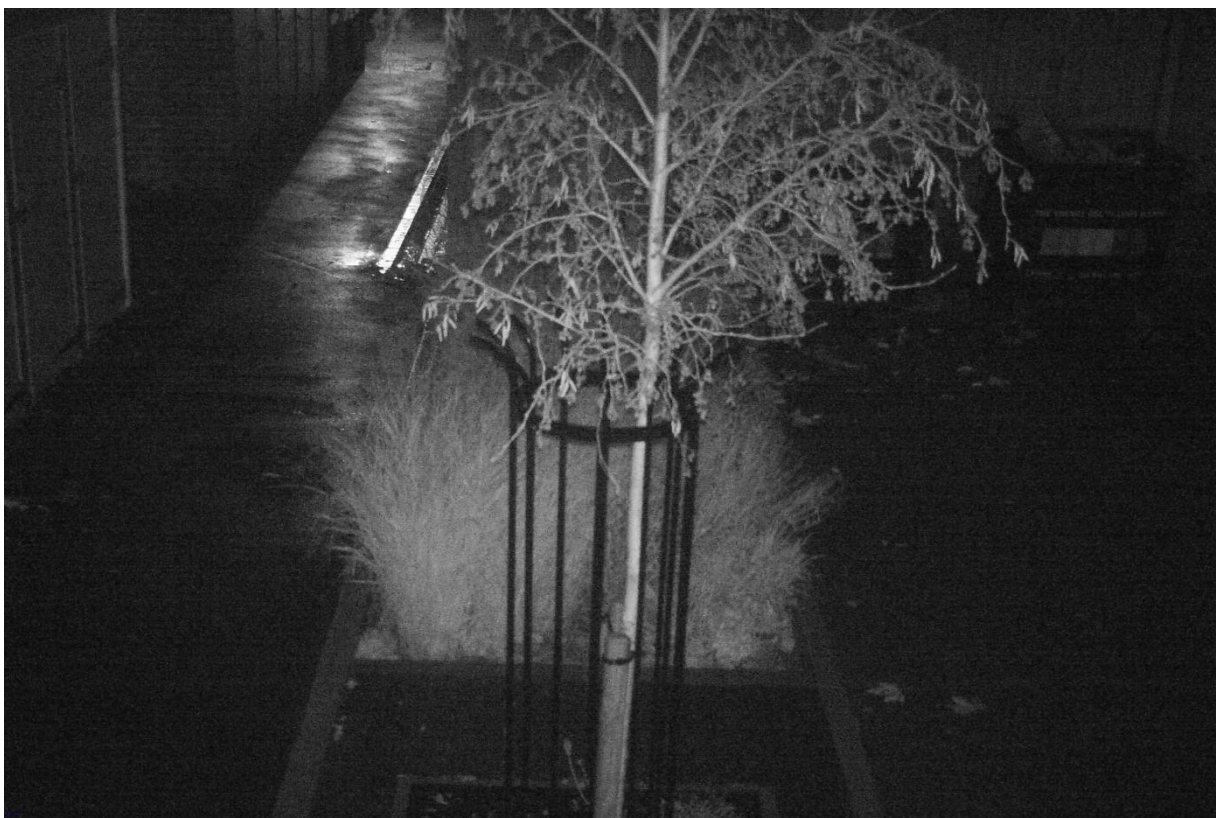
A complete collection of the images from the Richard Knight House rain garden during the rain event from 00:01 to 23:59 on the 21st November 2016 were captured and analysed. They demonstrated that the rain garden was able to retain and attenuate all of the rainfall that fell directly onto the area and that which was diverted from the neighbouring roofs. The images demonstrated that at around 18:45 during the peak of the rainfall, despite the channel supplying the rain garden becoming overloaded, there was no obvious standing water overflowing the bottom end of the rain garden, indicating that it was no filled to capacity (Figure 123.i). By the time of the end of the rain event at 23:59, there was also no obvious pooled water (Figure 123.ii) indicating that the rain garden was infiltrating all of the stormwater.

**Figure 123. Time-lapse camera images from Richard Knight House rain garden (FPC5), 21/11/2016.** Images show i) no evidence of overflowing during period of highest rain intensity at 18:42 and ii) evidence of 100% infiltration/conveyance by the end of the intense rain event at 23:59 on the same day.

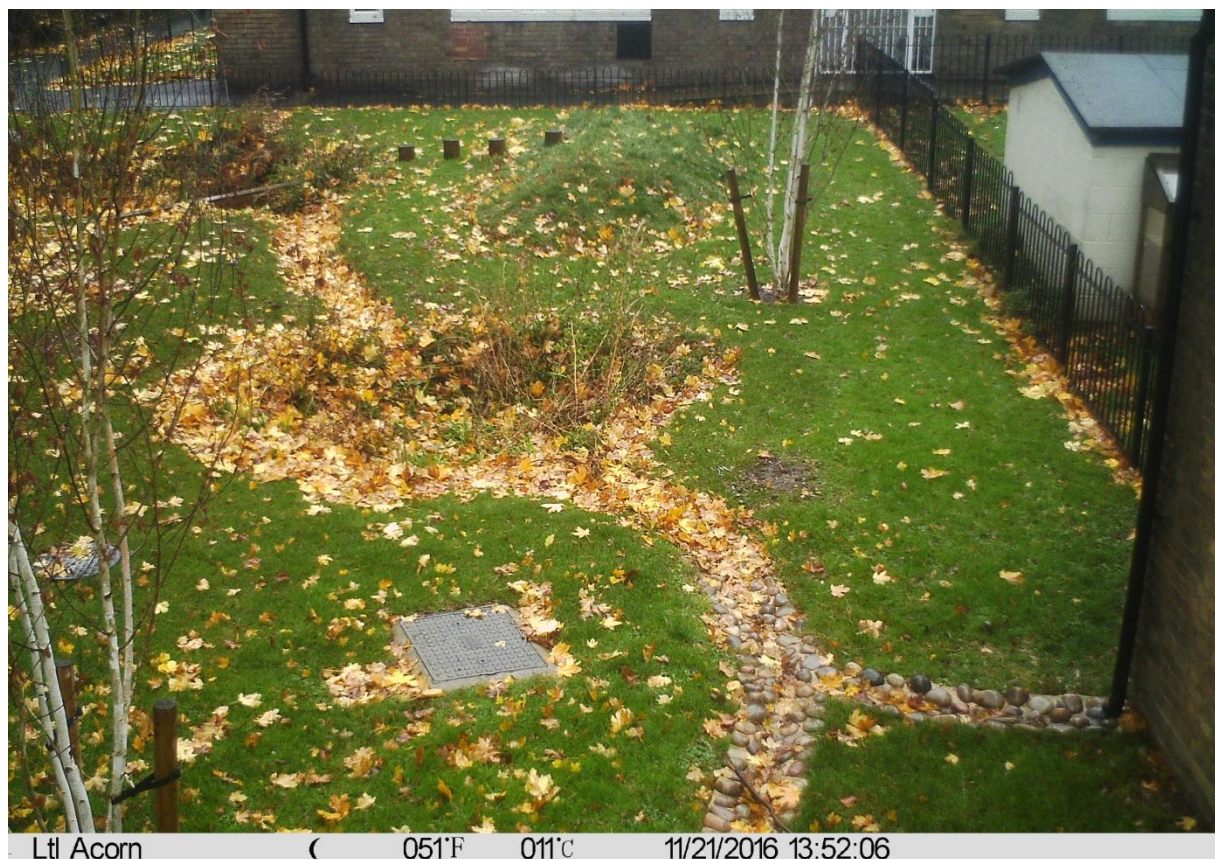
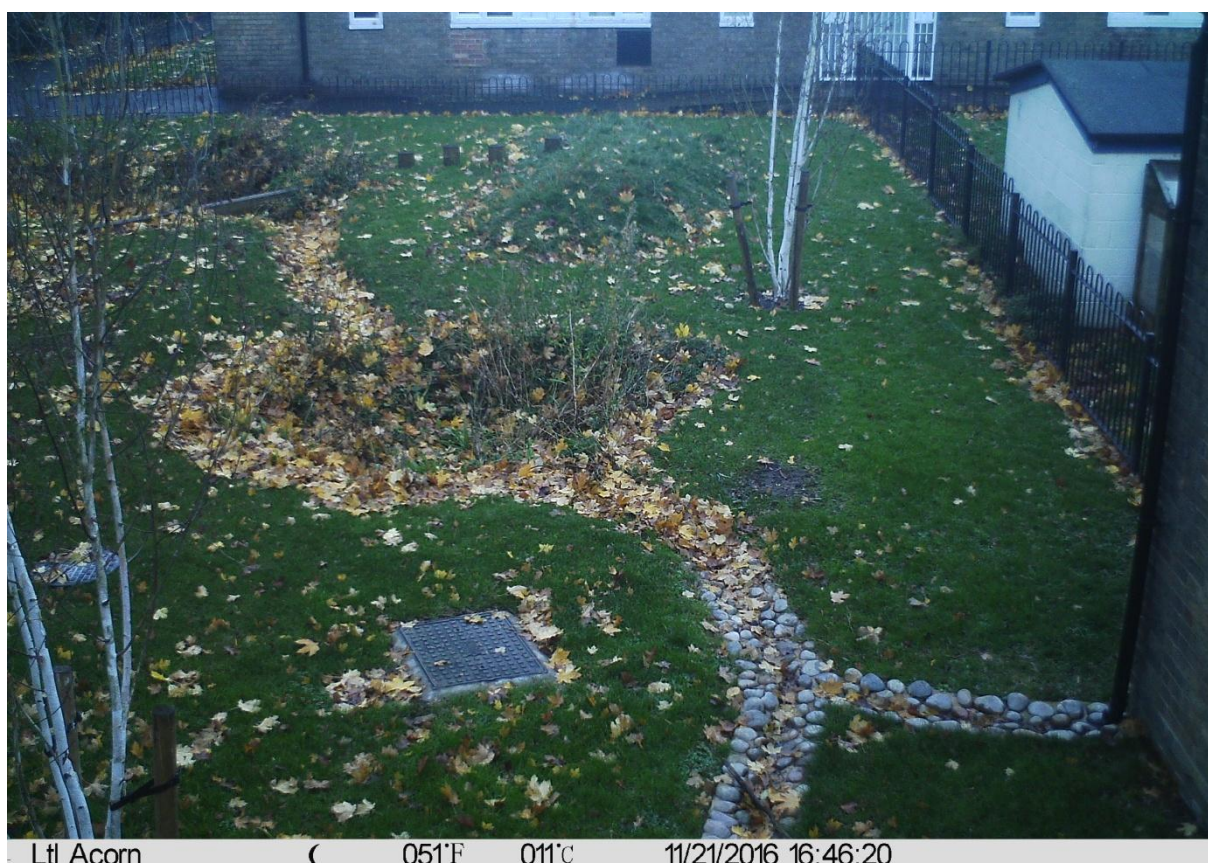
A complete collection of the images from the community hall and Sofia House basins during the rain event from 00:01 to 23:59 on the 21st November 2016 were captured and analysed. They demonstrated that the basins were able to retain and attenuate all of the rainfall that fell directly onto the area and that which was diverted from the neighbouring roofs. The images also demonstrated that at around 13:50 during the peak of the rainfall, despite substantial input from the community hall roof, there was no obvious standing water within or around the basin (Figure 125.i). Following the more substantial part of the prolonged rain event at 16:45, there was also no obvious pooled water (Figure 125.ii) indicating that the basins were infiltrating all of the stormwater.

**Figure 125. Time-lapse camera images from Community Hall and Sofia House basins (FPC2), 21/11/2016.** Images show i) no evidence of overflowing during a period of high rain intensity at 13:52 and ii) evidence of 100% infiltration/conveyance by the end of the intense rain event at 16:46 on the same day.
