**Climate Proofing Housing Landscapes:  
Monitoring Report 3**

**October 2016 to September 2017**

**Authors: Connop, S., Clough, J., Alam, R. and Nash, C.**

H&F Council and Groundwork London worked with local residents to design and implement climate change adaptation measures on three housing estates in the borough, making them more resilient and adapted for the future.

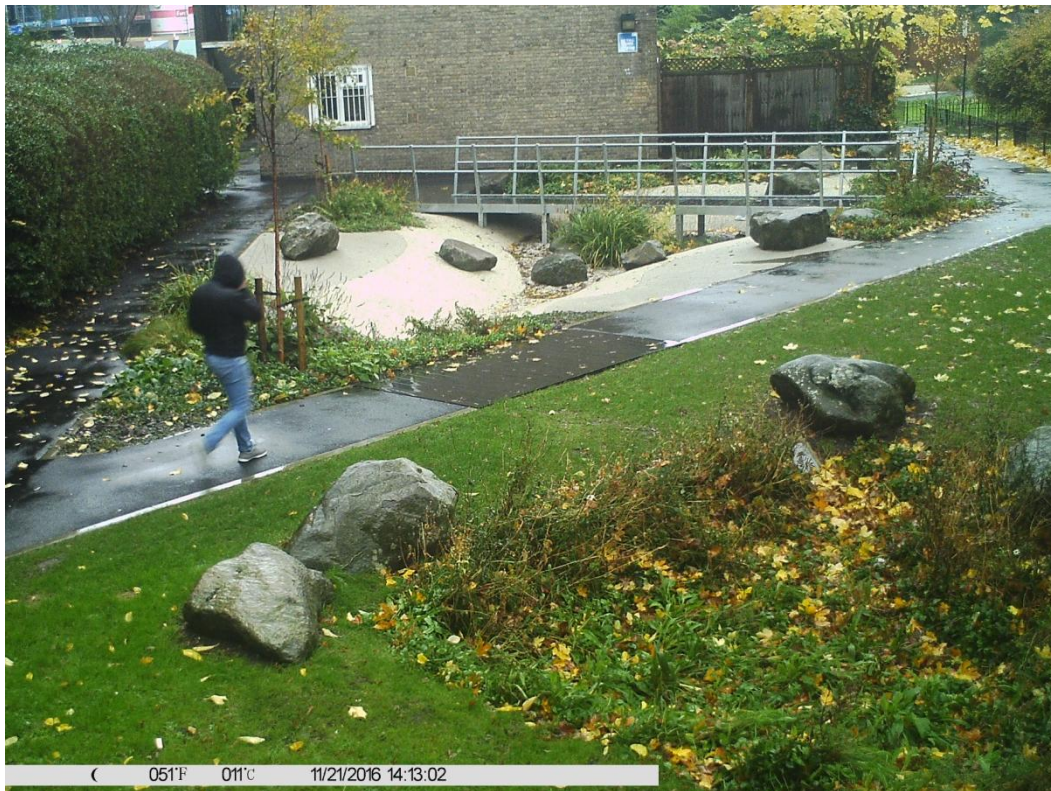
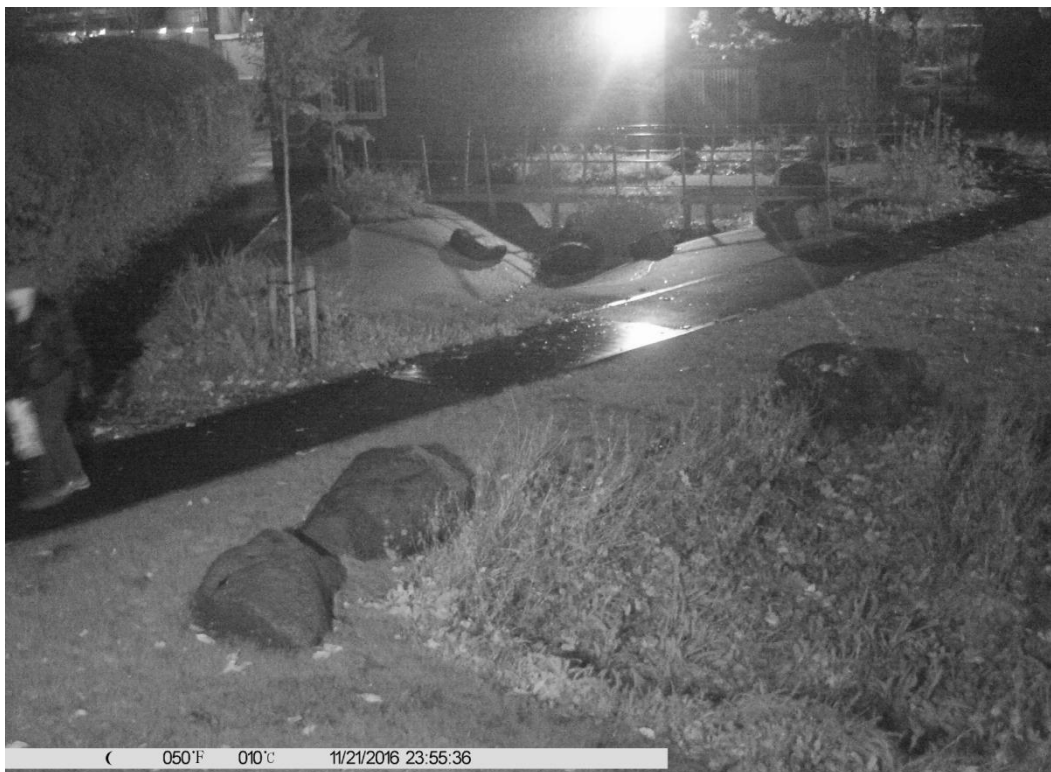
A complete collection of the images from Adella House basins during the rain event from 00:01 to 23:59 on the 21st November 2016 were captured and analysed. They demonstrated that the basins were able to retain and attenuate all of the rainfall that fell directly onto the area and that which was diverted from the neighbouring roofs. The images also demonstrated that at around 14:15 during the peak of the rainfall, despite substantial input from the Adella House roof, there was no obvious standing water within or around the basin (Figure 126.i). Following the prolonged rain event at 23:55, there was also no obvious pooled water (Figure 126.ii) indicating that the basins were infiltrating all of the stormwater.

**Figure 126. Time-lapse camera images from Adella House grass and stoney basins (FPC3), 21/11/2016.** Images show i) no evidence of overflowing during a period of high rain intensity at 14:13 and ii) evidence of 100% infiltration/conveyance by the end of the intense rain event at 23:55 on the same day.

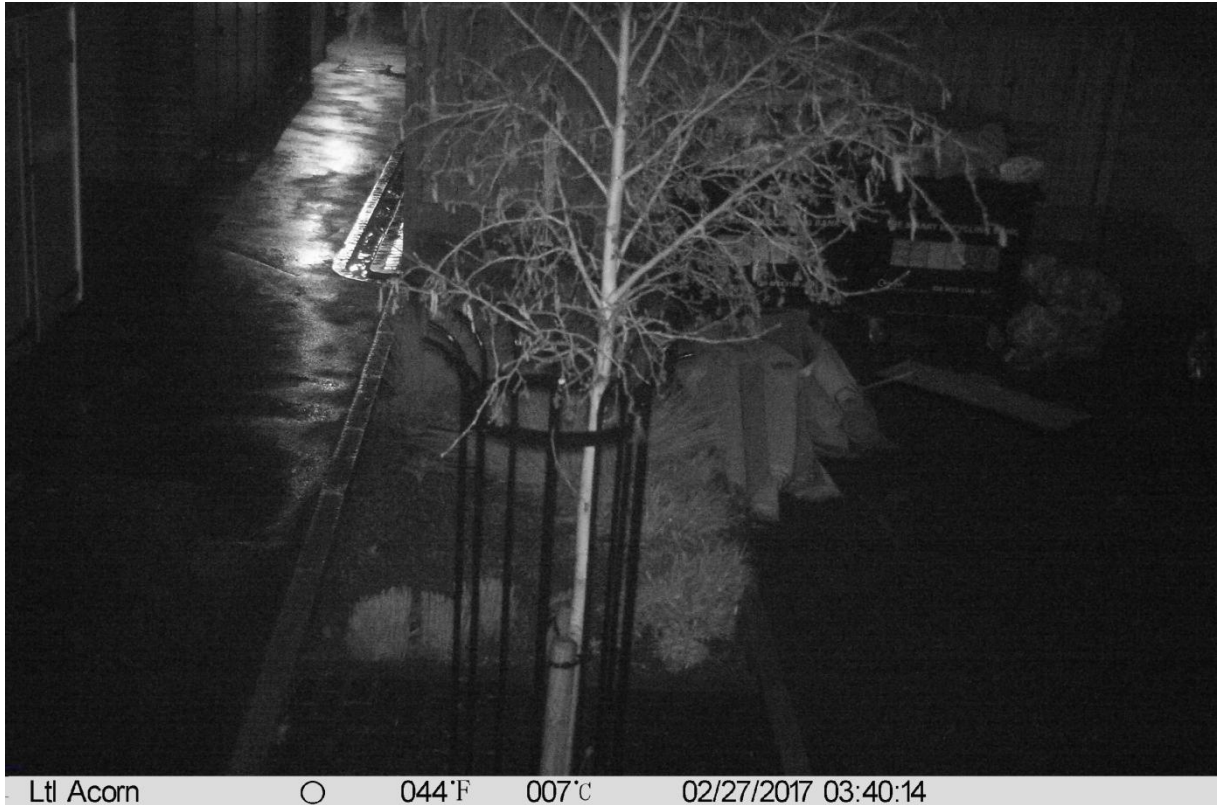
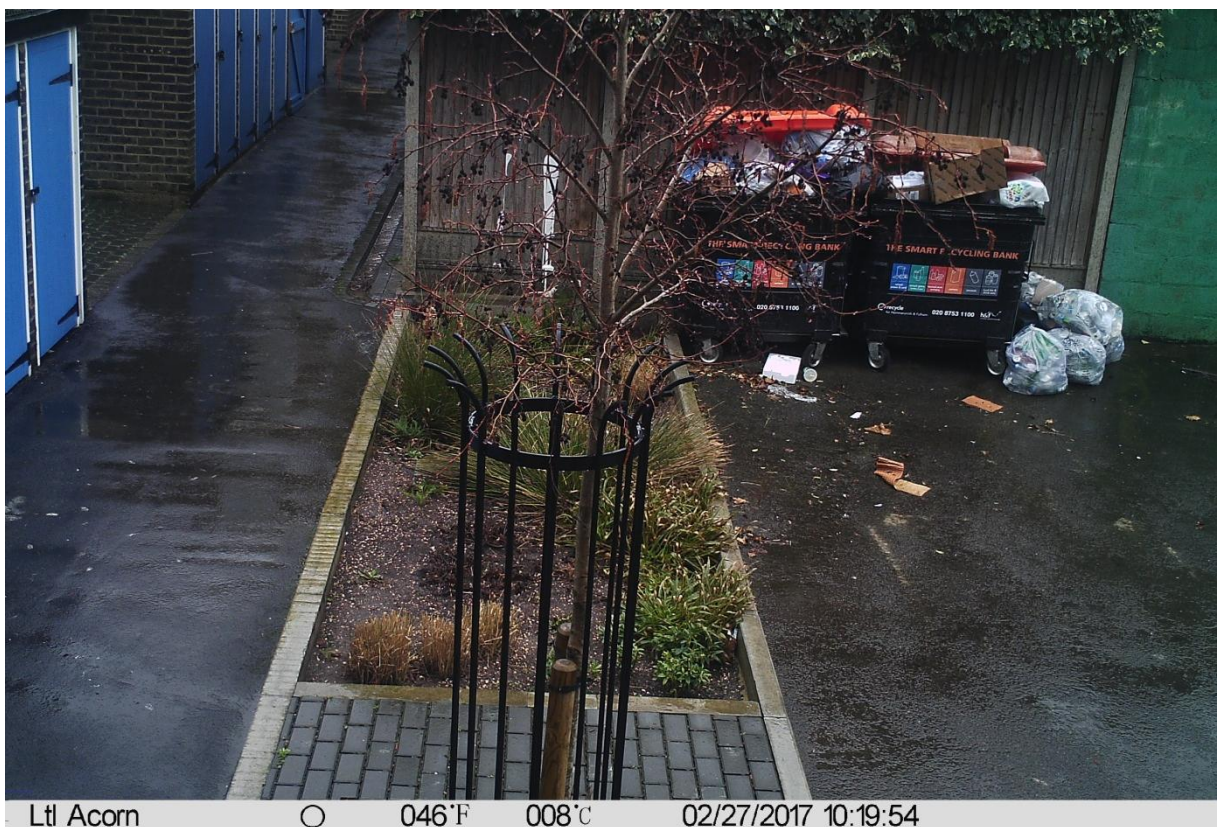
A complete collection of the images from the Richard Knight House rain garden during the rain event from 00:01 to 21:00 on the 27th February 2017 were captured and analysed. They demonstrated that the rain garden was able to retain and attenuate all of the rainfall that fell directly onto the area and that which was diverted from the neighbouring roofs. The images demonstrated that at around 03:40 during the peak of the first rainfall, there was no obvious standing water overflowing the bottom end of the rain garden, indicating that it was not filled to capacity (Figure 128.i). At the time of the second, more intense, rain event at

10:20, there was also no obvious pooled water (Figure 128.ii) indicating that the rain garden was infiltrating all of the stormwater.

**Figure 128. Time-lapse camera images from Richard Knight House rain garden (FPC5), 27/02/2017.** Images show i) no evidence of overflowing during the first rain event at 03:40 and ii) evidence of 100% infiltration/conveyance during the most intense rain event at 10:20 on the same day.

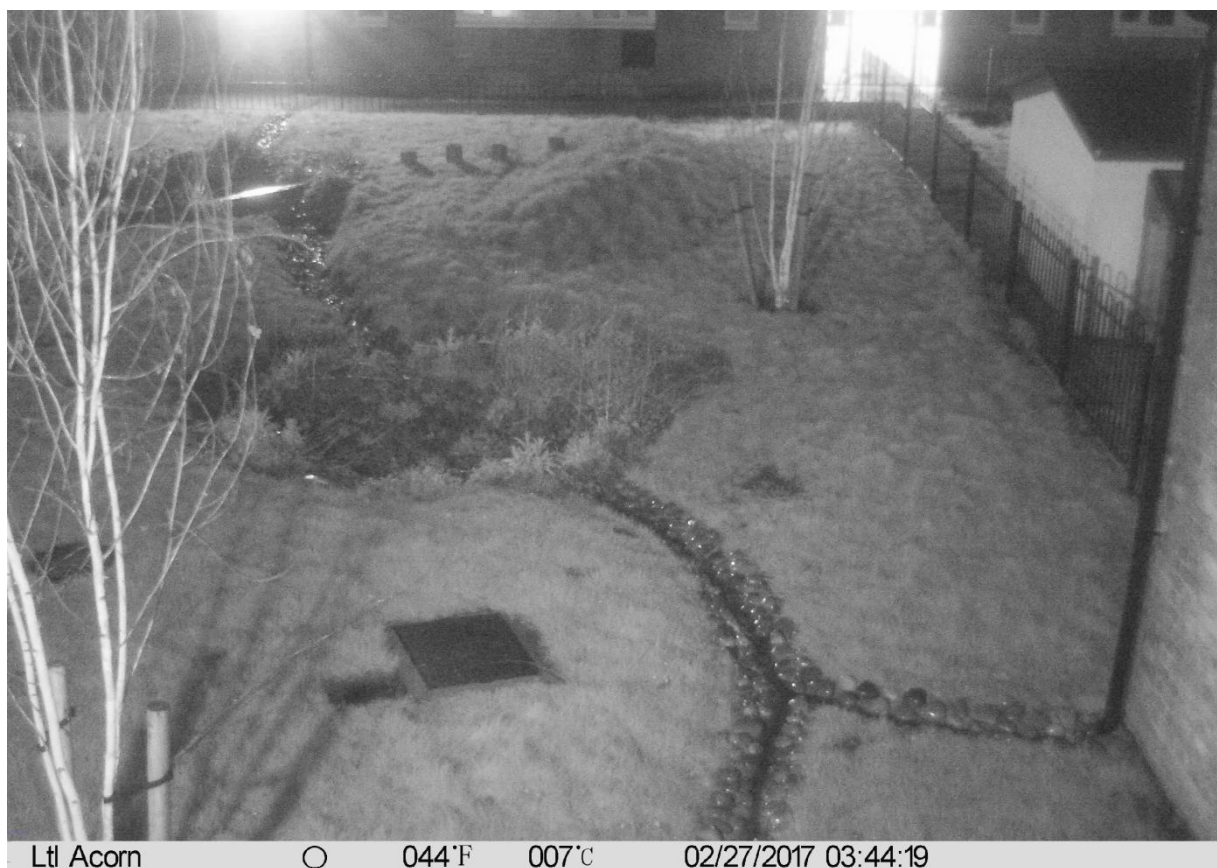
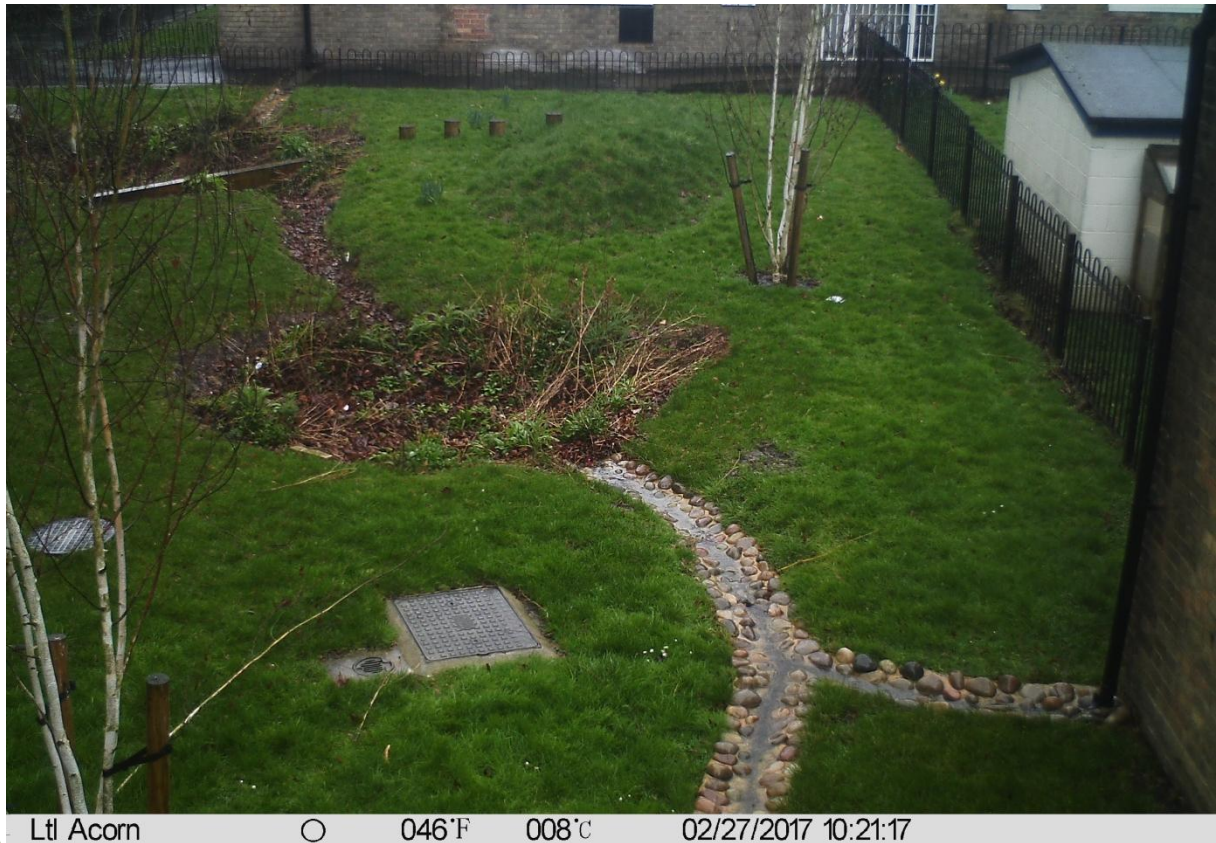
A complete collection of the images from the community hall and Sofia House basins during the rain event from 00:01 to 20:00 on the 27th February 2017 were captured and analysed. They demonstrated that the basins were able to retain and attenuate all of the rainfall that fell directly onto the area and that which was diverted from the neighbouring roofs. The images also demonstrated that at 03:45, at the time of the first substantial rainfall, despite substantial input from the community hall roof, there was no obvious standing water within or around the basins (Figure 130.i). During the second, more intense, event at 10:20, there was also no obvious pooled water (Figure 130.ii) indicating that the basins were infiltrating all of the stormwater.

**Figure 130. Time-lapse camera images from Community Hall and Sofia House basins (FPC2), 27/02/2017.** Images show i) no evidence of overflowing during the first a period of heavy rain at 03:44 and ii) evidence of 100% infiltration/conveyance during the second intense rain event at 10:20 on the same day.

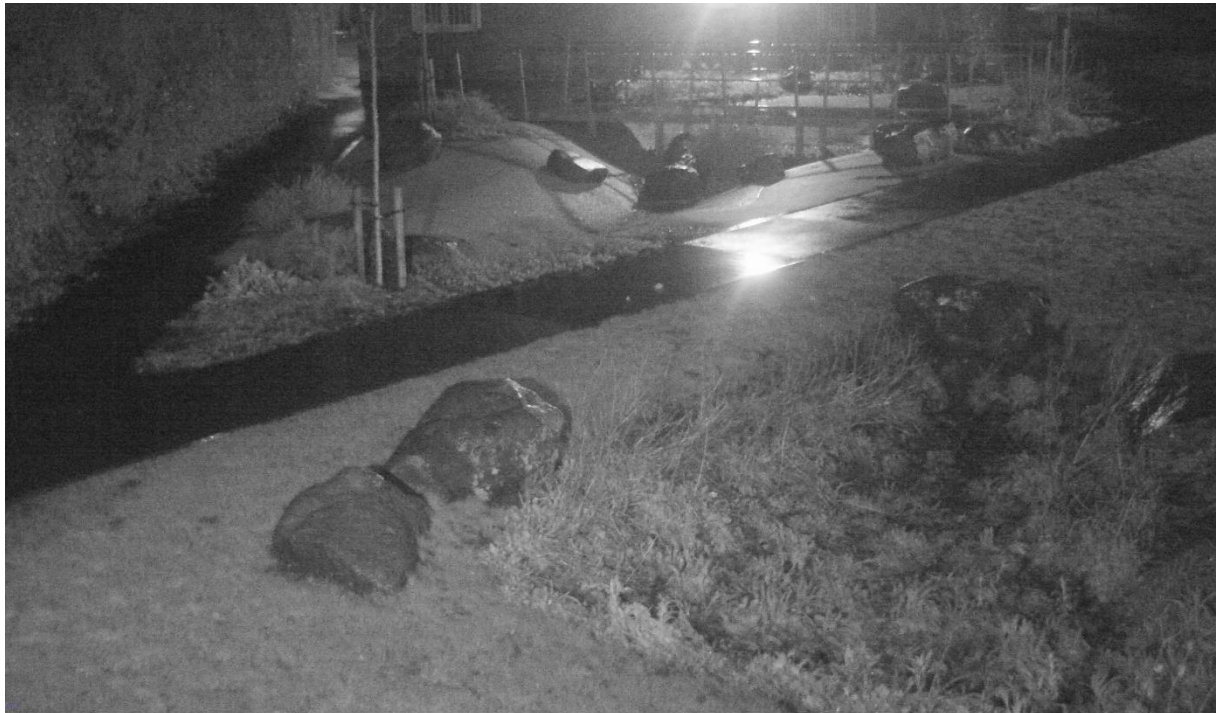
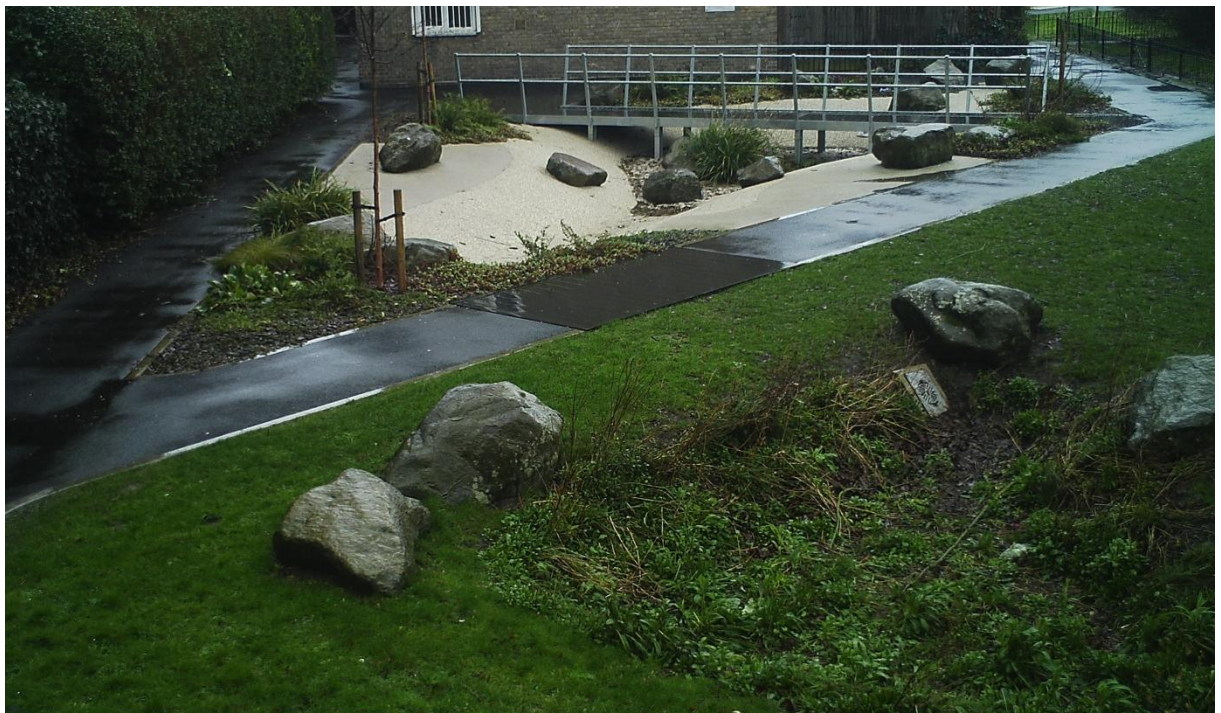
A complete collection of the images from the Adella House basins during the rain event from 00:01 to 20:00 on the 27th February 2017 were captured and analysed. They demonstrated that the basins were able to retain and attenuate all of the rainfall that fell directly onto the area and that which was diverted from the neighbouring roofs. The images also demonstrated that, during the first period of rain at around 03:35, there was no obvious standing water within or around the basins (Figure X.i). Following the second, more intense rain event at 10:30, there was also no obvious pooled water (Figure X. ii) indicating that the basins were infiltrating all of the stormwater.

**Figure 131. Time-lapse camera images from Adella House grass and stoney basins (FPC3), 27/02/2017.** Images show i) no evidence of overflowing during the first period of high rainfall at 03:36 and ii) evidence of 100% infiltration/conveyance during the second, more intense, rain event at 10:27 on the same day.

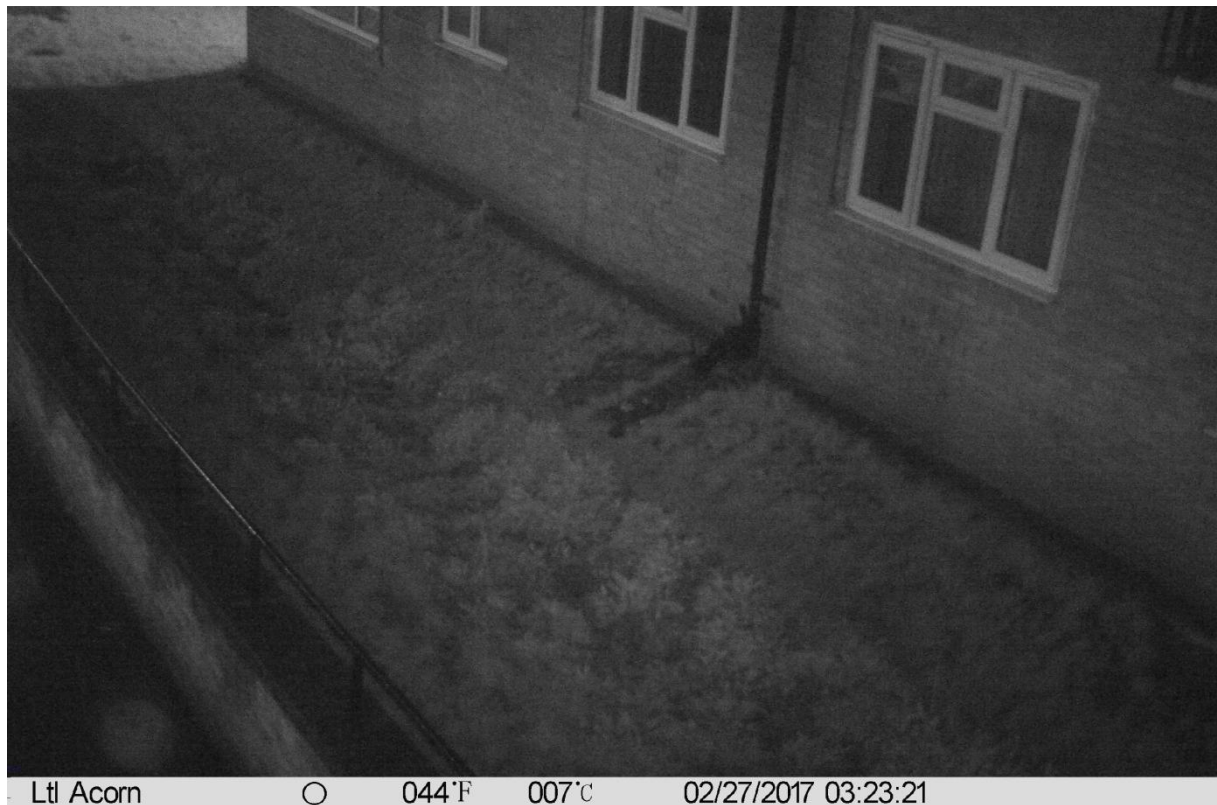
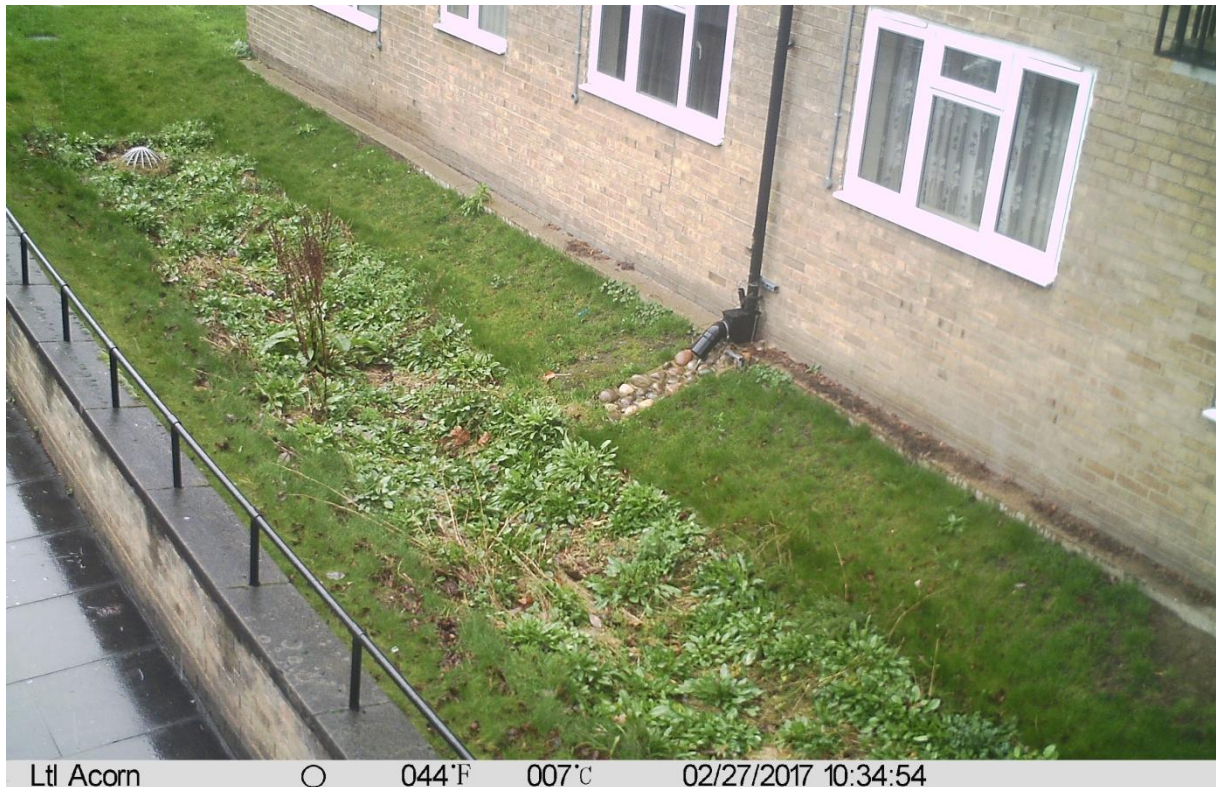
A complete collection of the images from Beatrice House swale during the rain event from 00:01 to 20:00 on the 27th February 2017 were captured and analysed. They demonstrated that the swale was able to retain and attenuate all of the rainfall that fell directly onto the area and that which was diverted from the neighbouring roof. The images also demonstrated that at around 03:45 during the first period of rain, despite substantial input from the Beatrice House roof, there was no obvious standing water within or around the swale (Figure 132.i). During the more intense rain at 10:30, there was also no obvious pooled water (Figure 132.ii) indicating that the basins were infiltrating all of the stormwater.

**Figure 132. Time-lapse camera images from Beatrice House swale (FPC4), 27/02/2017.** Images show i) no evidence of overflowing during the first period of high rainfall at 03:23 and ii) evidence of 100% infiltration/conveyance during the more intense rain event at 10:35 on the same day.

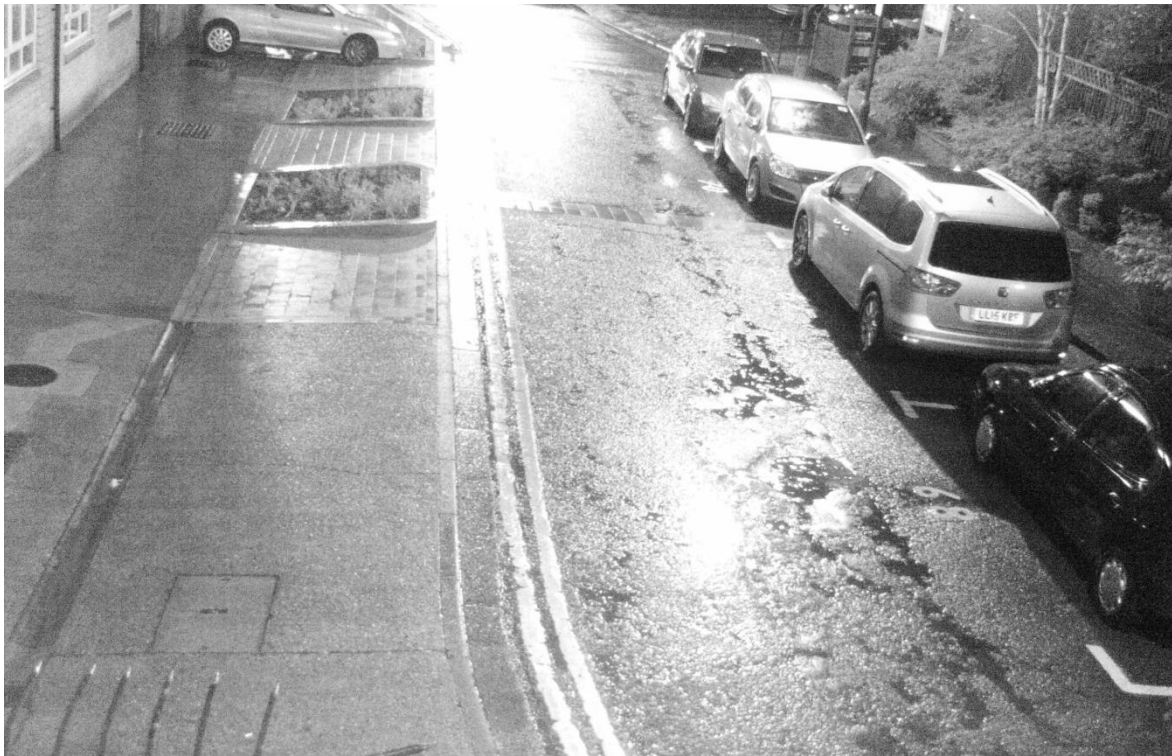
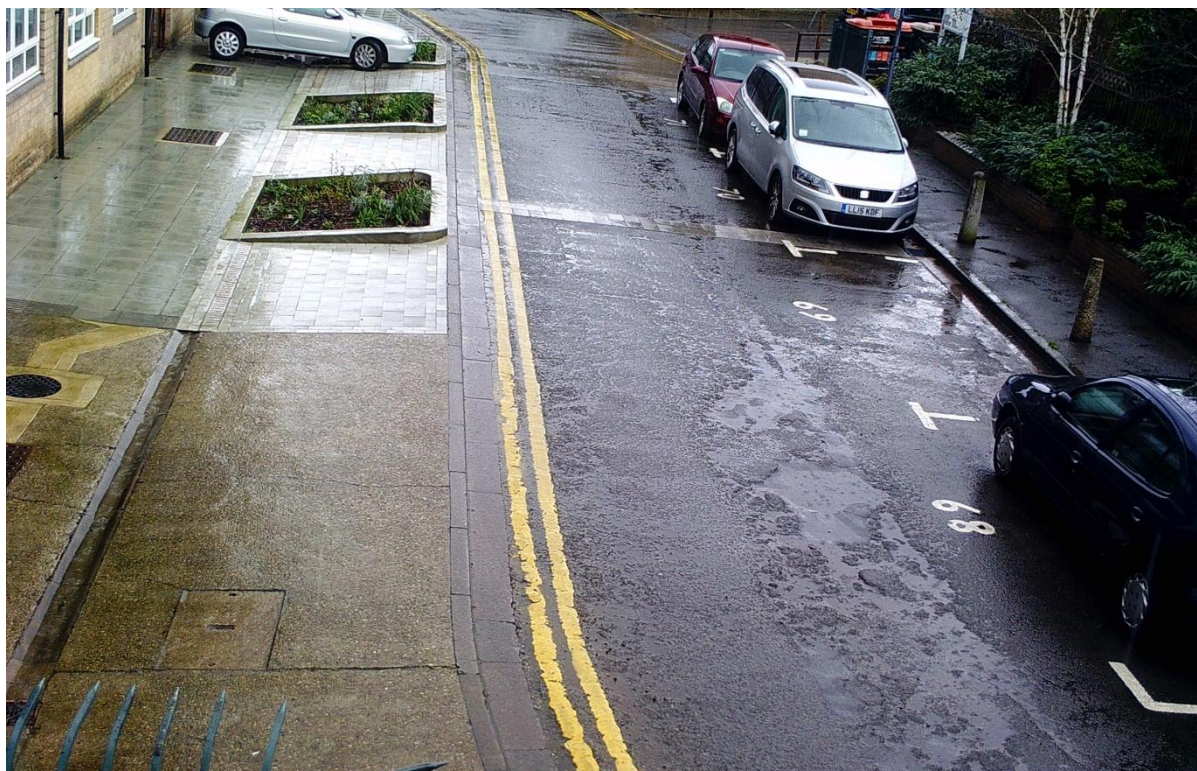
A complete collection of the images from Cheeseman Terrace rain gardens during the rain event from 00:01 to 20:00 on the 27th February 2017 were captured and analysed. They demonstrated that the rain gardens were able to retain and attenuate all of the rainfall that fell directly onto the area. Due to the design of the underdrainage from the road, analysis of pressure sensor data is required in order to establish whether all of the runoff from the road was also managed. Nevertheless, the images also demonstrated that at around 03:35 during the first rainfall period, there was no obvious standing water within or around the rain gardens (Figure 133.i). During the second, more intense event, at 20:00, there was also no obvious pooled water (Figure 133.ii) indicating that the rain gardens were not becoming saturated with stormwater.

**Figure 133. Time-lapse camera images from Cheeseman Terrace rain gardens (FPC6), 27/02/2017.** Images show i) no evidence of overflowing during the first period of high rainfall at 03:37 and ii) evidence of 100% infiltration/conveyance during the second, more intense, rain event at 10:22 on the same day.

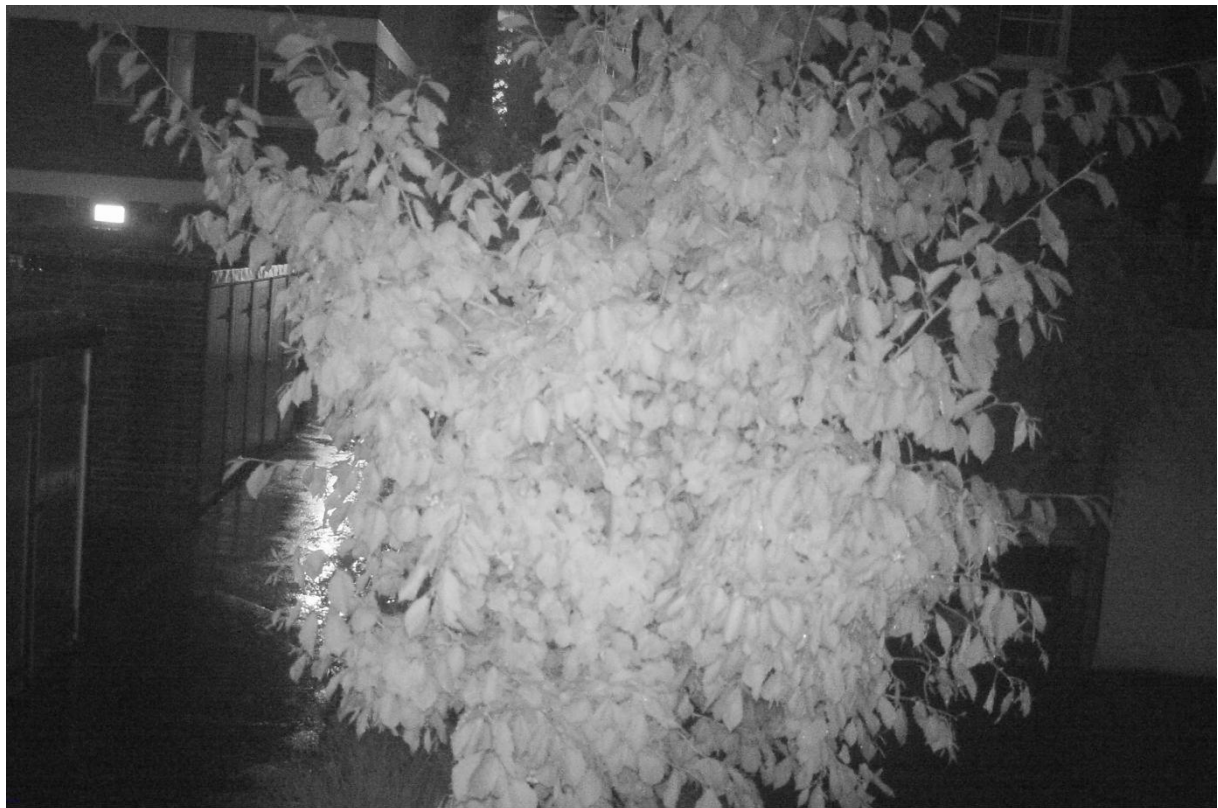
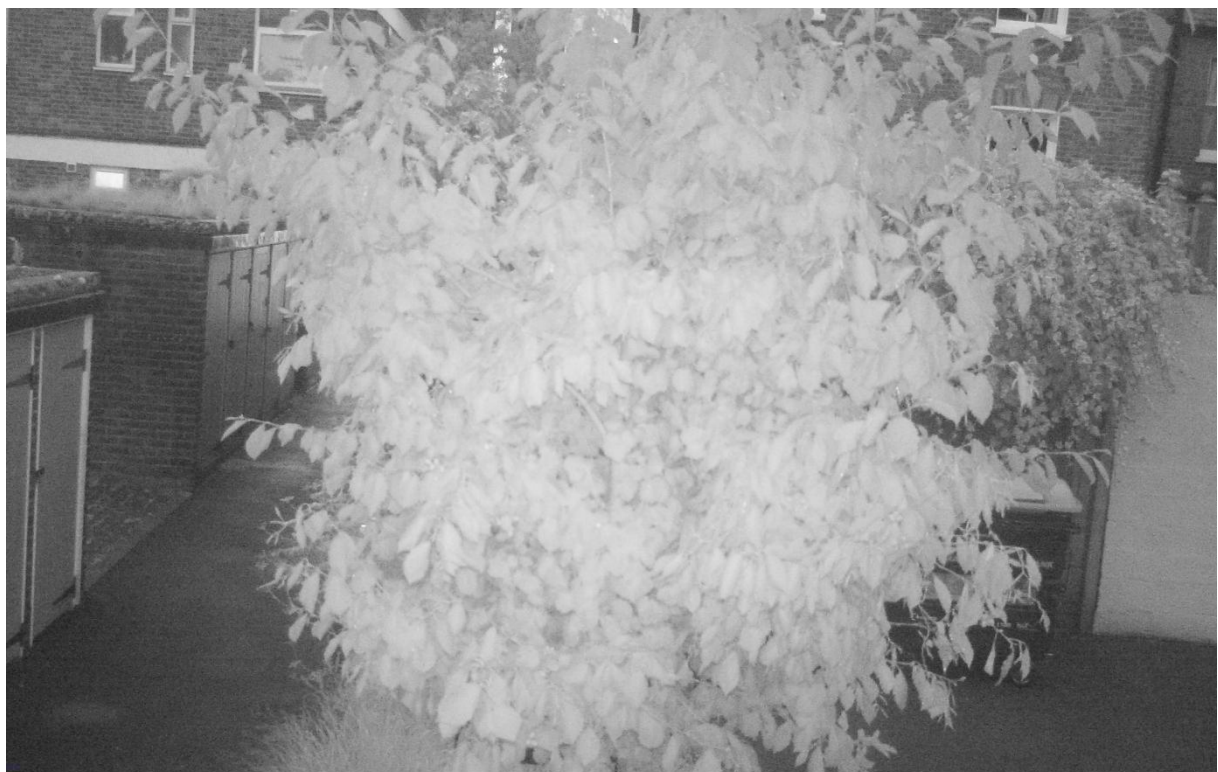
**Figure 135. Time-lapse camera images from Richard Knight House rain garden (FPC5), 30/07/2017.** Images show i) no evidence of overflowing during period of highest rain intensity at 02:05 and ii) evidence of 100% infiltration/conveyance by the end of the rain event at 04:52 on the same day.

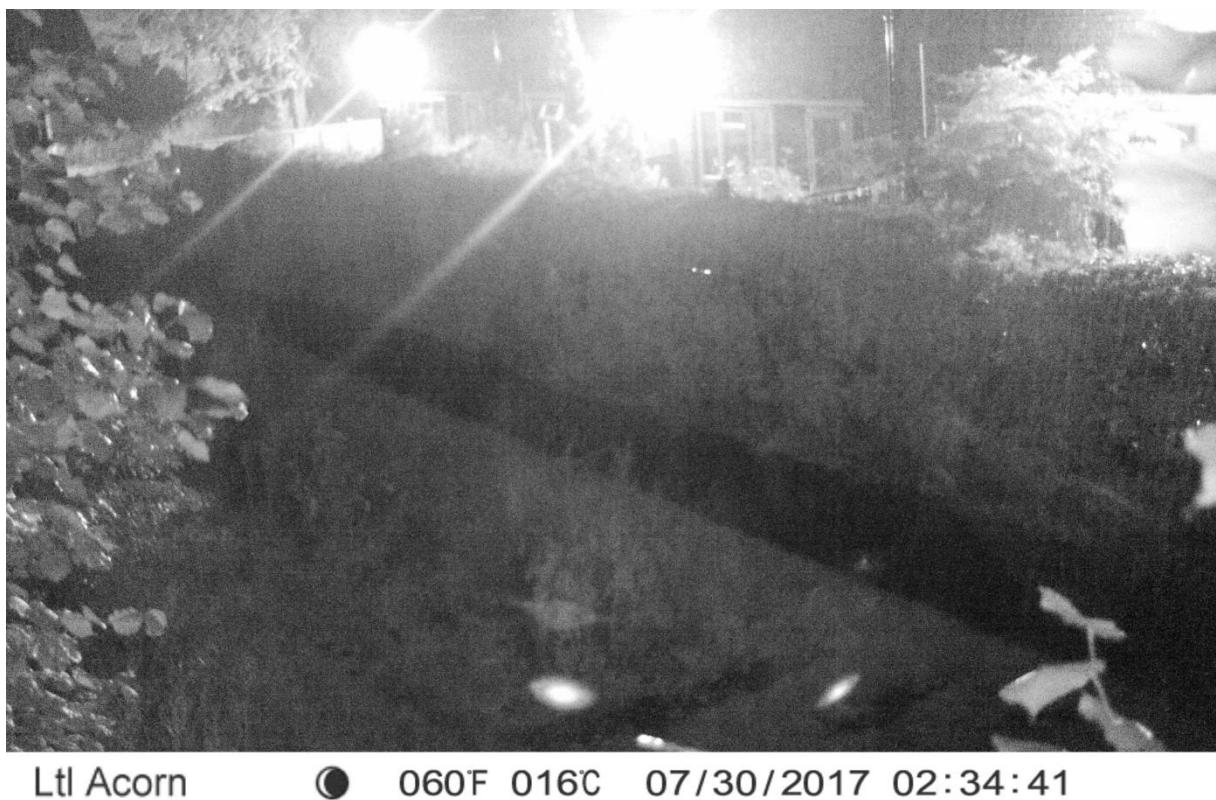
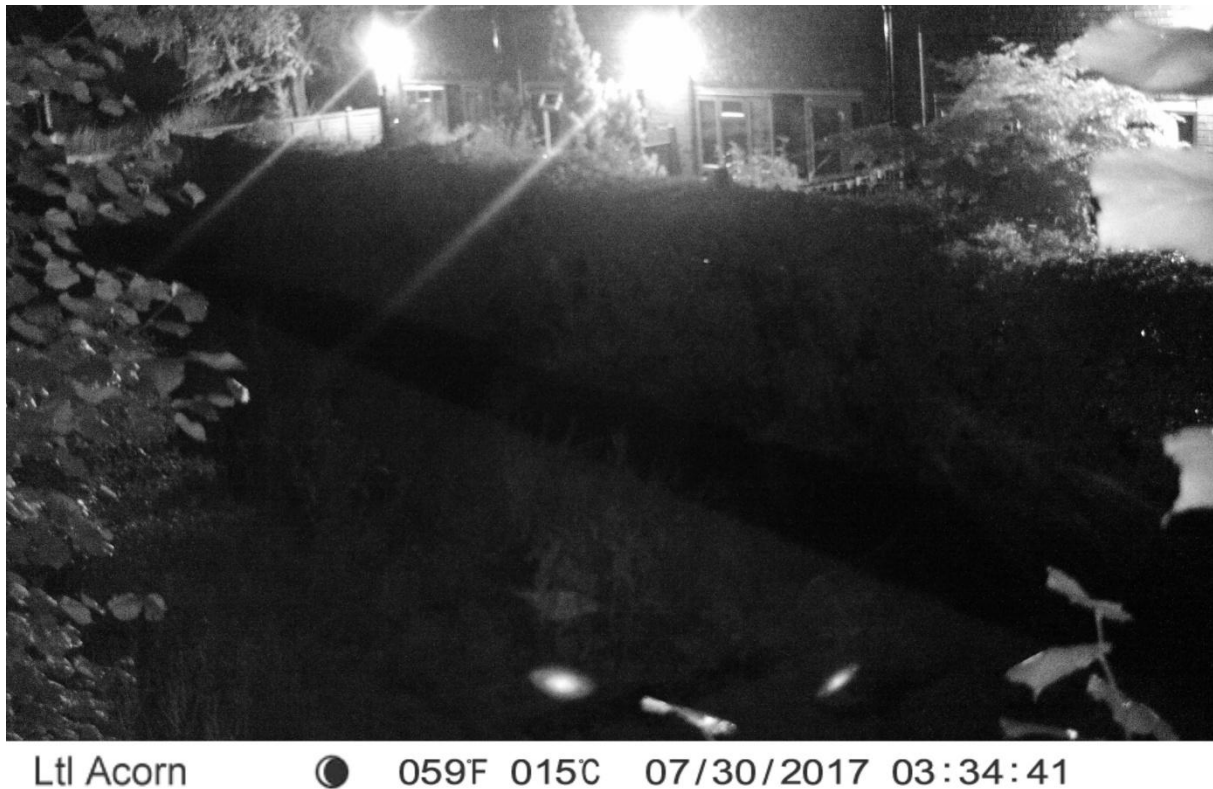
A complete collection of the images from the Alexandra House swale during the rain event from 02:00 to 03:30 on the 30th July 2017 were captured and analysed. They demonstrated that the swale was able to retain and attenuate all of the rainfall that fell directly onto the area and that which was diverted from the neighbouring roof. The images also demonstrated that at around 02:35 during the peak of the rainfall, despite substantial input from the neighbouring roof, there was no obvious standing water within or around the rain garden (Figure 137.i). By the time of the end of the rain event at 03:35, there was also no obvious pooled water (Figure 137.ii) indicating that the swale was infiltrating all of the stormwater.

**Figure 137. Time-lapse camera images from Alexandra House swale (FPC1), 30/07/2017.** Images show i) no evidence of overflowing during a period of high rain intensity at 02:34 and ii) evidence of 100% infiltration/conveyance by the end of the intense rain event at 03:34 on the same day.

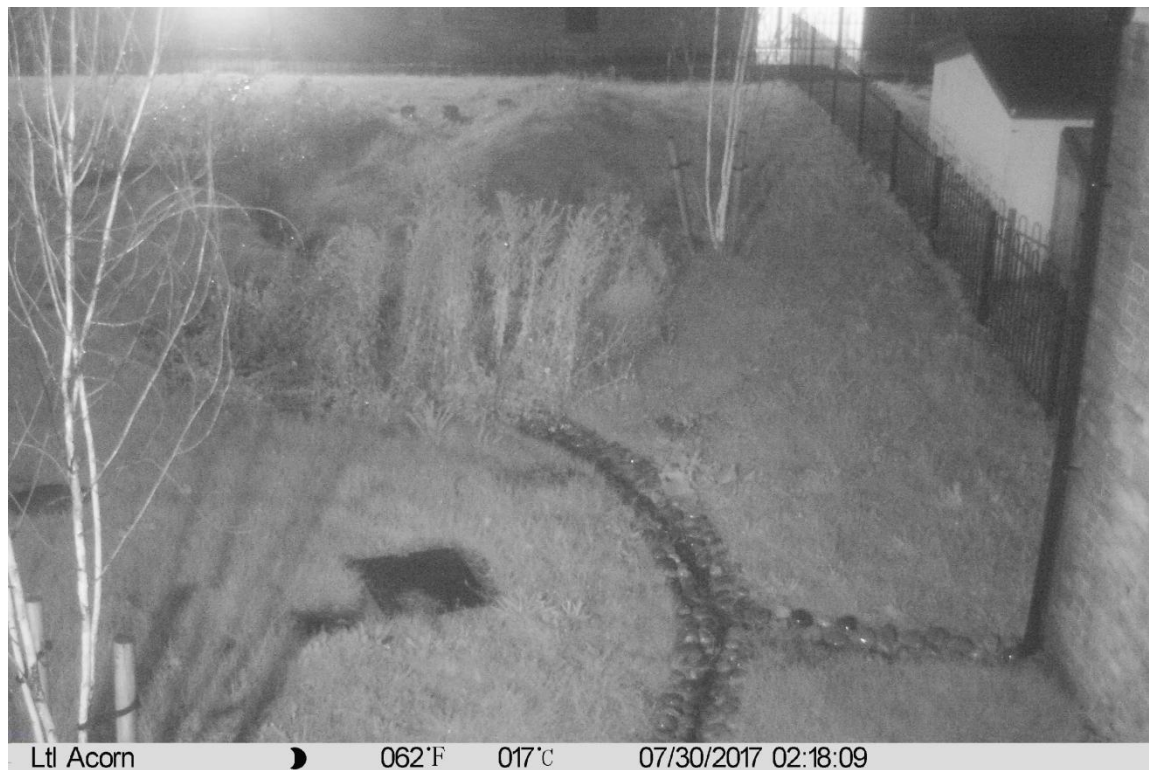
A complete collection of the images from the community hall and Sofia House basins during the rain event from 02:00 to 03:30 on the 30th July 2017 were captured and analysed. They demonstrated that the basins were able to retain and attenuate all of the rainfall that fell directly onto the area and that which was diverted from the neighbouring roofs. The images also demonstrated that at around 02:20 during the peak of the rainfall, despite substantial input from the community hall roof, there was no obvious standing water within or around the basins (Figure 138.i). Following the cessation of the event at 03:30, there was also no obvious pooled water (Figure 138.ii) indicating that the basins were infiltrating all of the stormwater.

**Figure 138. Time-lapse camera images from Community Hall and Sofia House basins (FPC2), 30/07/2017. Images show i) no evidence of overflowing during a period of high rain intensity at 02:18 and ii) evidence of 100% infiltration/conveyance by the end of the intense rain event at 03:32 on the same day.**

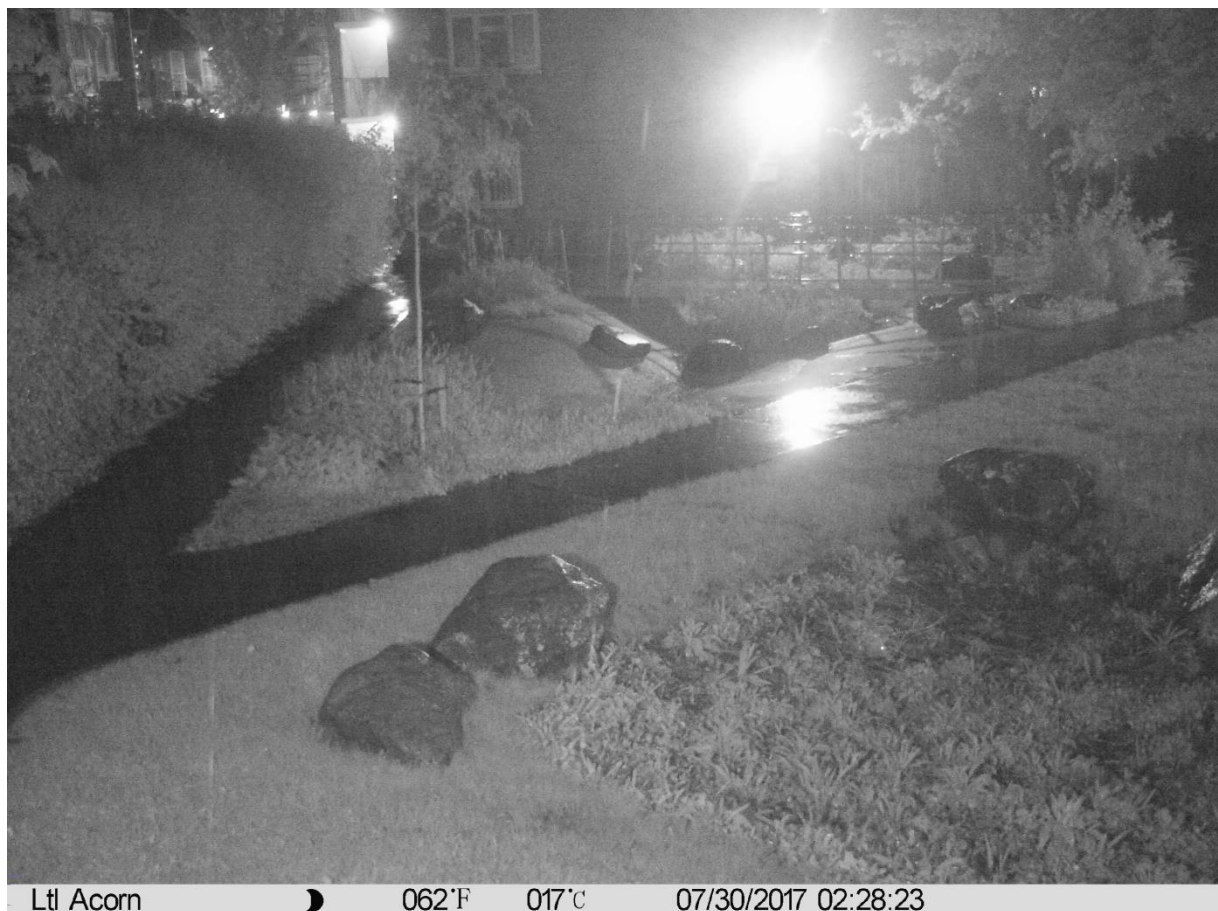
**Figure 139. (see below)**

A complete collection of the images from the Adella House basins during the rain event from 02:00 to 03:30 on the 30th July 2017 were captured and analysed. They demonstrated that the basins were able to retain and attenuate all of the rainfall that fell directly onto the area and that which was diverted from the neighbouring roofs. The images also demonstrated that at around 02:30 during the peak of the rainfall, despite substantial input from the Adella House roof, there was no obvious standing water within or around the basins (Figure 139.i). Following the cessation of the event at 03:30, there was also no obvious pooled water (Figure 139.ii) indicating that the basins were infiltrating all of the stormwater.

**Figure 139. Time-lapse camera images from Adella House grass and stoney basins (FPC3), 30/07/2017.** Images show i) no evidence of overflowing during a period of high rain intensity at 02:28 and ii) evidence of 100% infiltration/conveyance by the end of the intense rain event at 03:34 on the same day.

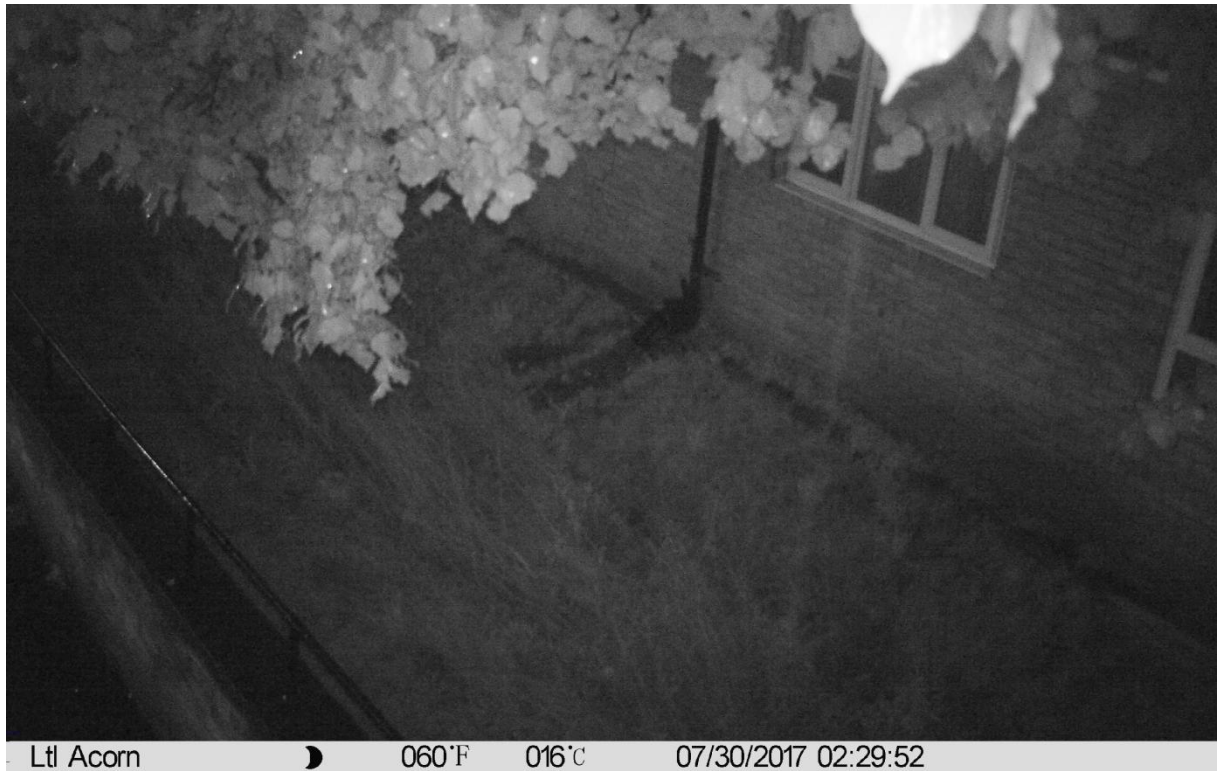
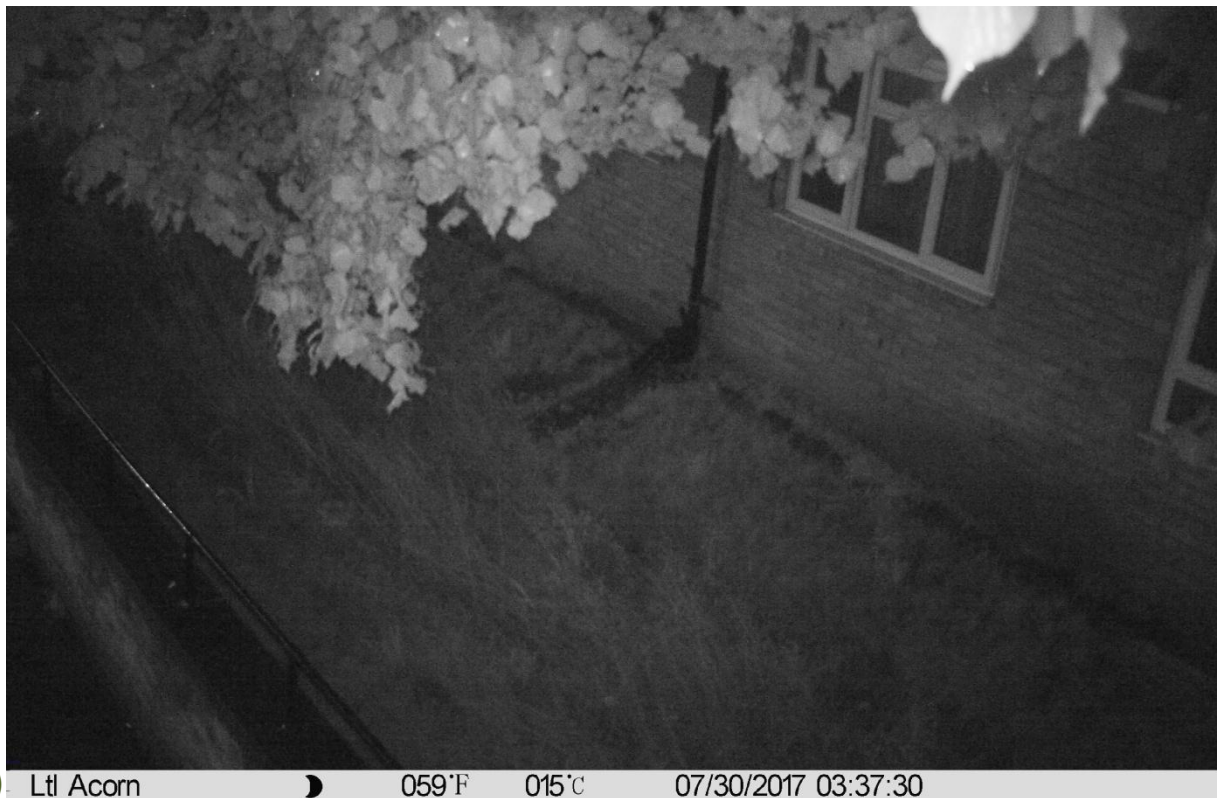
A complete collection of the images from Beatrice House swale during the rain event from 02:00 to 03:30 on the 30th July 2017 were captured and analysed. They demonstrated that the swale was able to retain and attenuate all of the rainfall that fell directly onto the area and that which was diverted from the neighbouring roof. The images also demonstrated that at around 02:30 during the peak of the rainfall, despite substantial input from the Beatrice House roof, there was no obvious standing water within or around the swale (Figure 140.i). Following the cessation of the event at 03:30 there was also no obvious pooled water (Figure 140.ii) indicating that the basins were infiltrating all of the stormwater.

**Figure 140. Time-lapse camera images from Beatrice House swale (FPC4), 30/07/2017.** Images show i) no evidence of overflowing during a period of high rain intensity at 02:29 and ii) evidence of 100% infiltration/conveyance by the end of the intense rain event at 03:37 on the same day.
