**Climate Proofing Housing Landscapes:  
Monitoring Report 3**

**October 2016 to September 2017**

**Authors: Connop, S., Clough, J., Alam, R. and Nash, C.**

H&F Council and Groundwork London worked with local residents to design and implement climate change adaptation measures on three housing estates in the borough, making them more resilient and adapted for the future.

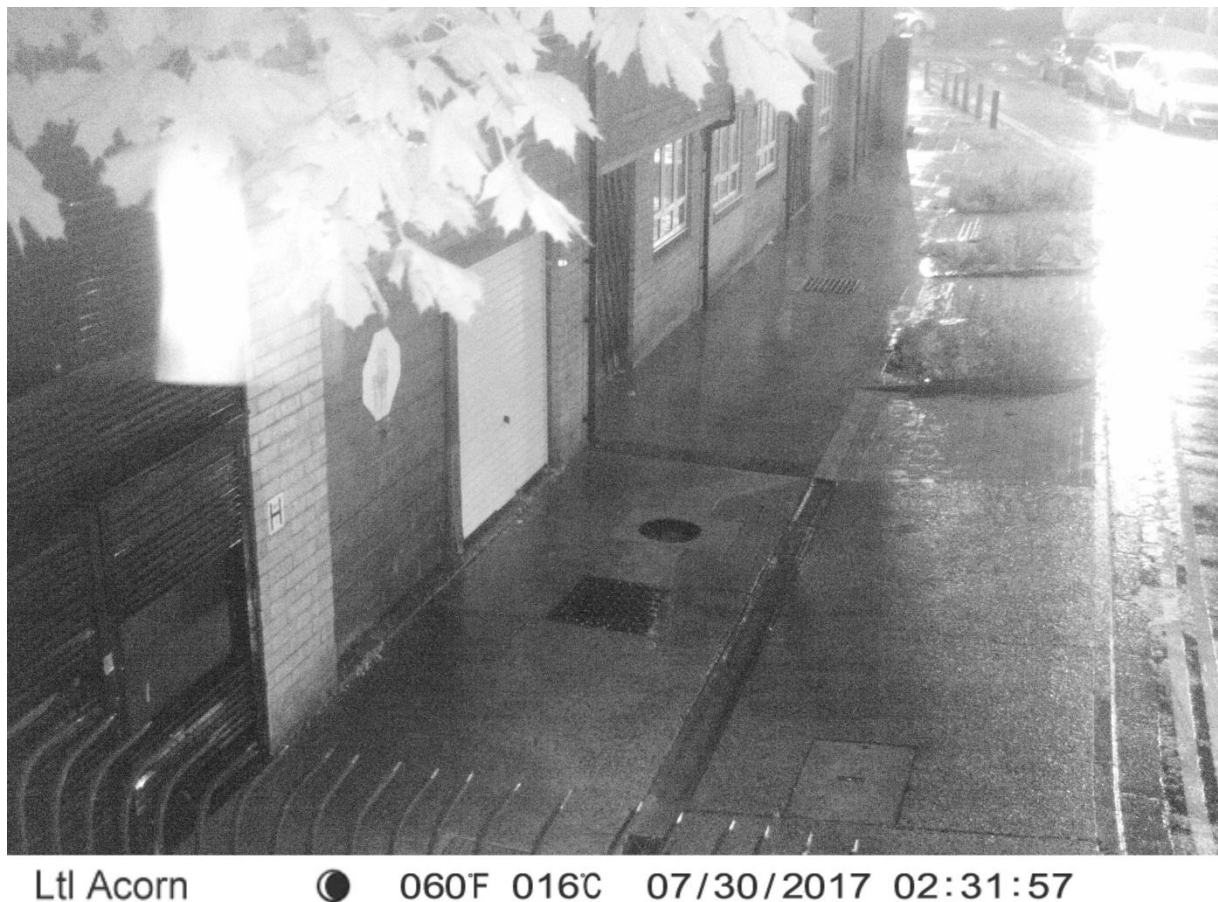
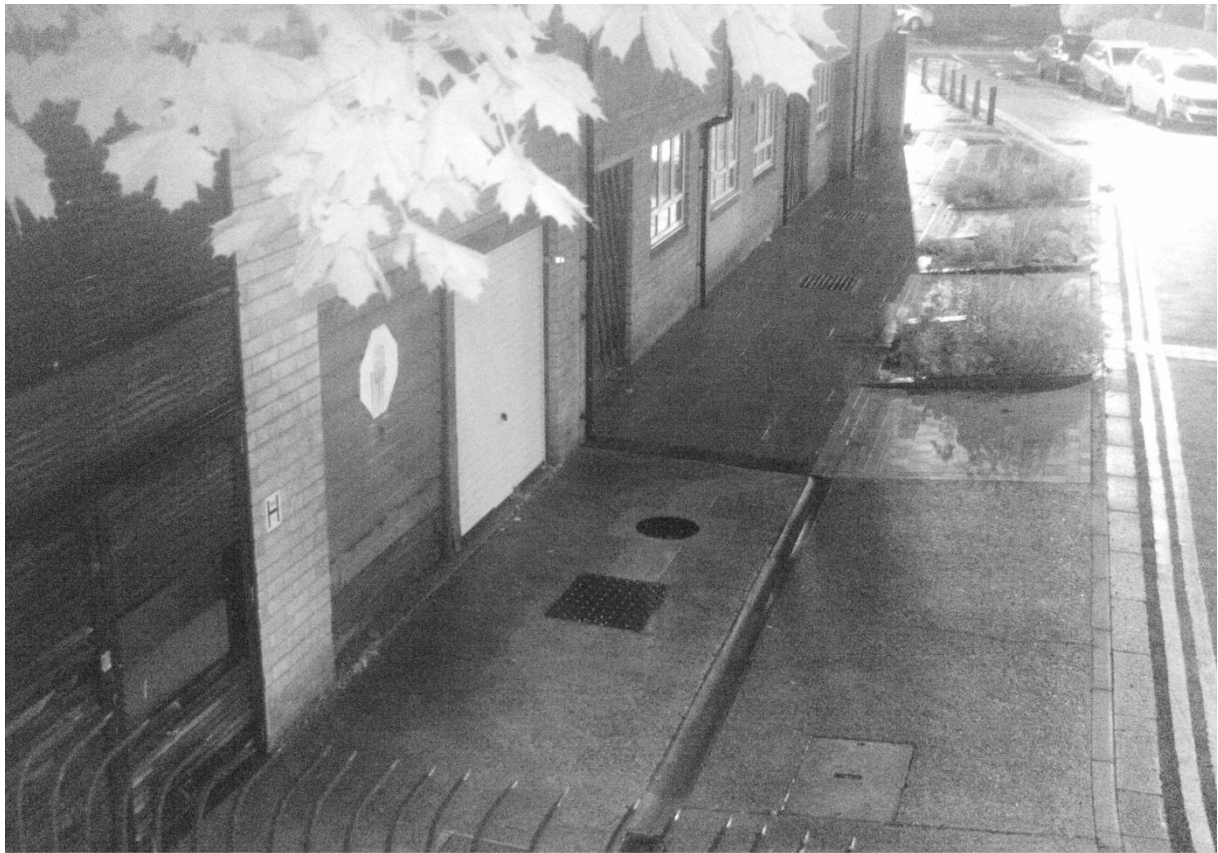
A complete collection of the images from Cheeseman Terrace rain gardens during the rain event from 02:00 to 03:30 on the 30th July 2017 were captured and analysed. They demonstrated that the rain gardens were able to retain and attenuate all of the rainfall that fell directly onto the area. Due to the design of the underdrainage from the road, analysis of pressure sensor data is required in order to establish whether all of the runoff from the road was also managed. Nevertheless, the images also demonstrated that at around 02:30 during the peak of the rainfall, there was no obvious standing water within or around the rain gardens (Figure 141.i). Following the cessation of the event at 03:30, there was also no obvious pooled water (Figure 141.ii) indicating that the rain gardens were not becoming saturated with stormwater.

**Figure 141. Time-lapse camera images from Cheeseman Terrace rain gardens (FPC6), 30/07/2011.** Images show i) no evidence of overflowing during a period of high rain intensity at 02:31 and ii) evidence of 100% infiltration/conveyance by the end of the intense rain event at 03:31 on the same day.

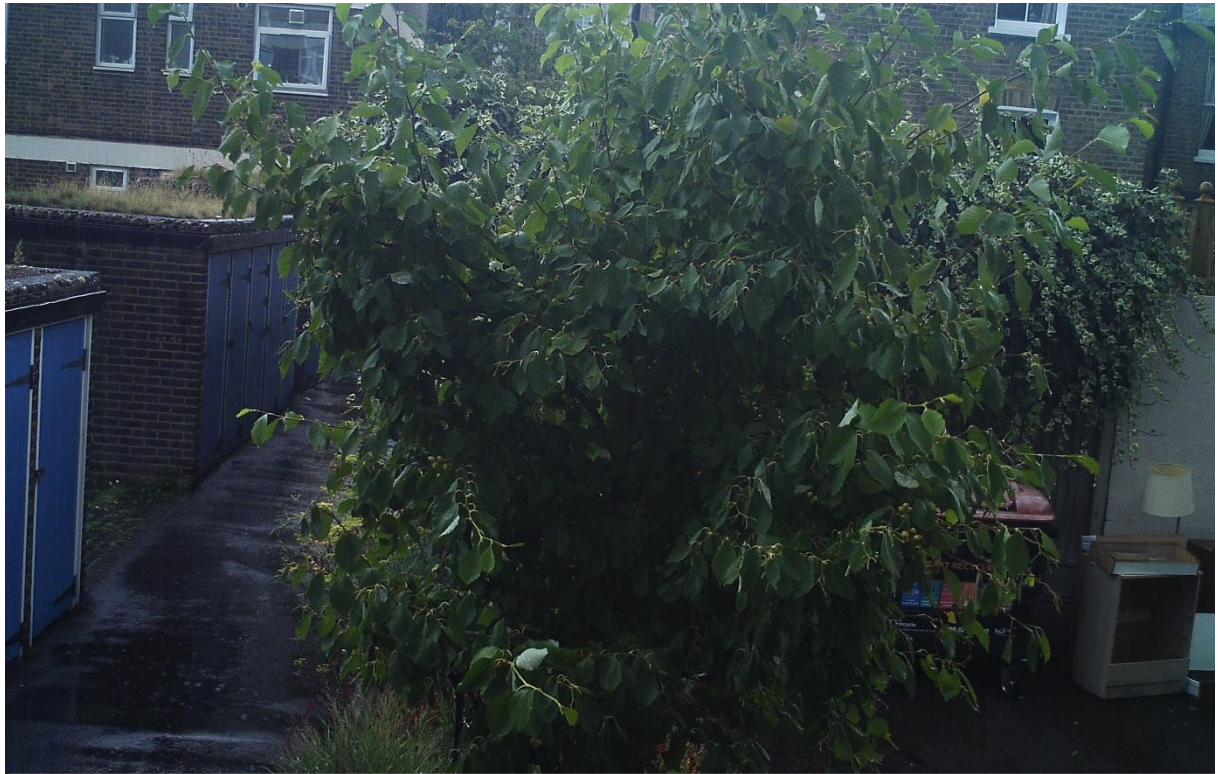
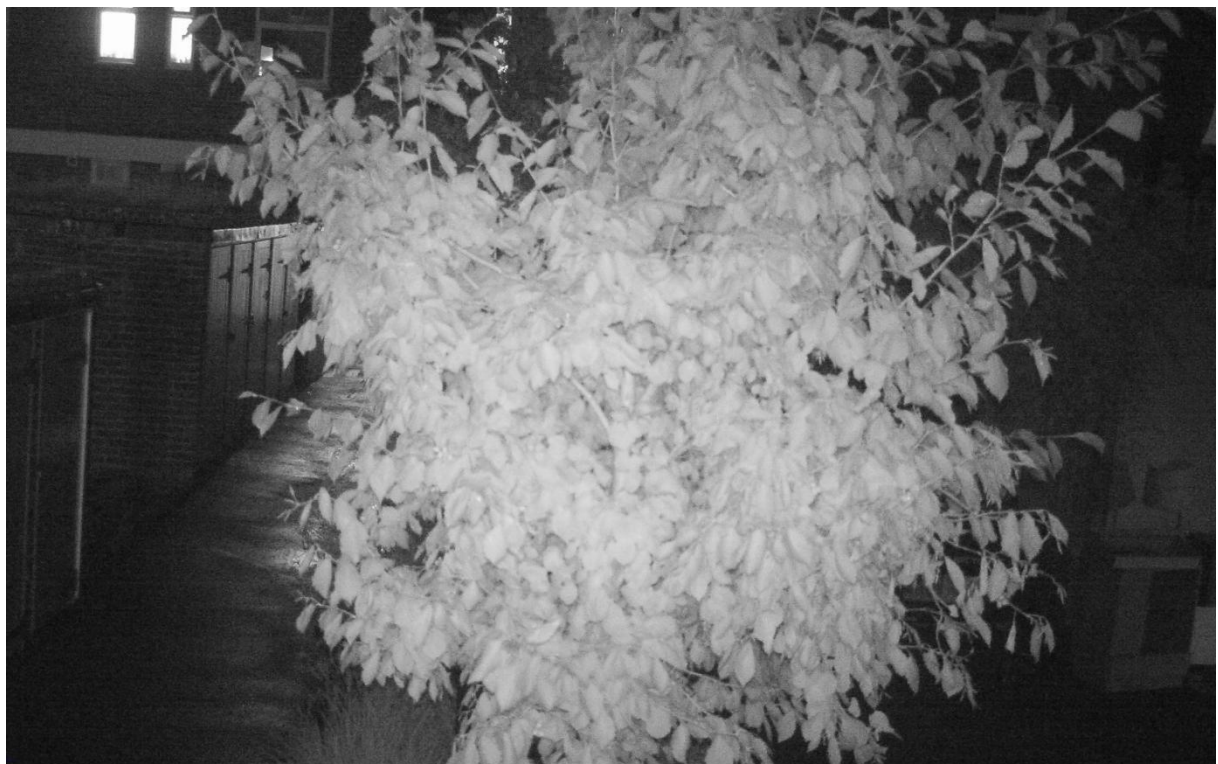
A complete collection of the images from the Richard Knight House rain garden during the rain event from 00:00 to 22:00 on the 22nd July 2017 were captured and analysed. They demonstrated that the rain garden was able to retain and attenuate all of the rainfall that fell directly onto the area and that which was diverted from the neighbouring roofs. The images also demonstrated that at around 19:10 during the peak of the rainfall, despite substantial input from the neighbouring roofs, there was no obvious standing water around the rain garden (Figure 143.i). By the time of the end of the rain event at 22:10, there was also no obvious pooled water (Figure 143.ii) indicating that the rain garden was infiltrating all of the stormwater.

**Figure 143. Time-lapse camera images from Richard Knight House rain garden (FPC5), 22/07/2017.** Images show i) no evidence of overflowing during period of highest rain intensity at 19:11 and ii) evidence of 100% infiltration/conveyance by the end of the rain event at 22:11 on the same day.

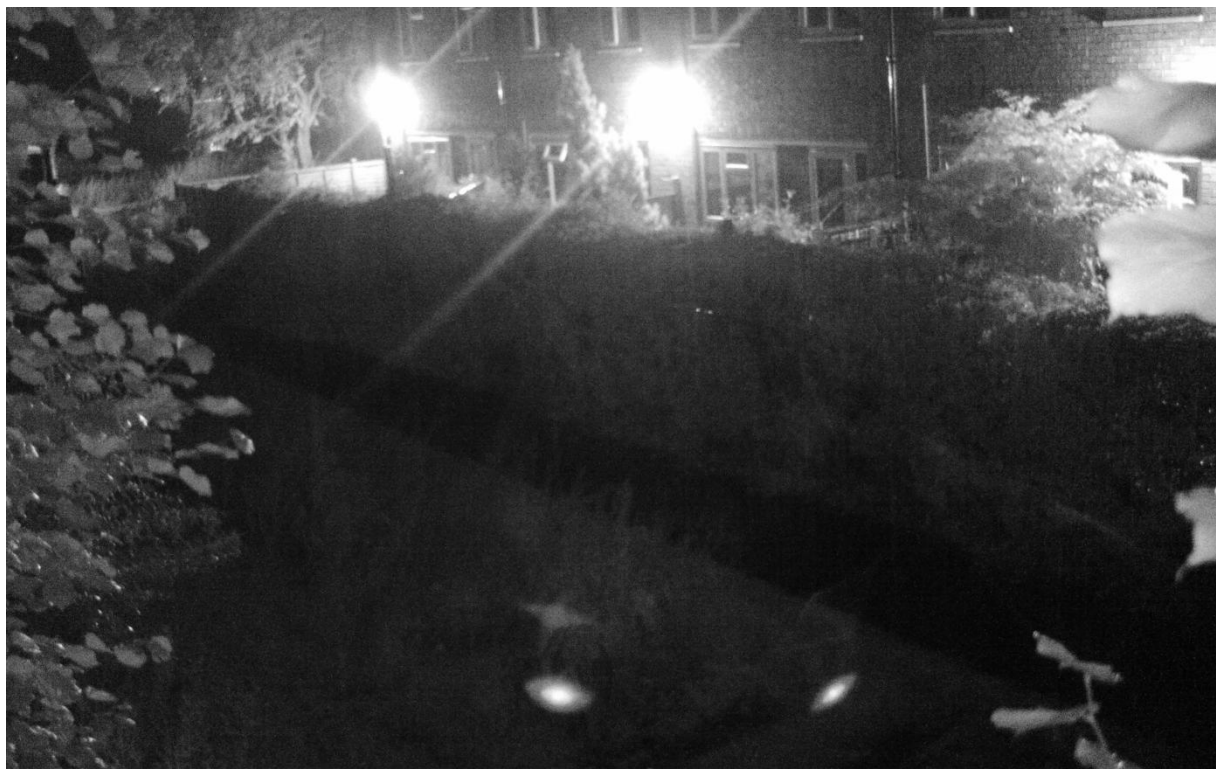
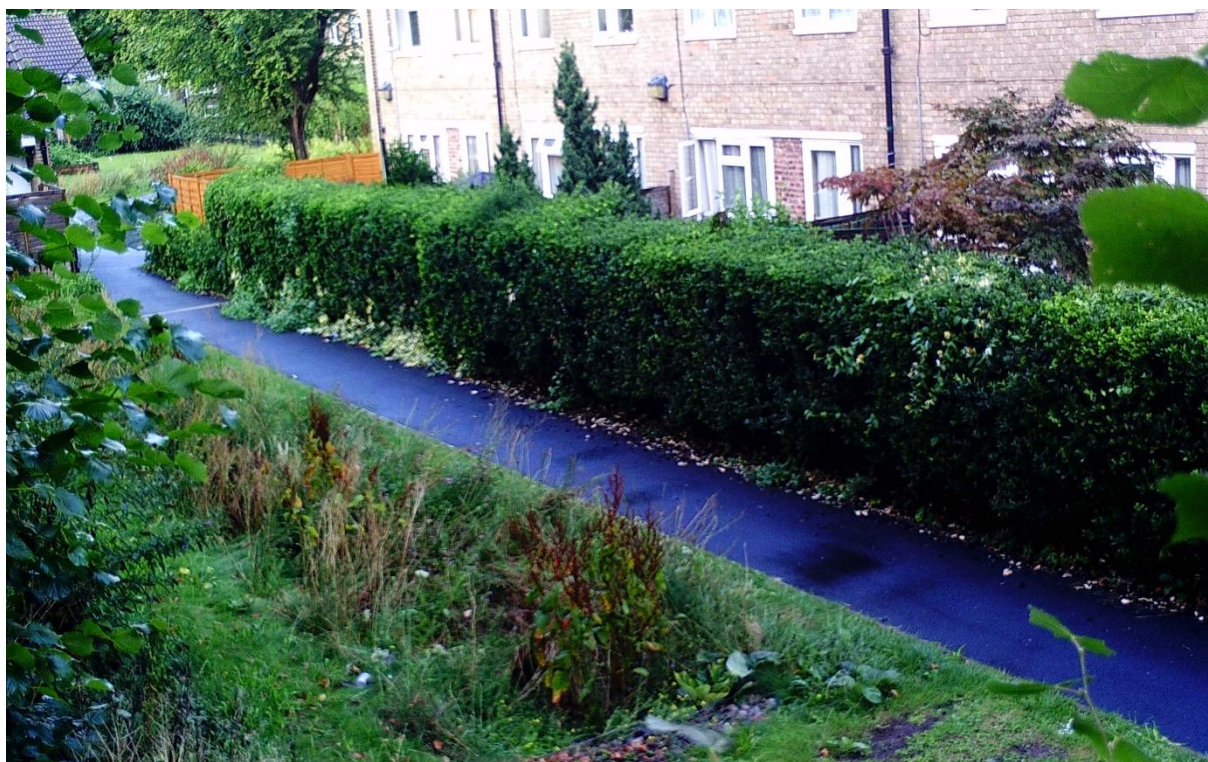
A complete collection of the images from the Alexandra House swale during the rain event from 00:00 to 19:30 on the 22nd July 2017 were captured and analysed. They demonstrated that the swale was able to retain and attenuate all of the rainfall that fell directly onto the area and that which was diverted from the neighbouring roof. The images also demonstrated that at around 02:20 during the peak of the rainfall, despite substantial input from the neighbouring roof, there was no obvious standing water within or around the rain garden (Figure 145.i). By the time of the end of the rain event at 19:50, there was also no obvious pooled water (Figure 145.ii) indicating that the swale was infiltrating all of the stormwater.

**Figure 145. Time-lapse camera images from Alexandra House swale (FPC1), 22/07/2017.** Images show i) no evidence of overflowing during a period of high rain intensity at 02:18 and ii) evidence of 100% infiltration/conveyance by the end of the intense rain event at 19:48 on the same day.

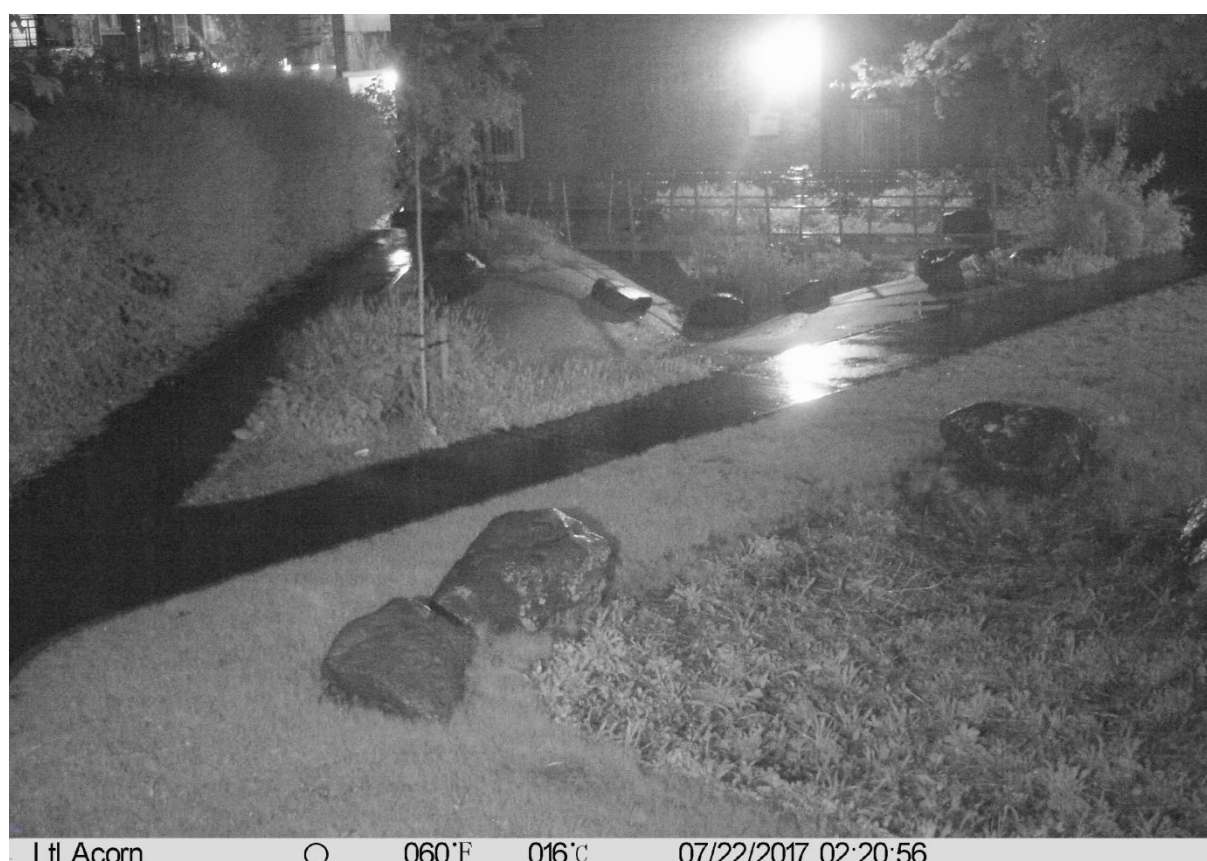
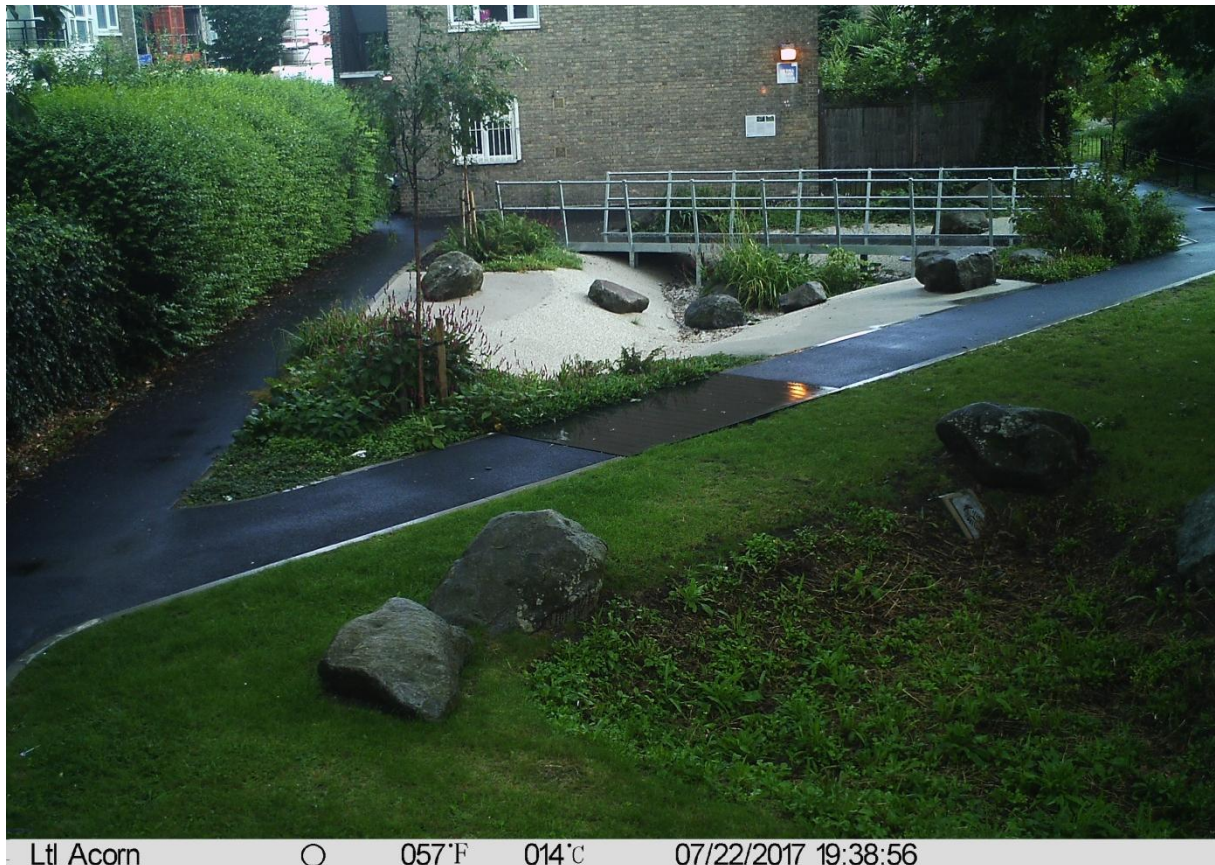
A complete collection of the images from the Adella House basins during the rain event from 00:00 to 19:30 on the 22nd July 2017 were captured and analysed. They demonstrated that the basins were able to retain and attenuate all of the rainfall that fell directly onto the area and that which was diverted from the neighbouring roofs. The images also demonstrated that at around 02:20 during the peak of the rainfall, despite substantial input from the Adella House roof, there was no obvious standing water within or around the basins (Figure 147.i). Following the cessation of the event at 19:40, there was also no obvious pooled water (Figure 147. ii) indicating that the basins were infiltrating all of the stormwater.

**Figure 147. Time-lapse camera images from Adella House grass and stoney basins (FPC3), 22/07/2017.** Images show i) no evidence of overflowing during a period of high rain intensity at 02:20 and ii) evidence of 100% infiltration/conveyance by the end of the intense rain event at 19:38 on the same day.

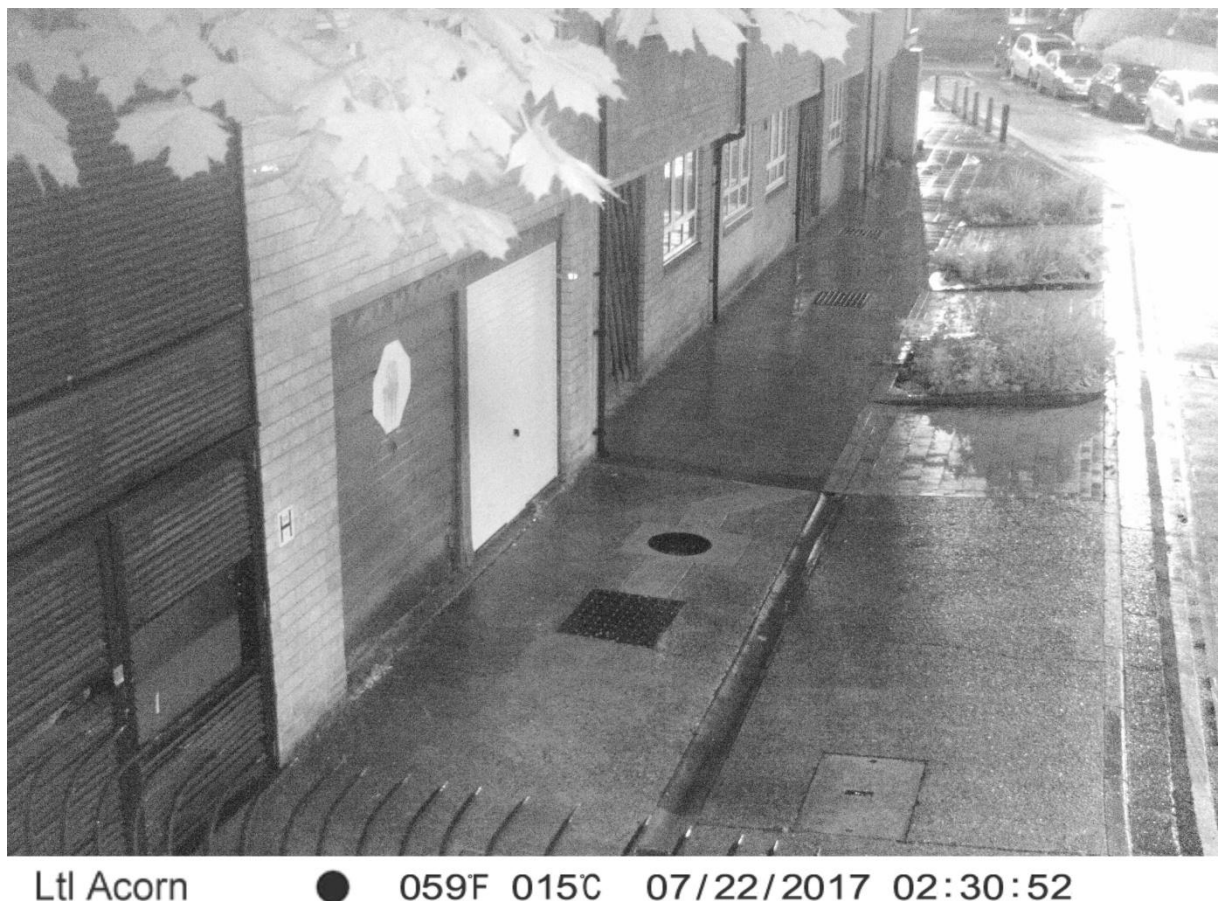
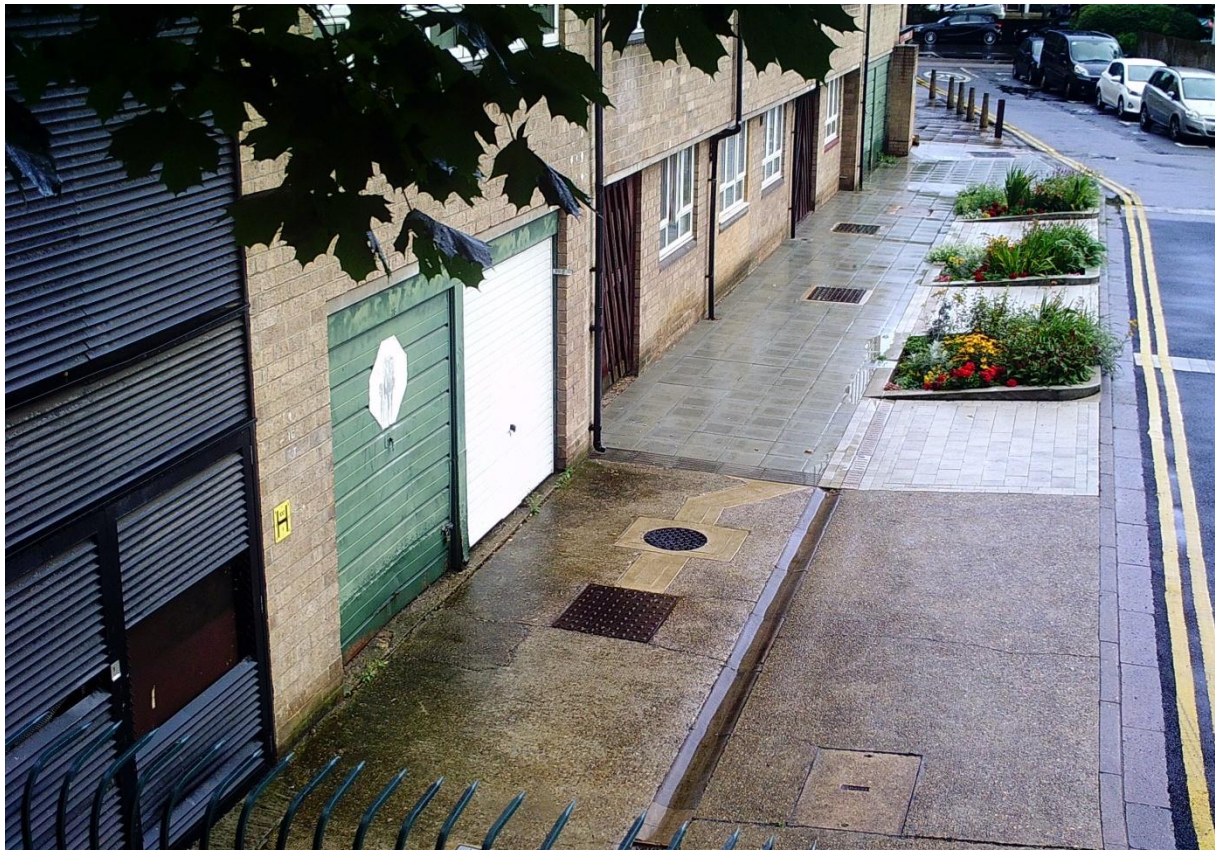
A complete collection of the images from Cheeseman Terrace rain gardens during the rain event from 00:00 to 19:30 on the 22nd July 2017 were captured and analysed. They demonstrated that the rain gardens were able to retain and attenuate all of the rainfall that fell directly onto the area. Due to the design of the underdrainage from the road, analysis of pressure sensor data is required in order to establish whether all of the runoff from the road was also managed. Nevertheless, the images also demonstrated that at around 02:30 during the peak of the rainfall, there was no obvious standing water within or around the rain gardens (Figure 149.i). Following the cessation of the event at 19:30, there was also no obvious pooled water (Figure 149.ii) indicating that the rain gardens were not becoming saturated with stormwater. The final image does have some evidence of pooling next to the entrance of the rain garden, but this appears to be related to run off from the pavement not entering the rain garden, rather than the rain garden overflowing on to the pavement.

**Figure 149. Time-lapse camera images from Cheeseman Terrace rain gardens (FPC6), 22/07/2011.** Images show i) no evidence of overflowing during a period of high rain intensity at 02:30 and ii) evidence of 100% infiltration/conveyance by the end of the intense rain event at 19:30 on the same day.

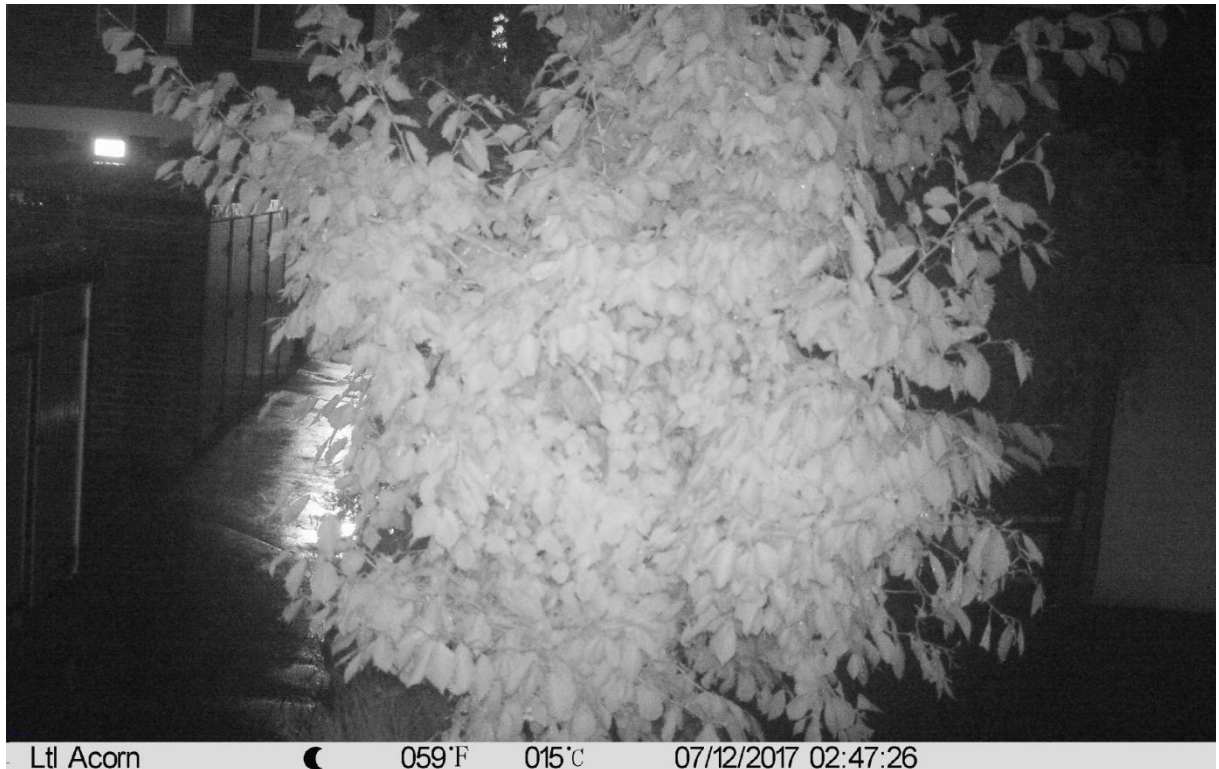
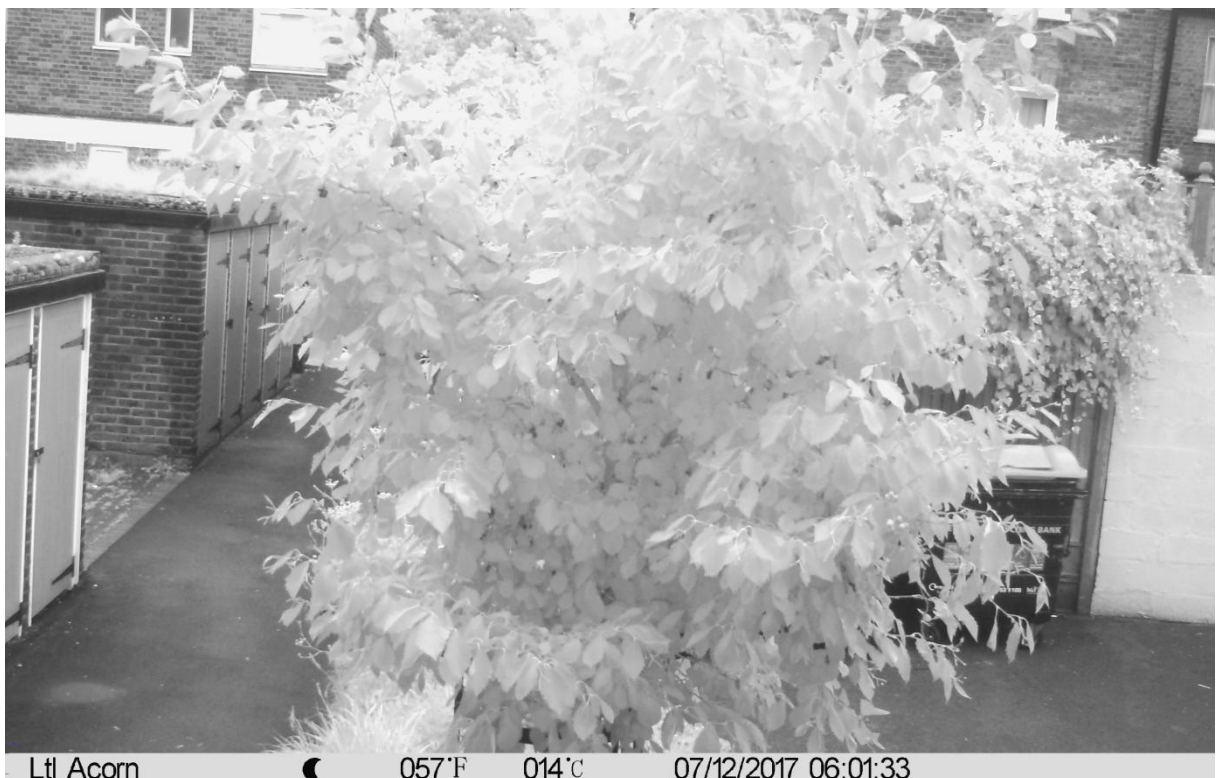
**Figure 151. Time-lapse camera images from Richard Knight House rain garden (FPC5), 11/07/2017 and 12/07/2017.** Images show i) no evidence of overflowing during period of highest rain intensity at 02:47 and ii) evidence of 100% infiltration/conveyance by the end of the rain event at 06:01 on the same day.

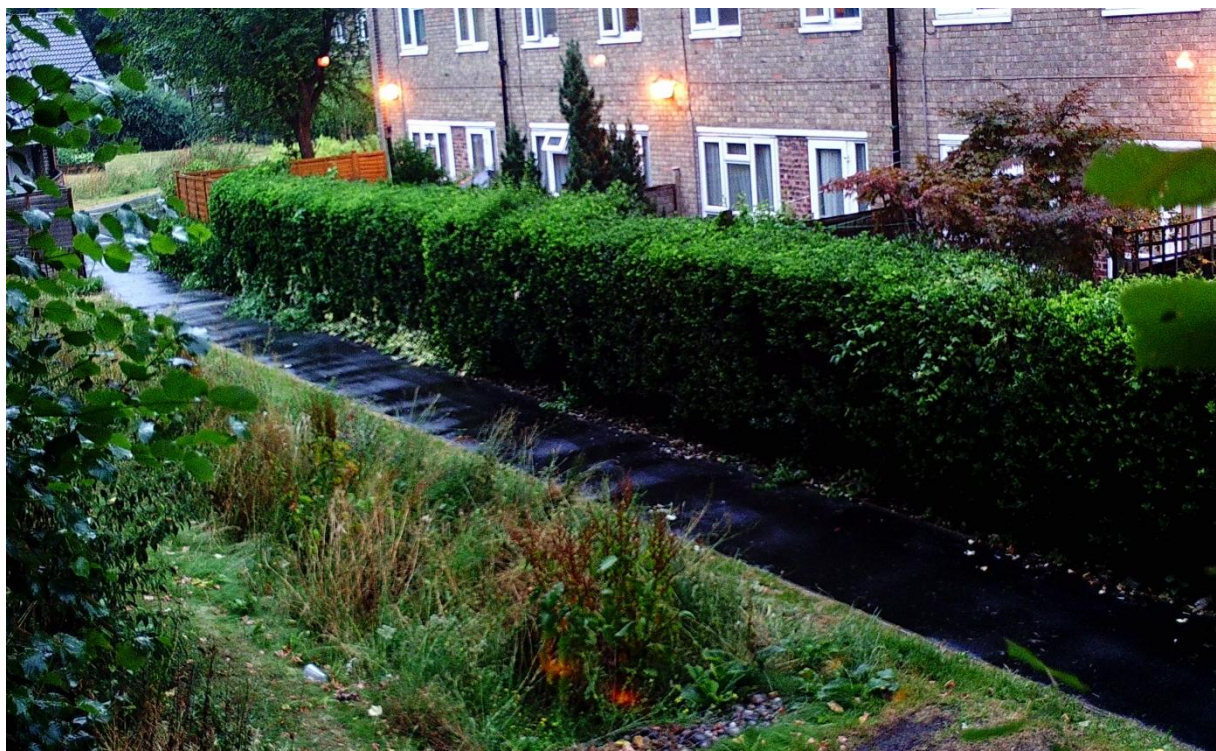
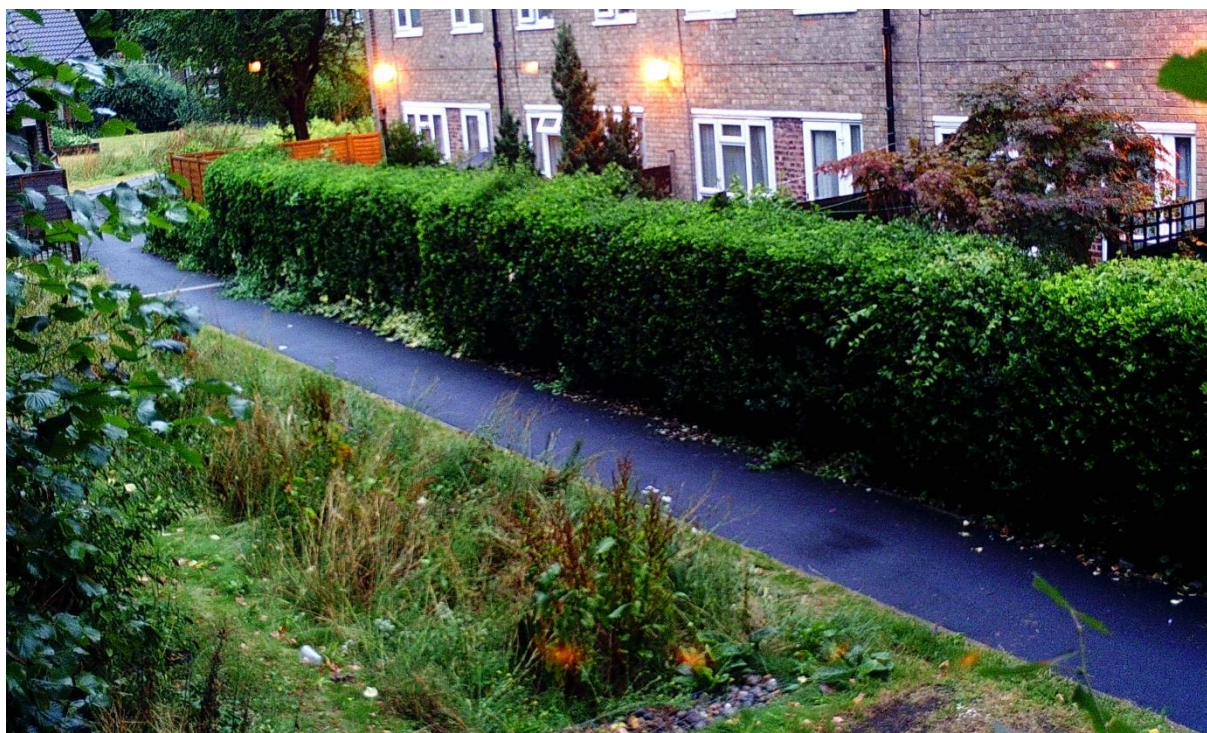
A complete collection of the images from the Alexandra House swale during the rain event from 19:30 on the 11th until 05:30 on the 12th July 2017 were captured and analysed. They demonstrated that the swale was able to retain and attenuate all of the rainfall that fell directly onto the area and that which was diverted from the neighbouring roof. The images also demonstrated that at around 20:00 on the 11th during the peak of the rainfall, despite substantial input from the neighbouring roof, there was no obvious standing water within or around the rain garden (Figure 153.i). By the time of the end of the rain event at 06:00 on the 12th, there was also no obvious pooled water (Figure 153.ii) indicating that the swale was infiltrating all of the stormwater.

**Figure 153. Time-lapse camera images from Alexandra House swale (FPC1), 11/07/2017 and 12/07/2017.** Images show i) no evidence of overflowing during a period of high rain intensity at 19:56 on the 11th and ii) evidence of 100% infiltration/conveyance by the end of the intense rain event at 05:58 on the 12th.

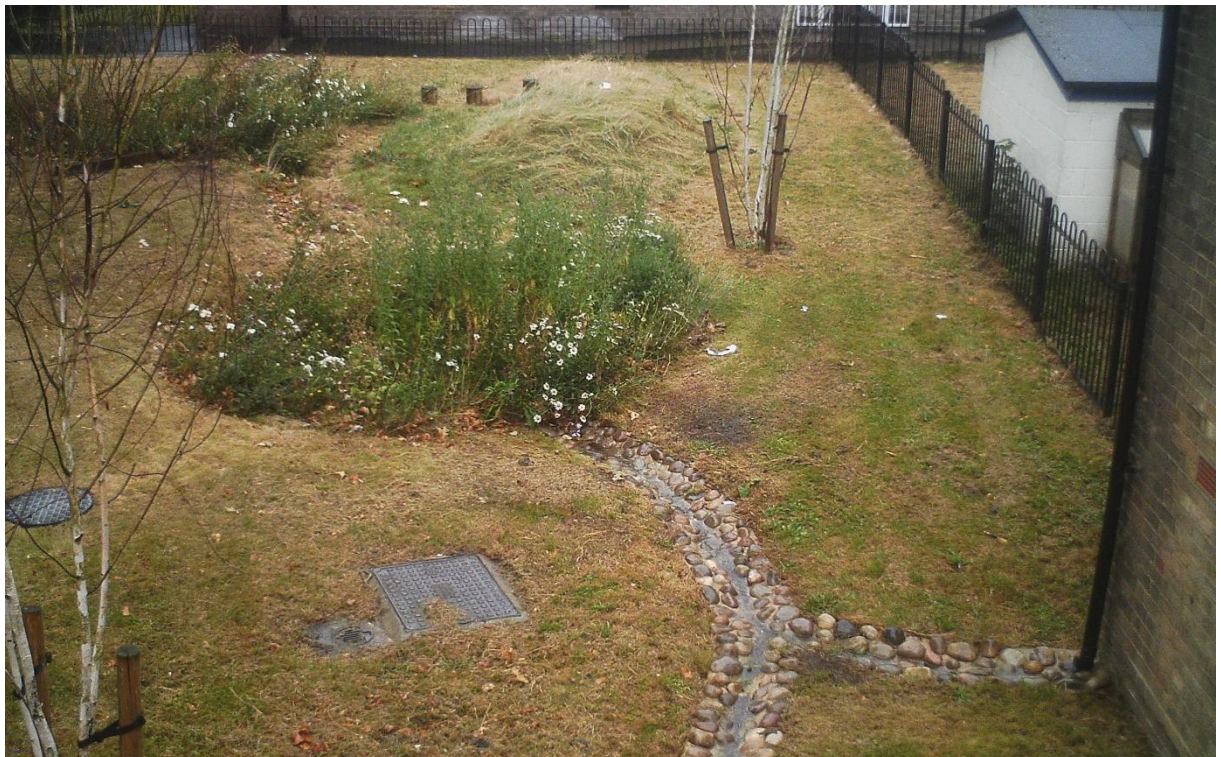
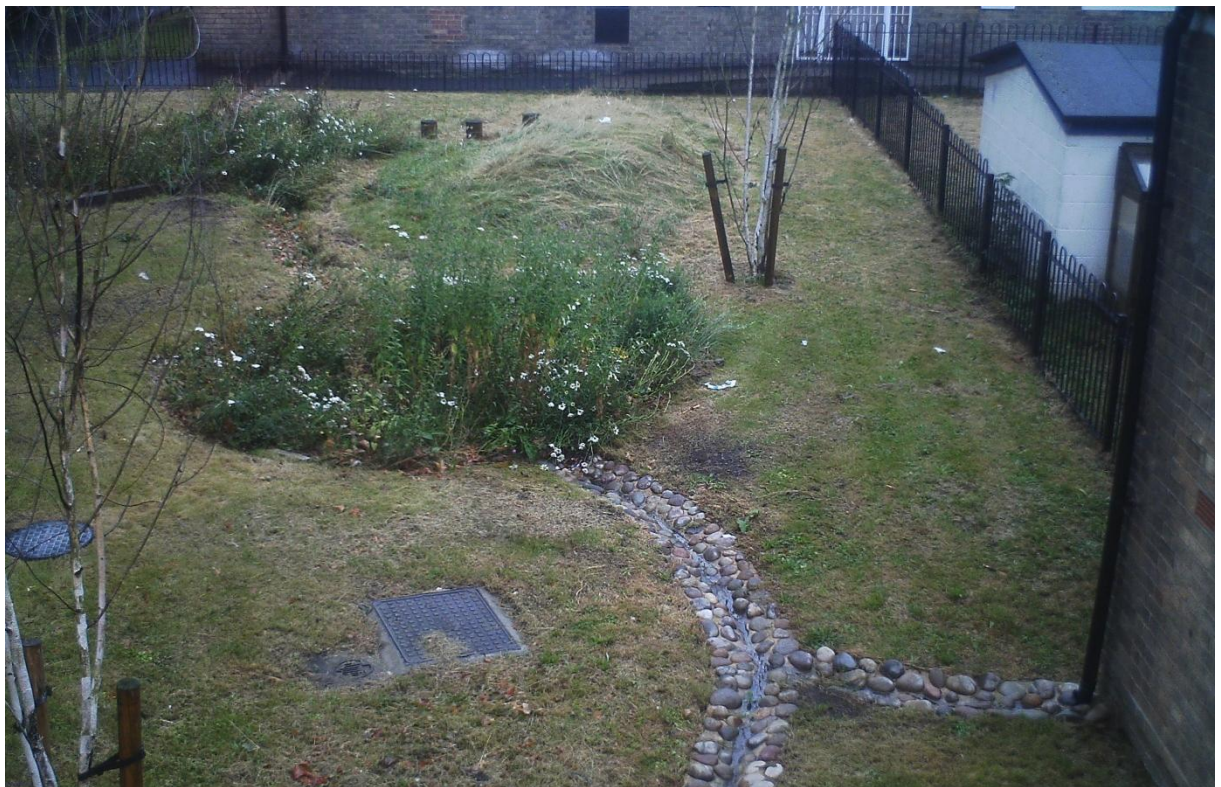
A complete collection of the images from the community hall and Sofia House basins during the rain event from 19:30 on the 11th to 05:30 on the 12th July 2017 were captured and analysed. They demonstrated that the basins were able to retain and attenuate all of the rainfall that fell directly onto the area and that which was diverted from the neighbouring roofs. The images also demonstrated that at around 19:30 on the 11th during the peak of the rainfall, despite substantial input from the community hall roof, there was no obvious standing water within or around the basins (Figure 154.i). Following the cessation of the event at 06:15 on the 12th, there was also no obvious pooled water (Figure 154.ii) indicating that the basins were infiltrating all of the stormwater.

**Figure 154. Time-lapse camera images from Community Hall and Sofia House basins (FPC2), 11/07/2017 and 12/07/2017. Images show i) no evidence of overflowing during a period of high rain intensity at 19:34 on the 11th and ii) evidence of 100% infiltration/conveyance by the end of the intense rain event at 06:15 on the 12th.**

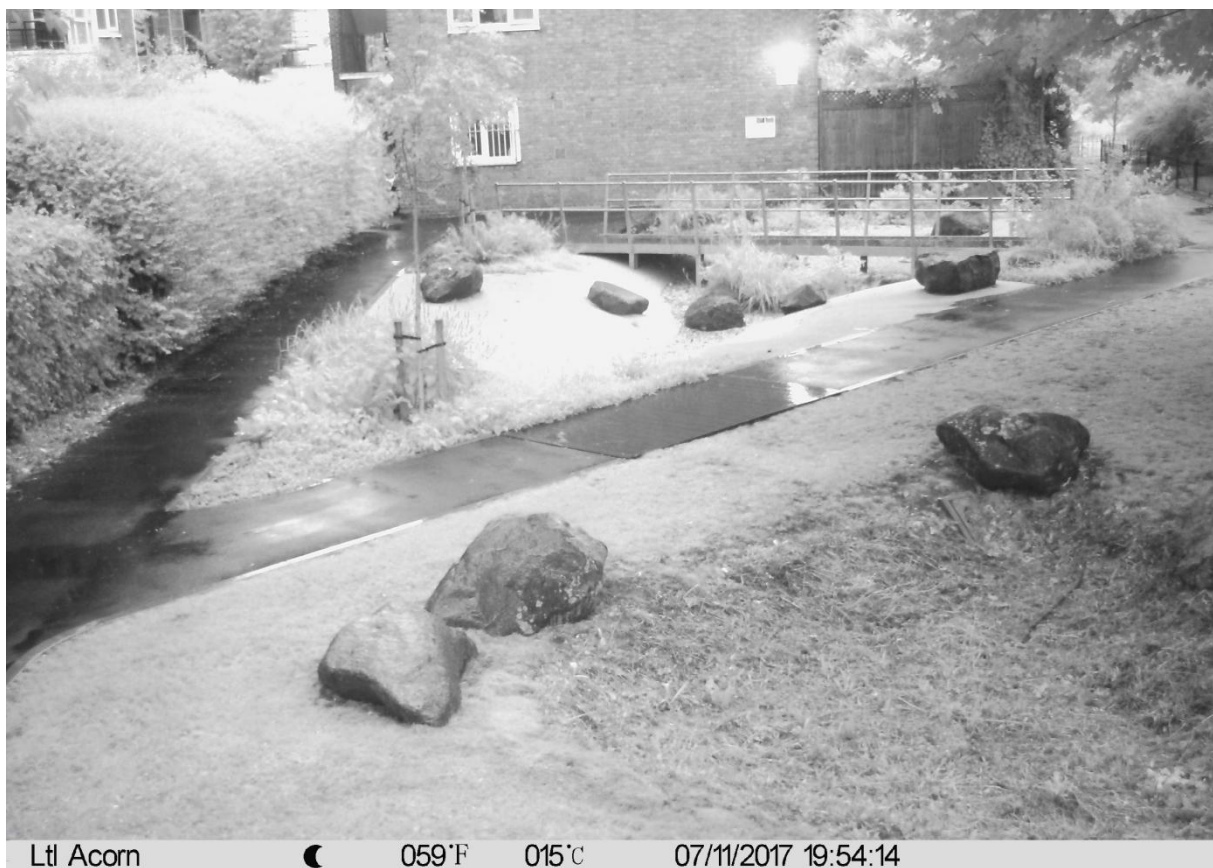
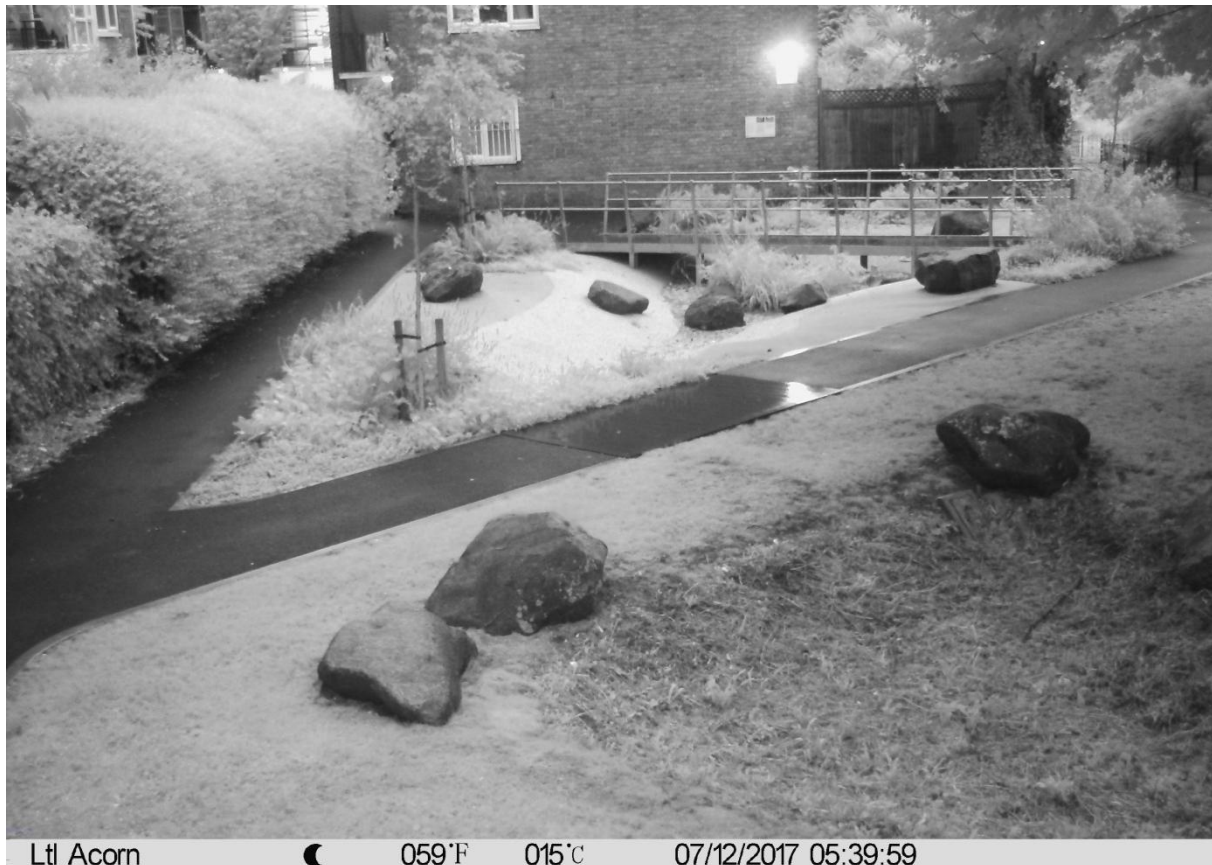
A complete collection of the images from the Adella House basins during the rain event from 19:30 on the 11th to 05:30 on the 12th July 2017 were captured and analysed. They demonstrated that the basins were able to retain and attenuate all of the rainfall that fell directly onto the area and that which was diverted from the neighbouring roofs. The images also demonstrated that at around 20:00 on the 11th during the peak of the rainfall, despite substantial input from the Adella House roof, there was no obvious standing water within or around the basins (Figure 155.i). Following the cessation of the event at 05:40 on the 12th, there was also no obvious pooled water (Figure 155.ii) indicating that the basins were infiltrating all of the stormwater.

**Figure 155. Time-lapse camera images from Adella House grass and stoney basins (FPC3), 22/07/2017.** Images show i) no evidence of overflowing during a period of high rain intensity at 19:54 on the 11th and ii) evidence of 100% infiltration/conveyance by the end of the intense rain event at 05:39 on the 12th.

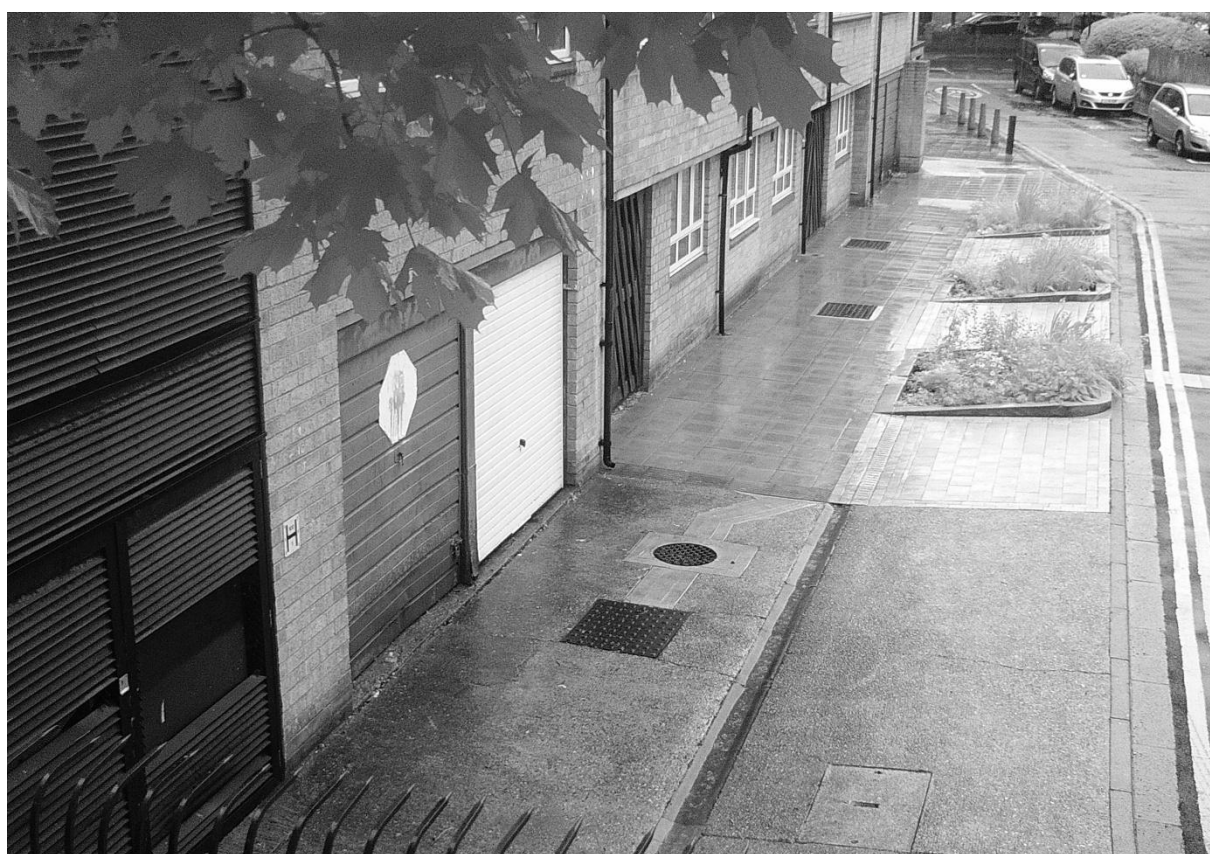
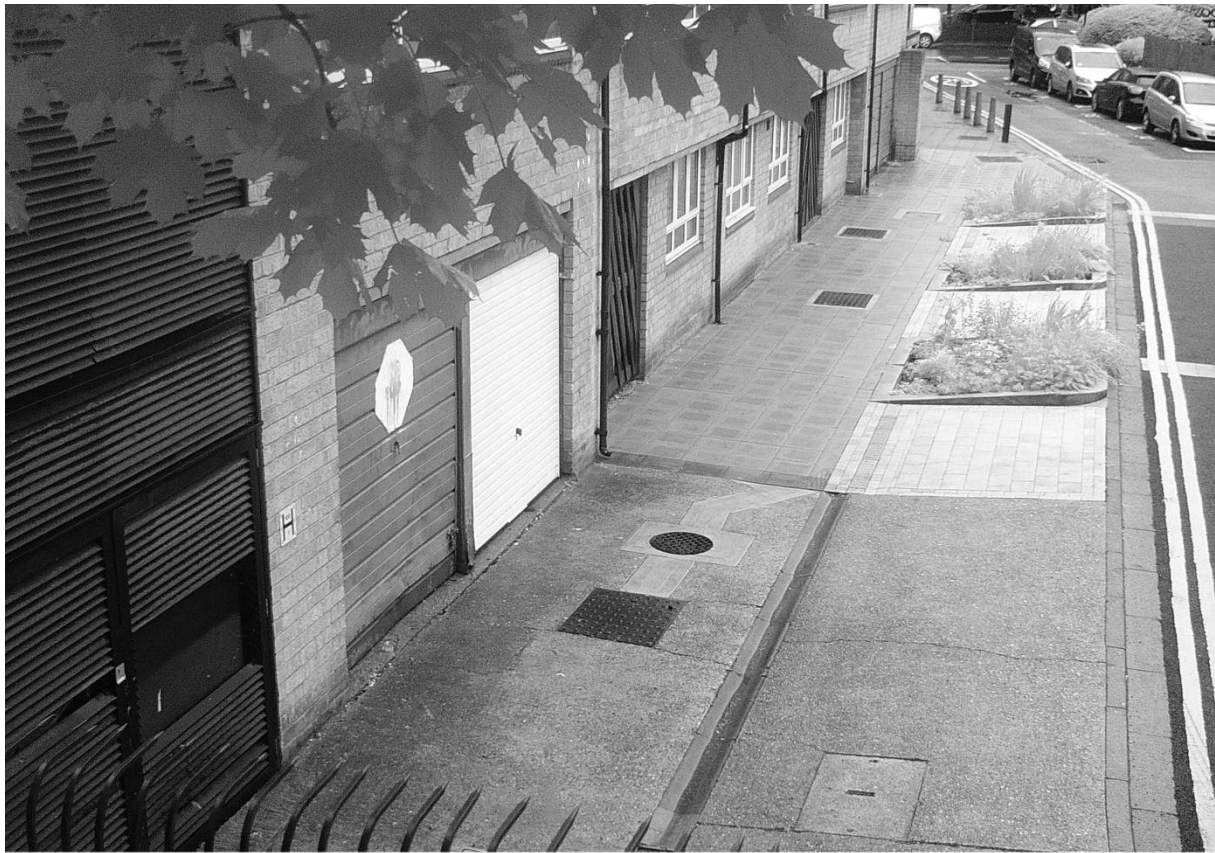
A complete collection of the images from Cheeseman Terrace rain gardens during the rain event from 19:30 on the 11th to 05:30 on the 12th July 2017 were captured and analysed. They demonstrated that the rain gardens were able to retain and attenuate all of the rainfall that fell directly onto the area. Due to the design of the underdrainage from the road, analysis of pressure sensor data is required in order to establish whether all of the runoff from the road was also managed. Nevertheless, the images also demonstrated that at around 19:50 on the 11th during the peak of the rainfall, there was no obvious standing water within or around the rain gardens (Figure 157.i). Following the cessation of the event at 06:00 on the 12th, there was also no obvious pooled water (Figure 157.ii) indicating that the rain gardens were not becoming saturated with stormwater. Some of the images do have some evidence of pooling next to the entrance of the rain garden, but this appears to be related to run off from the pavement not entering the rain garden, rather than the rain garden overflowing on to the pavement.

**Figure 157. Time-lapse camera images from Cheeseman Terrace rain gardens (FPC6), 22/07/2011.** Images show i) no evidence of overflowing during a period of high rain intensity at 19:53 on the 11th and ii) evidence of 100% infiltration/conveyance by the end of the intense rain event at 05:55 on the 12th.
