FULL-SCALE SHAKING TABLE TESTS ON DEFICIENT RC BUILDINGS STRENGTHENED WITH FRP COMPOSITES

The paper discusses the results from experimental programmes including full-scale shaking table tests on two deficient one-span two-storey RC frame buildings strengthened with Carbon Fibre Reinforced Polymer (CFRP) composites. The tests were performed at one of the world class shaking table testing facility, the AZALEE shake table at the Commissariat à l'Énergie Atomique (CEA), Laboratory in Saclay, France, as part of two European (EU) funded research projects (EU ECOLEADER project and EU FP7 SERIES/ BANDIT project). The aim of these experimental programmes was to investigate the effectiveness of externally bonded CFRP reinforcement in improving the seismic behaviour of deficiently designed RC buildings. To simulate typical substandard design, the reinforcement of beam-column joints and columns of the two full-scale frames had inadequate detailing. In both projects, initial shaking table tests were carried out to assess the seismic behaviour of the bare frame buildings. Columns and joints were subsequently repaired and strengthened using CFRP composite material for the ECOLEADER frame, and a

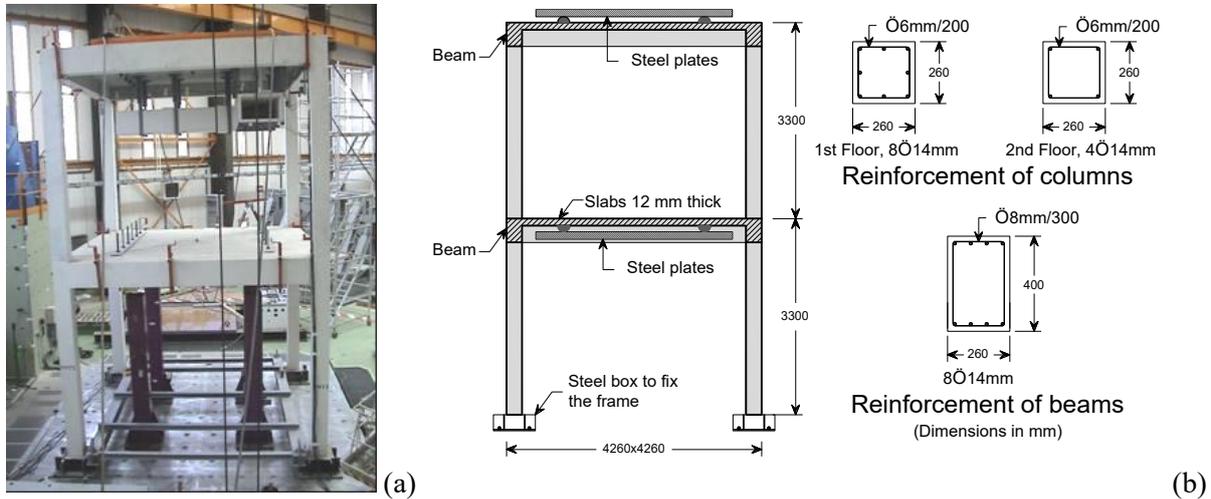
Fig. 1 - ECOLADER frame building: (a) general view, (b) geometry of the frame and structural elements

The tested frame building was a RC one-span two-storey frame, regular in plan and elevation, designed using old European earthquake-resistant provisions from the 60's [9, 10]. As a result, columns and beam-column joints were expected to experience significant damage during the initial shaking tests. The frame had the dimensions in plan of 4.26×4.26 m and had a constant storey height of 3.30 m. The general view of the

frame, along with details of the general geometry, element sections and corresponding reinforcement are shown in Fig.1.

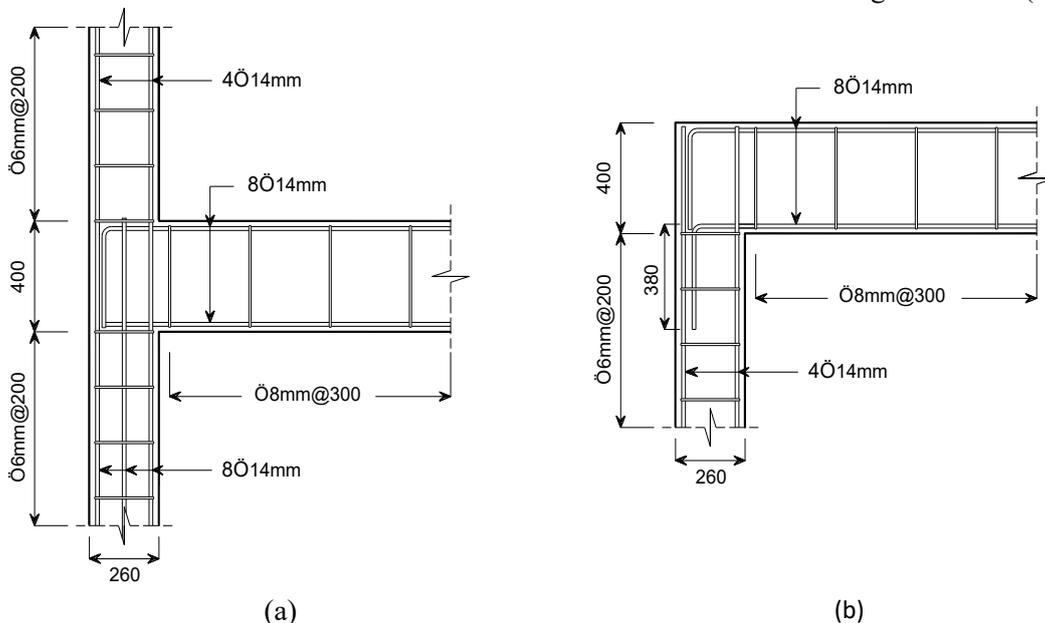
Fig. 2 - Detailing of reinforcing steel in beam-column joints at: (a) 1st storey and (b) 2nd storey

The detailing of the reinforcing steel in beam-column joints is shown in Fig.2. The concrete compressive strength and modulus of elasticity were $f_c=20$ MPa and $E_c=25545$ MPa, and the yield and ultimate strength of steel reinforcement were $f_y=551$ MPa and $f_u=656$ MPa, respectively. The manufacturer's mechanical and physical properties of the utilised unidirectional CFRP composite material were: the tensile strength $f_{FRP}=1350$ MPa, modulus of elasticity $E_{FRP}=105$ GPa, and layer thickness of 0.48 mm. An additional mass of 9.0 ton was attached to each slab to simulate real loading conditions (Fig.1).

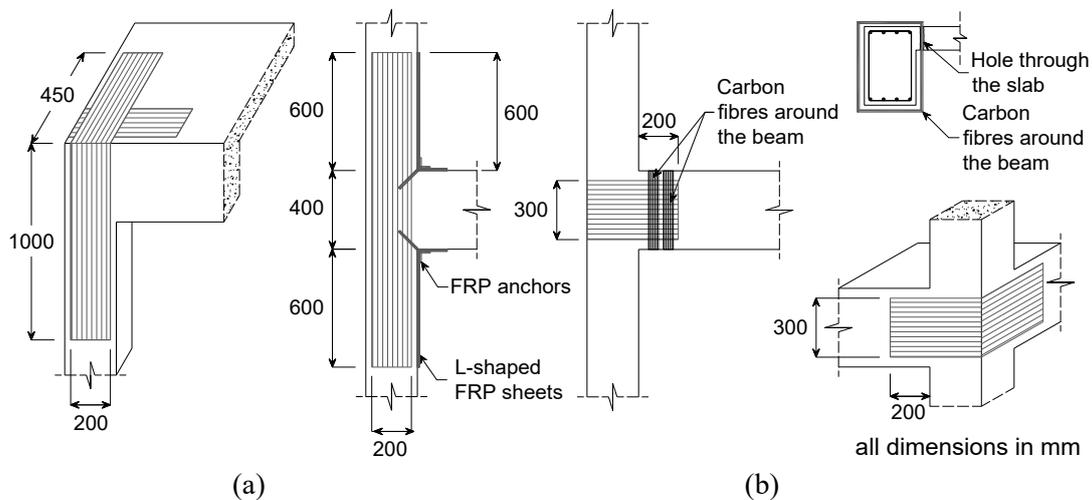
Fig. 3 - Strengthening of the frame using CFRP material at (a) exterior faces of columns, and (b) exterior zone of beam-column joints

The initial series of tests with PGAs varying between 0.05g and 0.40g produced significant damage on the frame, especially at the ends of columns (weak column-strong beam damage mechanism). After these tests, the damaged frame was strengthened locally with externally bonded CFRP composites using a wet lay-up technique. The main scope of the strengthening was to produce a strong column-weak beam mechanism, which is in line with current seismic design provisions. Before strengthening, the damaged concrete was repaired using repair mortar and the main cracks were injected with epoxy resin. One vertical CFRP sheet (parallel to the columns' axes) was attached at the interior and exterior faces of columns ends to enhance their flexural strength (Fig.3a). Beam-column joints at both storeys were also strengthened using one orthogonal sheet to avoid a premature shear failure, as shown in Fig.3b. In order to prevent premature debonding of the sheets applied to the strengthened joints, two thin strips of CFRPs were wrapped around the beams ends (Fig.3b). Additionally, CFRP confinement was used to further increase the column capacity and to avoid possible buckling and premature debonding of the longitudinal sheets along the columns' axes (Fig.4). The existing transverse reinforcement was sufficient to prevent shear failure in beams and columns, therefore no additional CFRP was required in this case.

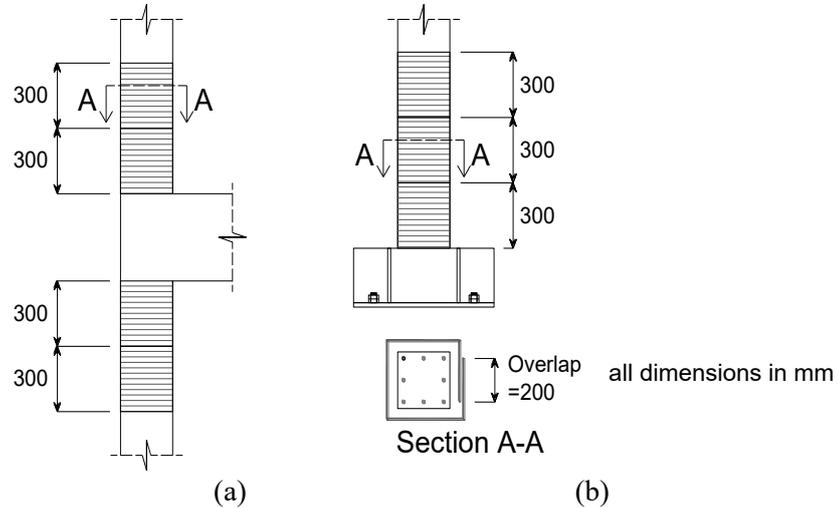
Fig. 4 - Confinement of the columns using CFRP composite material at (a) columns ends, and (b) bottom of 1st storey columns

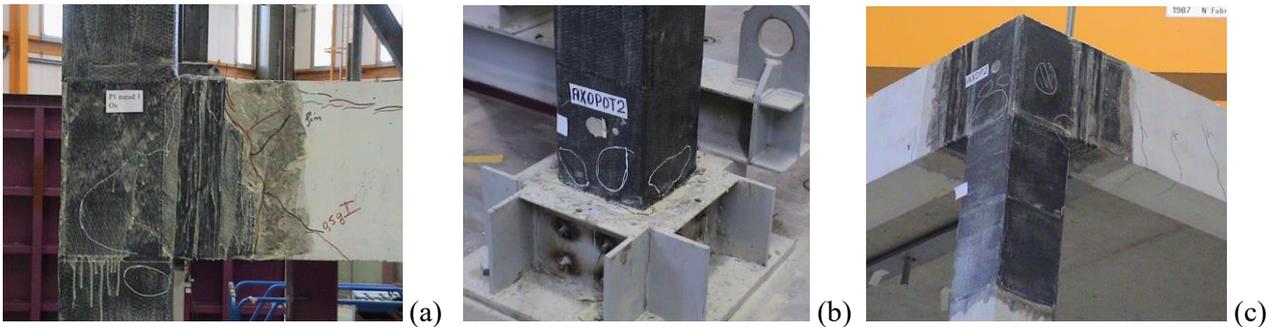
Fig. 5 - Damage after the test at PGA=0.5g on the CFRP strengthened frame: (a) beam end at 1st storey, (b) bottom of column 1st storey, (c) 2nd storey joint

Following the CFRP strengthening of the frame, a second series of shaking table tests were conducted with PGA levels ranging from 0.05g to 0.50g. No evident damage appeared during the test at PGA= 0.05g. The first damage to the CFRP sheets at the 2nd storey columns was observed after the test at PGA level of 0.20g. No further damage was noted at columns or CFRP sheets until after the final tests, although some fracture of the sheets occurred at beam-column joints. The adopted strengthening strategy was effective in preventing debonding of the CFRP sheets, as this type of failure was not observed during the tests. However, after the test at a PGA of 0.50g, significant concrete cracking occurred on the beams (Fig.5a), concrete cover spoiling under the CFRP confinement at the end of columns (Fig.5b) and at joints (Fig.5c). Fig.6 shows the deformed shape at maximum deformation for the bare and CFRP strengthened frame. It was noted that the use of CFRP strengthening resulted in a significant reduction in the inter-storey drift of 67% at the second

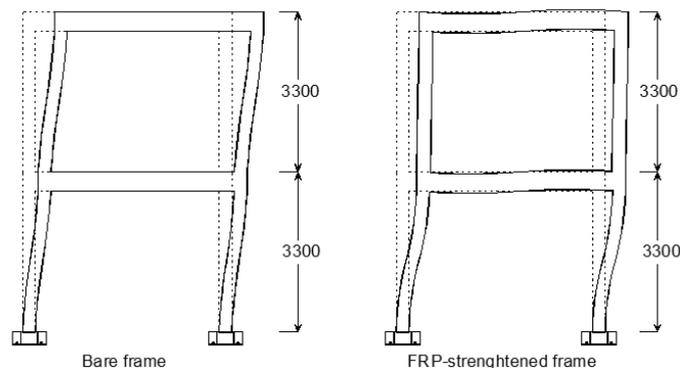
Fig. 6 - Deformed shape of the bare and CFRP strengthened frame at PGA=0.40g

floor (from 3.9% to 1.3%) for the PGA of 0.4g and delayed the deterioration of the frame due to bond-slip of the reinforcing steel at beams and columns.

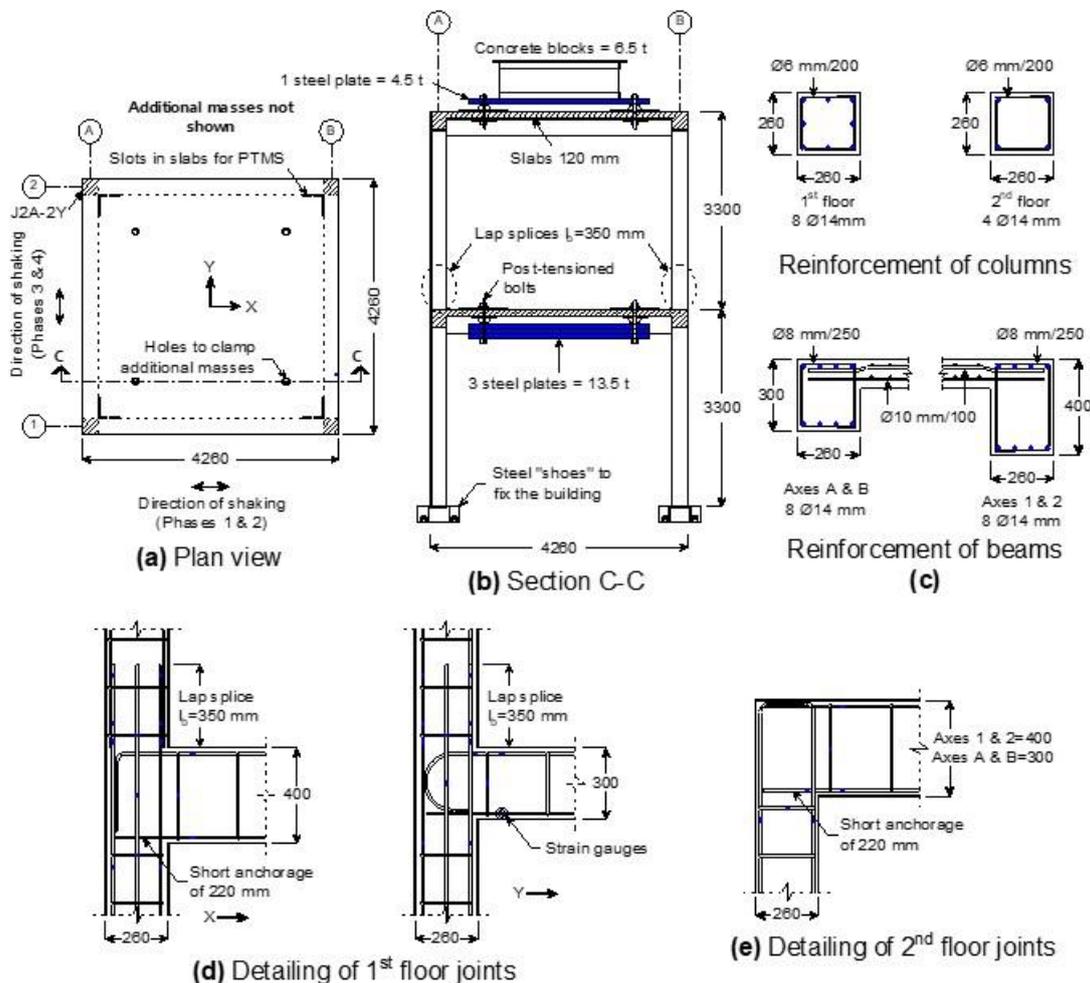
Fig. 7 - General geometry and reinforcement detailing of BANDIT frame building (units: mm), partially adapted from [12]

The geometry of the full-scale two-storey one-span frame building was similar to that of the frame tested as part of the ECOLEADER project, as discussed in Section 2 and [14]. The regular dimensions in plan of the frame building were 4.26×4.26 m and its constant floor height was 3.30 m (Fig.7a-b). The cross section of columns was 260×260 mm and longitudinal column bars were of diameter Ø14 mm (Fig.7c). The column bars were lapped over a length $l_b=25\phi=350$ mm just above the 1st floor joints (Fig.7d) to simulate old construction practices.

The beams had a cross section of 260×400 mm in the X direction and 260×300 mm in the Y direction (Fig.7c). The smaller beam depth was selected to increase the flexibility of the building in the Y direction, thus undergoing large interstorey drifts, therefore damage, in this direction during the tests at higher PGA levels. The longitudinal beam reinforcement had a diameter of Ø14 mm. The bottom beam reinforcement was anchored into the joints with no hooks/bends for a length of 220 mm (approximately 16Ø) to study the effect of deficient bar anchorage on the structural response (Fig.7d). This short anchorage length would be

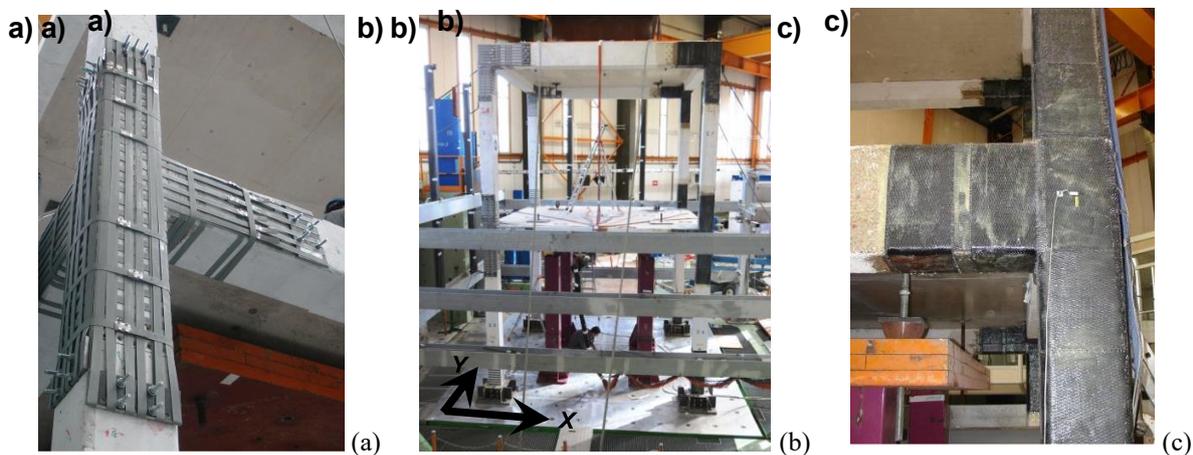
Fig. 8 - View of the frame building after the CFRP/PTMS strengthening: (a) PTMS strengthened joint, (b) general view of the strengthened frame on shake table, (c) CFRP strengthened joint

The dual strengthening intervention aimed at providing a strong column-weak beam damage mechanism by preventing the premature failure of the joints and by enhancing the flexural capacity of the columns, thus complying with current seismic design provisions. Fig.8 shows a general view of the strengthened building, where Fig.8a shows the PTMS installed so that it creates a confining 'mesh' around the beam-column joints, whilst Fig.8c shows the CFRP strengthened joint. The layout of CFRP sheets was similar to that used to retrofit the ECOLEADER frame building presented in section 2.3 (see also [12, 14]).

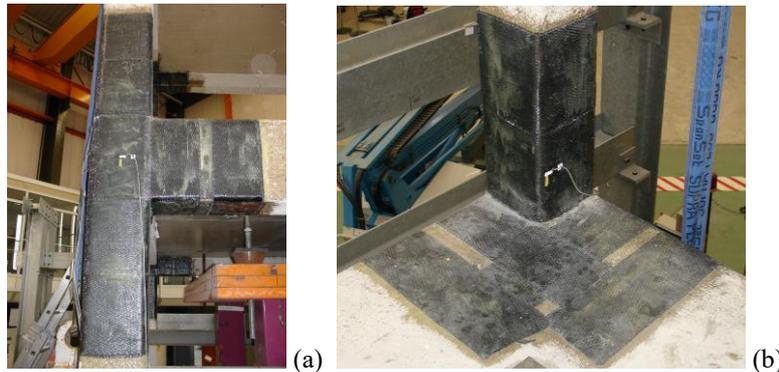
Fig. 9 - View of the CFRP strengthening after the testing phase 4 at PGA=0.35g
(a) external view of 1st storey joint, (b) internal view of 1st storey joint

no apparent damage was caused on the CFRP sheets or on the straps. Overall, the CFRP sheets maintained their physical integrity (Fig.9) and the metal straps maintained most of the post-tensioning force, with the exception of some longitudinal straps placed along the columns of the 1st floor joints. Some cracking was also evident at the beam-column joints, but only on frame B (Fig.7a) where the PTMS strengthening was applied. The damage observed in the frame in phase 4 indicated that the repairs and CFRP/PTMS strengthening intervention prevented the premature shear failure of the deficient joints.

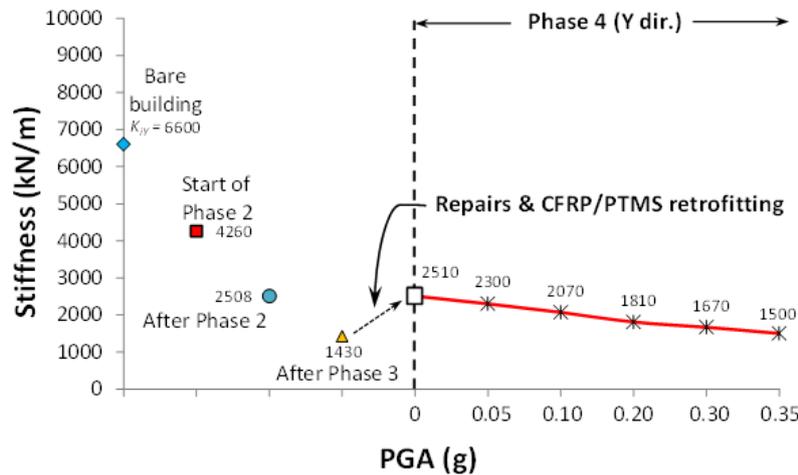
Fig. 10 - Lateral stiffness during testing phase 4 (Y direction)

The analysis of the global lateral stiffness of the structure (K) during testing phase 4 was performed, based on the implementation of an equivalent SDOF model. This showed that the repairs and strengthening restored the stiffness of the building from $K=1430$ kN/m (end of phase 3) to 2510 kN/m (beginning of phase 4), resulting in an enhancement of 75% (Fig.10). At the end of phase 4 (PGA=0.35g), damage accumulation degraded the stiffness of the original bare frame building by 77% (from 6600 kN/m at the beginning of phase 1 to 1500 kN/m). Despite this severe stiffness reduction, the limited structural damage observed after phase 4 indicated that the building was capable of sustaining seismic shaking at higher seismic intensities. Further tests confirmed that the stability of the building was not compromised even during the shake table tests at PGA of 0.60g. In general, the adopted CFRP strengthening solution was very effective in preventing

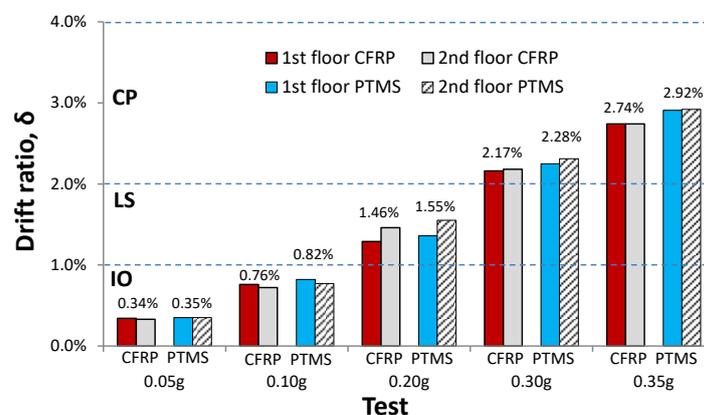
Fig. 11 - Interstorey drift ratio of 1st and 2nd floors during phase 4 (Y direction)

The maximum interstorey drift ratios of the 1st and 2nd floor of the CFRP and PTMS-strengthened frames are shown in Fig.11. This figure presents the results from two equidistant displacement transducers fixed on each exterior face of the slabs, labelled as “CFRP” and “PTMS” according to the strengthening technique used on the frame. It is shown that the 1st and 2nd floors of the strengthened frame had similar δ_s at all PGA levels. This implies that both CFRP/PTMS strengthening solutions led to a more uniform damage distribution over the building height, which allowed a better exploitation of the available capacity of members. The building remained safe within the CP performance level during the last test at PGA of $0.35g$ ($\delta=2.92\%$). Overall, maximum drift values of the “PTMS” frame were only 2-6% larger than those of the “CFRP” frame, thus indicating that some negligible in-plane torsion occurred during the tests.
